MONTGOMERY COUNTY DEPARTMENT OF PARKS
THE MARYLAND-NATIONAL CAPITAL PARK AND PLANNING COMMISSION

MEMORANDUM

SUBJECT: Remedial Measures Program for Lake Needwood Dam

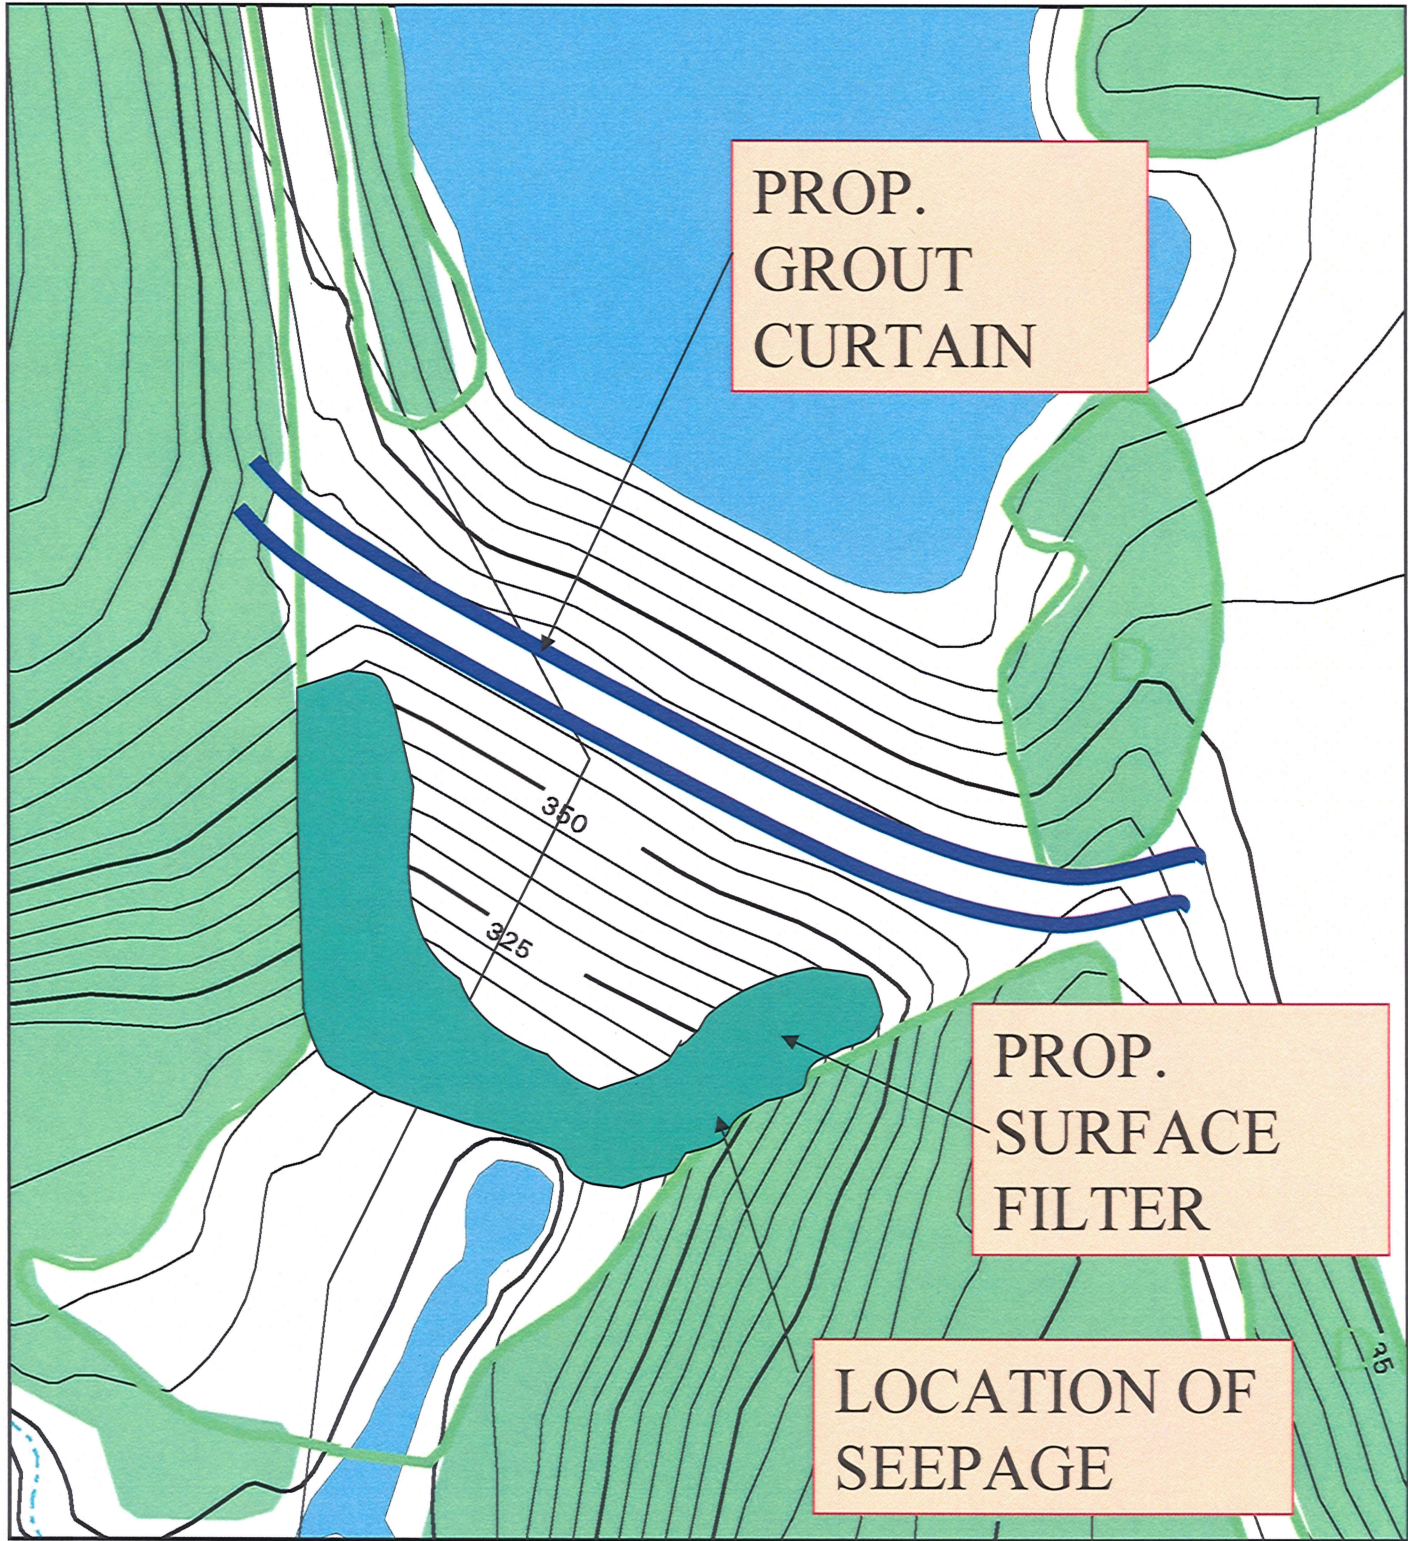
LAKE NEEDWOOD REMEDIAL MEASURES

flowpaths within the existing bedrock, which is the likely cause of the recent seepage event. On the other hand, the subsurface exploration within the dam embankment itself did not reveal any significant defects that would be able to produce the amount of seepage observed during the June 2006 event. Therefore, based on the subsurface information, it was determined that the seepage occurred through the fractured rock beneath the dam rather than through the embankment itself. Additionally, a review of the monitoring well data indicates that the existing stone blanket installed below the downstream side of the dam may not be functioning to convey seepage water to the toe of dam, as designed.

A second technical meeting was held in late October 2006, where the installation of a grout curtain into the bedrock foundation and abutments together with construction a new surface drainage/filter blanket on the downstream slope was selected as the preferred means of rehabilitating the dam. The grout curtain installation consists of drilling a series of holes down through the embankment into underlying bedrock and injecting cement grout to fill the fractures in the rock, which will significantly reduce the potential for water from the reservoir to flow around the dam and create another seepage occurrence on the downstream side of the dam. The downstream surface filter will collect any residual water from the reservoir that might flow around the grout curtain or come from the rock abutments along the downstream side of the dam and safely convey it to the outfall.
