## MEMORANDUM

**RE:** **Randolph Hills Park Activity Building and Future Use Options**  
Pubic testimony will be taken

**Engineering Consulting Services**  
**Randolph Hills Recreation Building**  
**Westmoreland Hills Recreation Building**  
**Ken-Gar Palisades Recreation Building**

**FEA Project No.: R01.2006.004801**  
**December 11, 2007**

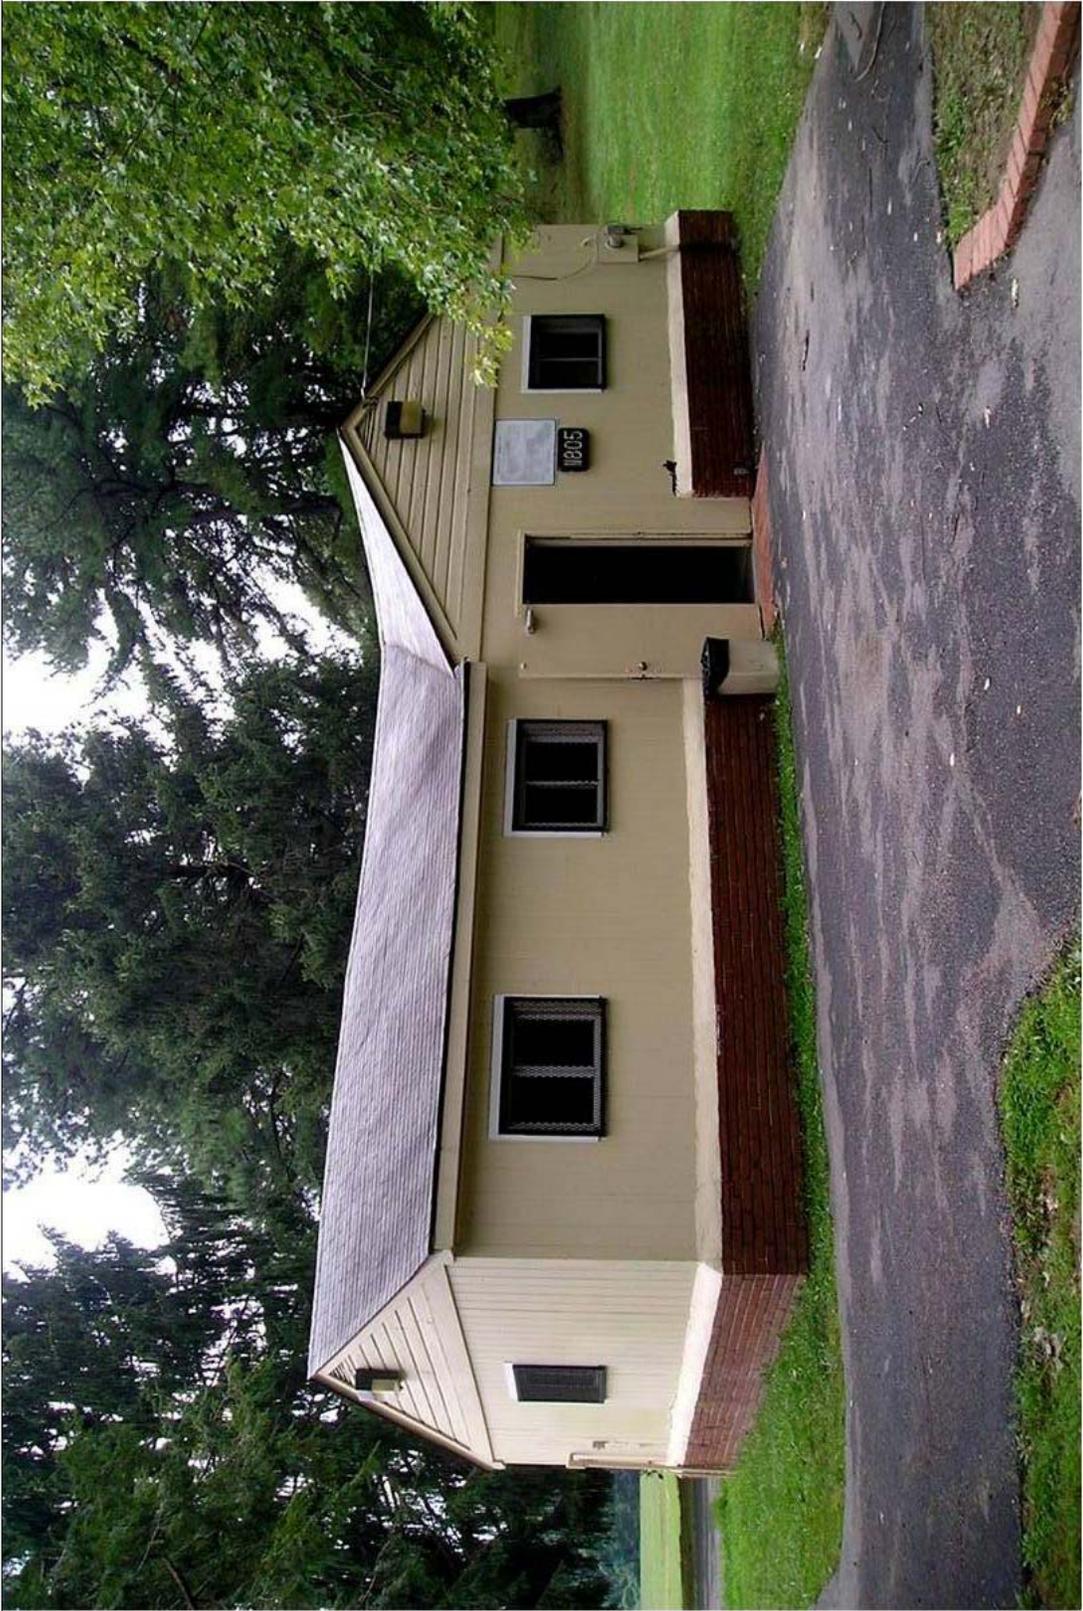
**Figure 3 - Randolph Hills Park Activity Building**

The park activity building is a pre-fabricated house that was donated to the park system after being declared surplus by the Navy in 1956. A picture is attached as *Figure 3*. Over the past 50 years, it has been rented by the hour for use as meeting space, parties, and classes. Based on recent engineering studies, the building is no longer safe or suitable for public use and has been closed. Department of Parks staff has concluded the building should be demolished. The basis for this recommendation is included as *Attachment 1*.

Based on FEA recommendation and this building history, we recommend that this building be closed to the public and demolished.

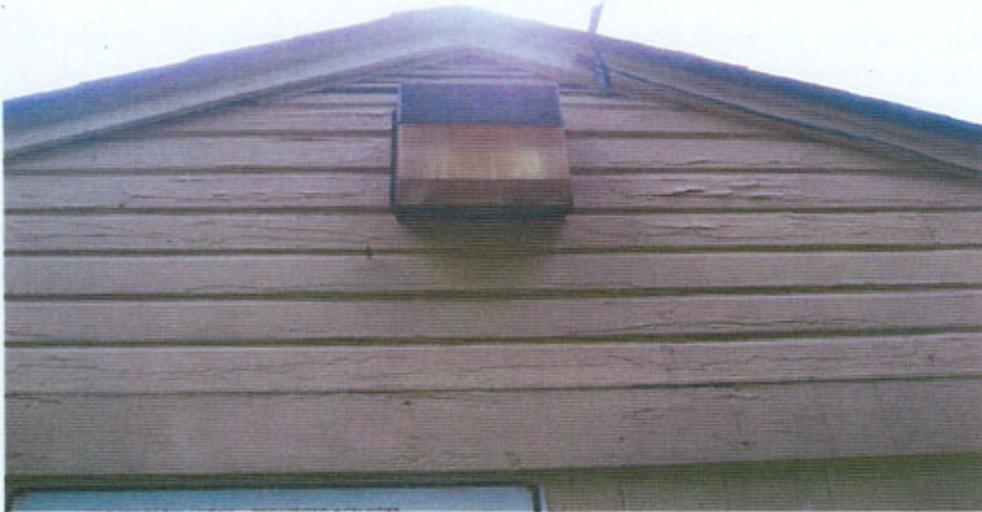
**PHOTOGRAPH 1:**  
Exterior Paint Peeling on  
Gable End Siding

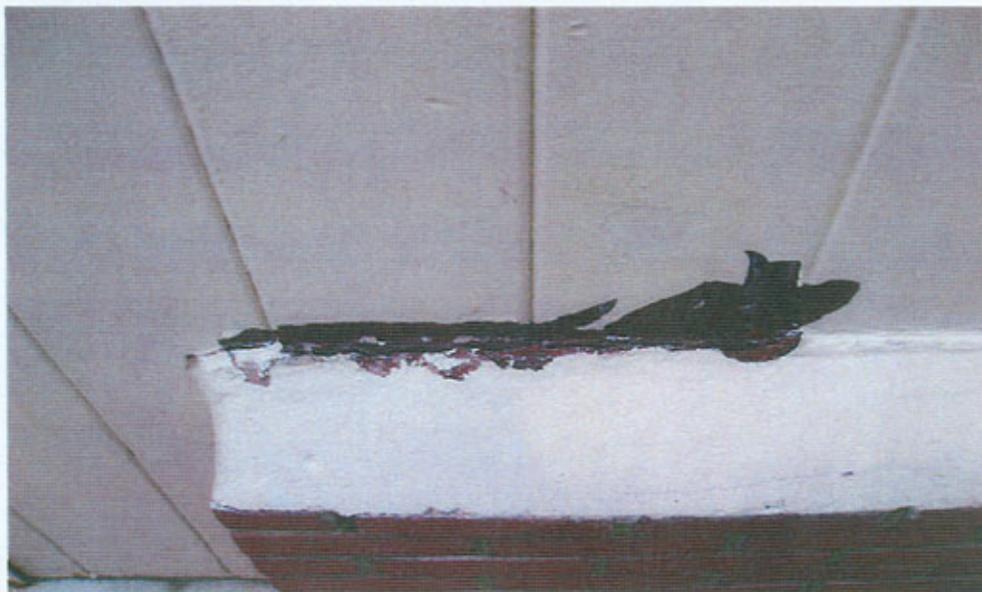
Mildew staining was noticed on exterior walls, and a mildew odor was noticed throughout the building. It was reported, but not visually observed by FEA, that the exterior walls were rotting and the building has been exposed to water infiltration, which is possibly compromising the integrity of the structure. We recommend a structural evaluation be performed to help determine the cause of the moisture infiltration, the extent of deterioration, and the integrity of the exterior wood walls. This type of investigation should include opening and observing the wall system construction, and noting the condition of the underlying structural elements. For budgeting purposes, we

**PHOTOGRAPH 2:**  
Area of Expected Exterior  
Wall Water Infiltration

We also recommend that a mold evaluation and air sampling be performed at the time of the structural evaluation. This is so mold samples can be taken from inside the exterior wall cavity. Once the evaluation is complete, recommendations for remediation or repairs should be followed. Actual cost for repairs for any structural findings is not included in capital expenditure forecast due to unknown problems. Any damage to the building prior to and after the evaluation should be repaired. Peeling paint was also observed on the exterior walls (at gable ends) that we recommend be tested for lead before any exterior repairs are performed.

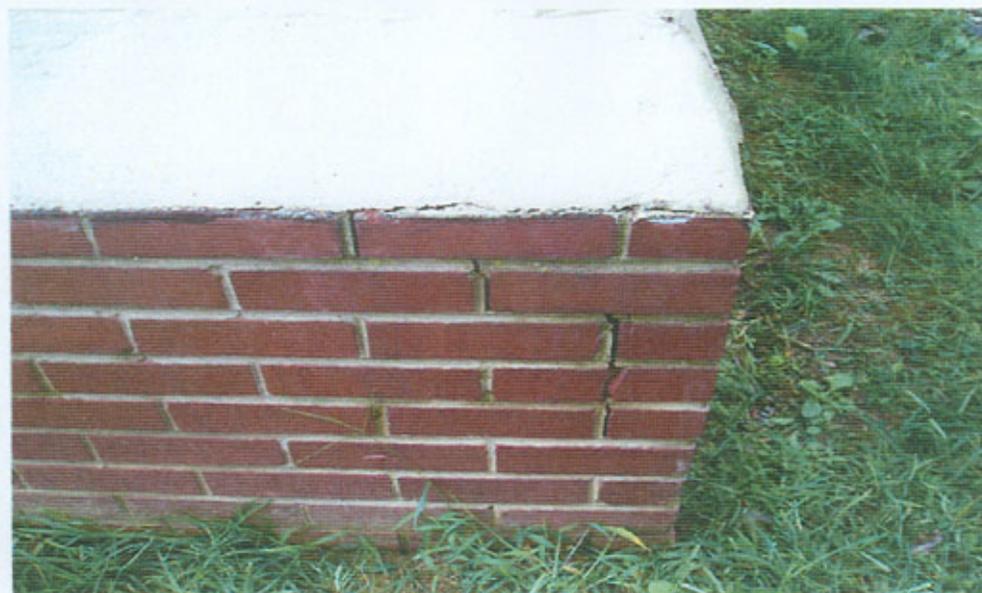
**PHOTOGRAPH 3:**  
Minor Cracks in Exterior  
Brick and Mortar Joints

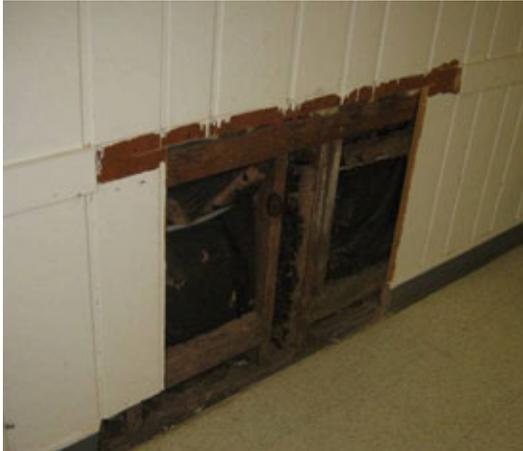
For the structural evaluation, three exploratory openings were made: one in the wall in the back mechanical room, one in the interior of the north-east wall of the main room, and one in the interior of the south-west wall of the main room. The opening in the mechanical room was made at the reported location of an opening made during the 1995 building study. This opening revealed limited deterioration, but, due to evidence of newer wood from a localized repair, the condition at this location should be considered separately from that of the overall building. In each main room opening, several linear feet of baseboard and wall panels beneath the chair rail were removed. At these locations, FEA observed severe structural deterioration due to water infiltration. The wooden sill plates and studs were in extremely poor condition, and high levels of moisture were found. There appeared to be potential microbial growth in the wall cavity as well as possible insect damage. Our assessment indicated the conditions observed were widespread and not isolated to the exploration locations. Also, deflection of the roof decking was noted, but significant structural defects were not observed.

Figure A-2: Interior opening, South-West wall

To correct the deficiencies noted, the recommended repairs would generally include removal of wall finishes, replacement of structural members, and abatement of hazardous materials. Also, modification to roof framing components in order to meet current code requirements may be needed. Essentially, M-NCPPC should expect overall removal, reframing, and reconstruction of building wall elements as well as a possible reconstruction of the foundation in order to restore this building. Based on the extent of deterioration, we recommend reconstruction rather than component repair. Our opinion of cost is based on this approach.

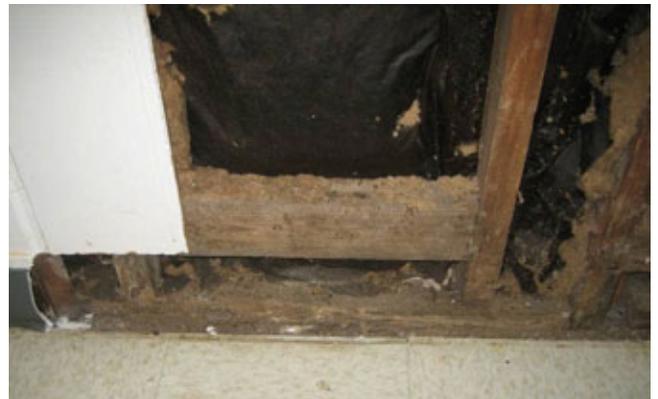
Figure A-3: Interior opening, South-West wall

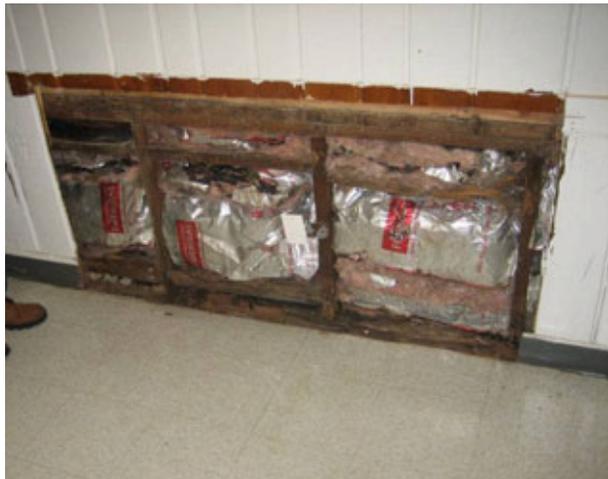
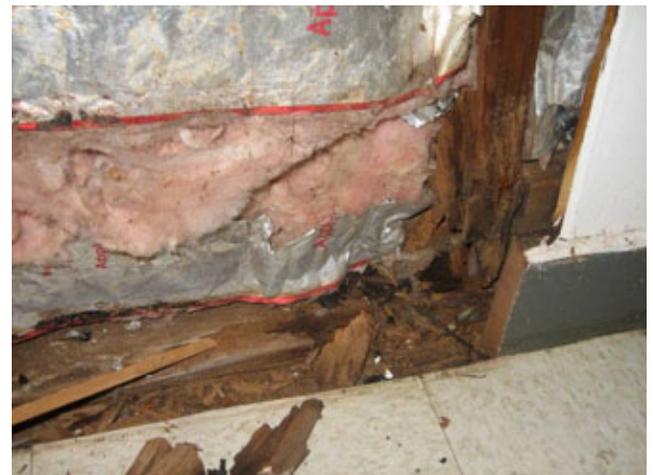
Figure A-4: Interior opening, North-East wall

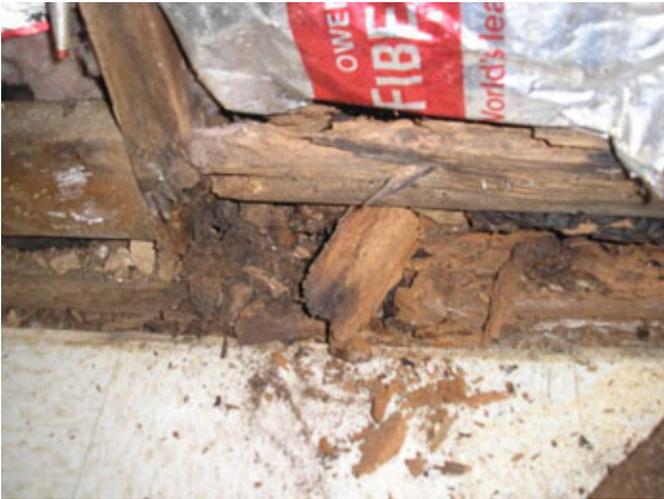
Figure A-6: Significant deterioration

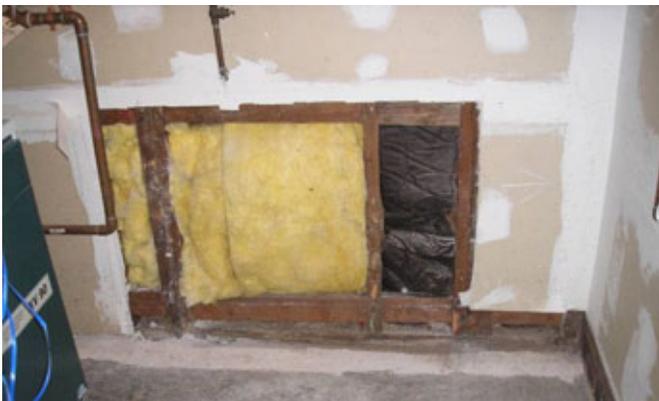
Figure A-7: Mechanical room wall opening

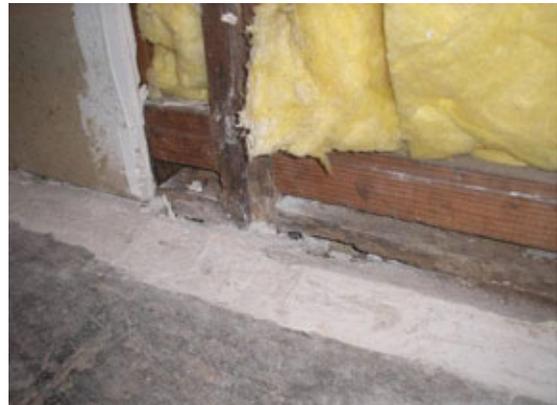
Figure A-8: Mechanical room wall opening

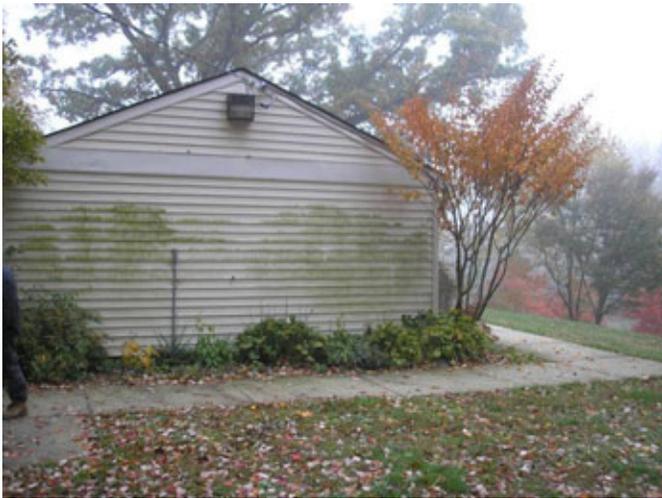
Figure B-2: North wall

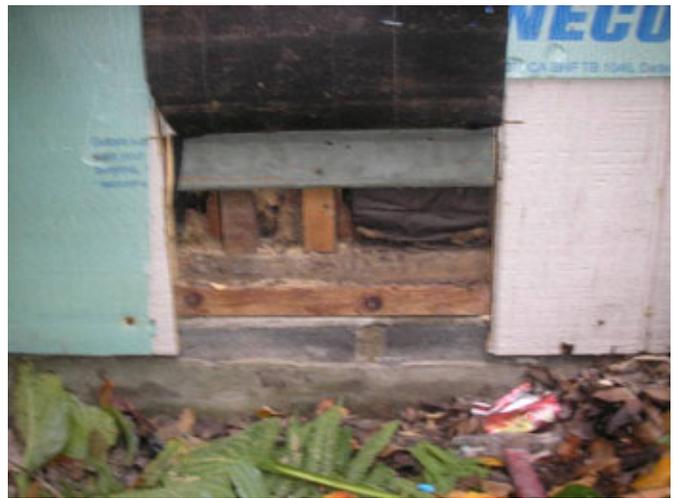
For the structural evaluation, exploratory openings were made at the exterior of the north wall and in three interior locations along the base of the walls for a total of four openings. There was minimal evidence of deterioration at the exterior exploratory opening, but the interior locations showed significant structural deterioration. Based on our assessment, deterioration appeared to be widespread rather than isolated in the building. At the interior openings, FEA observed extensive wood element deterioration due to water infiltration, which could have been caused by several potential sources. There also appeared to be potential microbial growth in the wall cavity and possible insect damage.

Figure B-3: North wall exterior opening

To correct the deficiencies noted, recommended repairs include removal of wall finishes, replacement of structural members, and abatement of hazardous materials. Also, it is possible that modification of roof framing components in order to meet current code requirements is needed. Essentially, M-NCPPC should expect overall removal, reframing, and reconstruction of building wall elements as well as a possible reconstruction of the foundation in order to restore this building. Based on the extent of deterioration, we recommend reconstruction rather than component repair. Our opinion of cost is based on this approach.

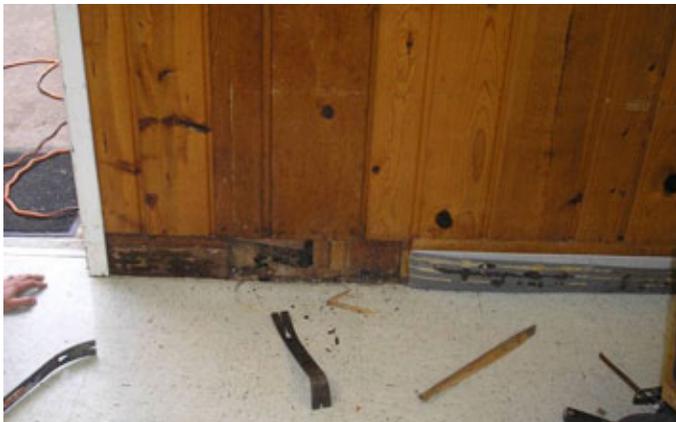
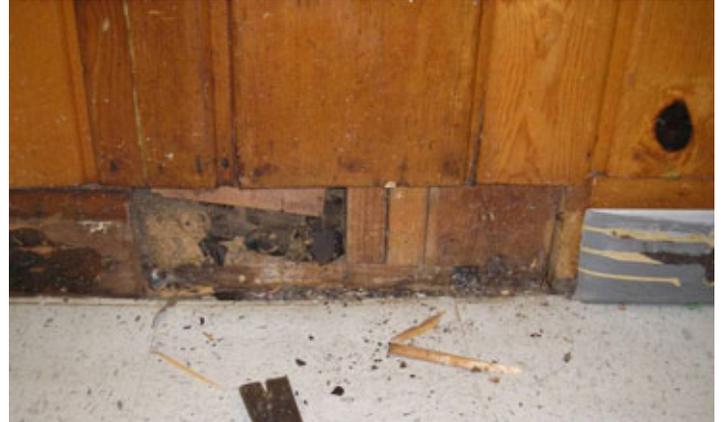
Figure B-4: Interior opening, South of front door

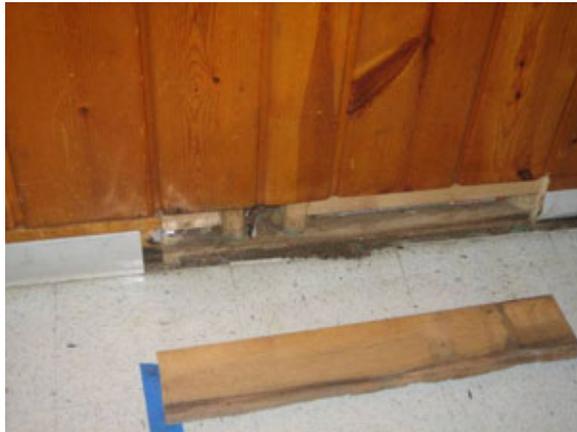
Figure B-5: Interior opening, South of front door

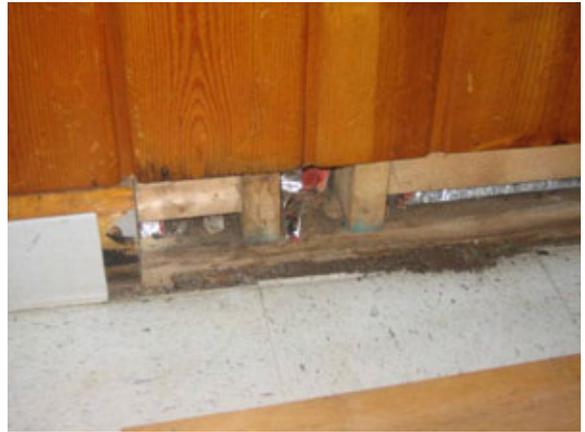
Figure B-6: Interior opening, East wall

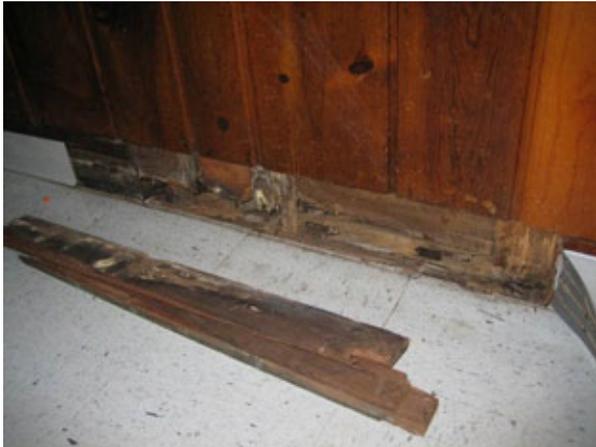
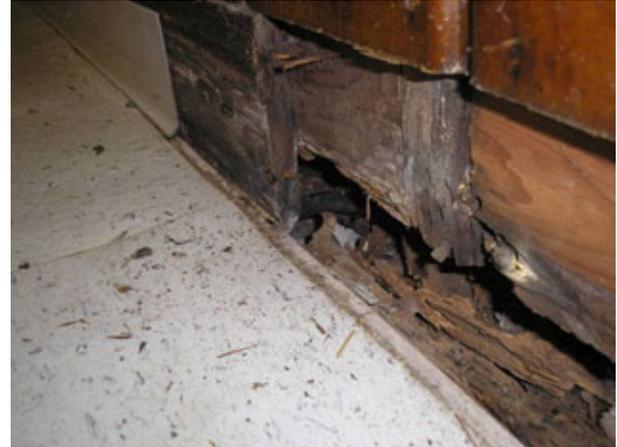
Figure B-7: Interior opening, North of front door

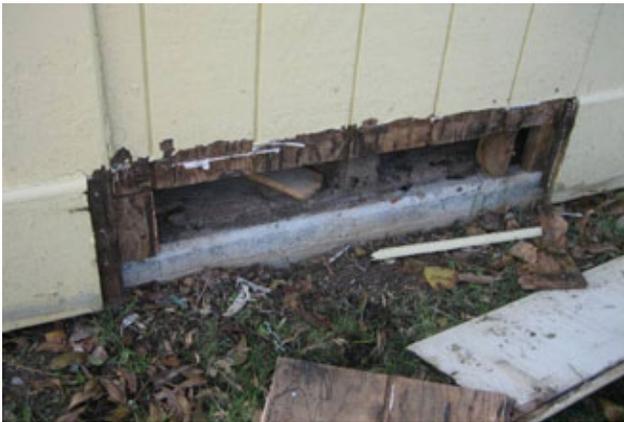
During our evaluation, an opening to provide access to the crawl space was installed and an exploratory opening on the exterior of the east wall was made. FEA also observed conditions in the attic. The exterior opening revealed severe deterioration of wood elements at that location of the building perimeter. Foundation sill plates, wall elements, floor elements, and joists supporting the wall plate were all deteriorated where there was close proximity to soil and moisture. However, while the condition was severe, it appeared to be localized; joints and support elements adjacent to deteriorated sections were observed to be in satisfactory condition. There was evidence that modifications to the exterior wall had been made on the east gable. The crawl space investigation revealed that the floor system was well supported by means of a system of concrete block and wood framing. The condition of framing members, as observed from the crawl space, was generally good. Significant deterioration was not observed. Observations from the crawl space indicated that the elevated structure was not exposed to poor drainage on the west half of the building. The deterioration at the east wall was limited to an isolated area.

Figure C-2: Exterior wall opening, East wall

Overall, this building was in fair condition. To correct the deficiencies noted, we recommend partial-height repairs of the structural framing and replacement of finishes along the east wall (approximately a 20-foot-long area). Also, general framing improvements may be added for stability.

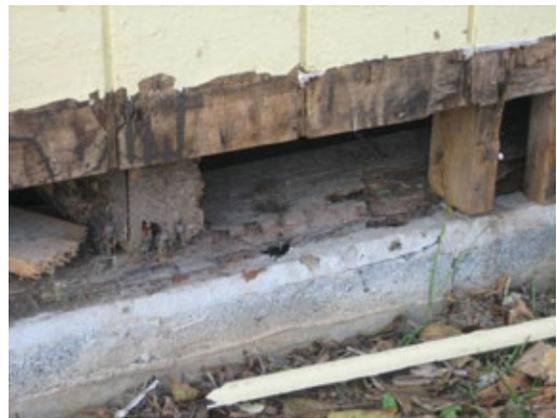
Figure C-3: Exterior opening, East wall

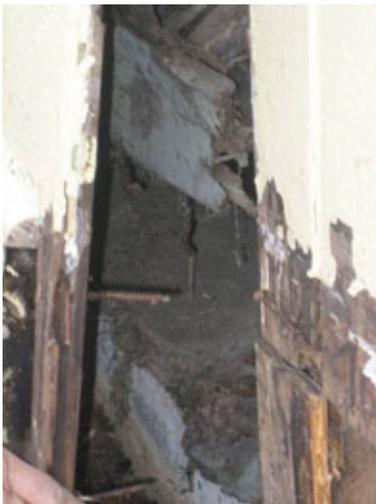
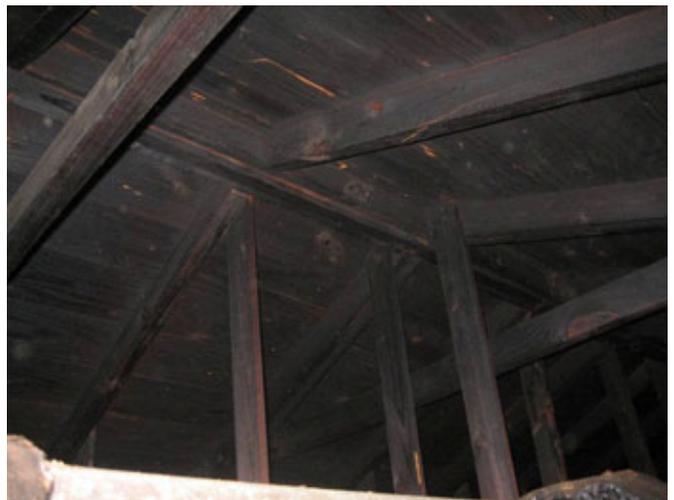
Figure C-4: Exterior opening, East wall

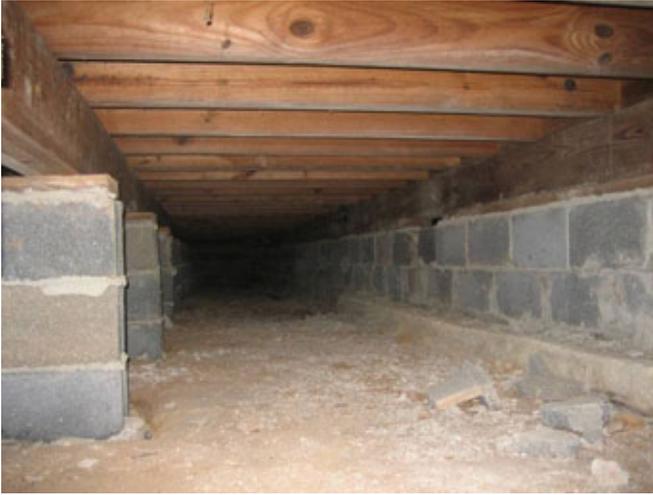
Figure C-6: Crawl space

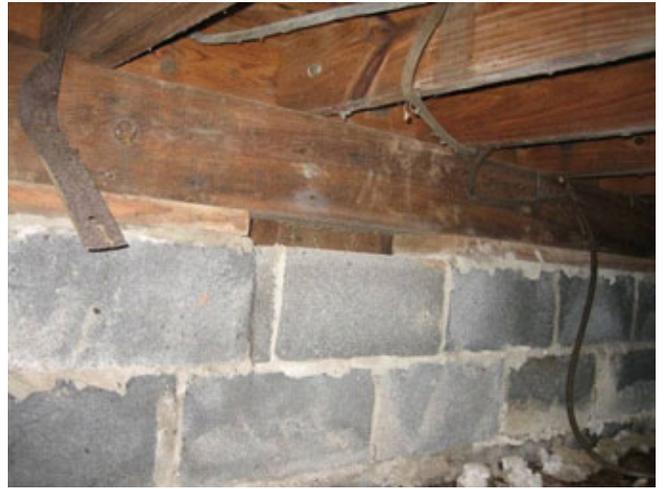
Figure C-7: Crawl space wall
