To: Montgomery County Park Board  
Via: Mary Bradford, Director of Parks  
Mike Riley, Deputy Director of Parks  
From: Carrye Palleschi, Park Property Manager  
Date: December 31, 2008  
Re: **Westmoreland Hills Ancillary Building and Future Park Options**  
Public Testimony will be taken

##### **Approve Demolition of Westmoreland Hills Park Ancillary Building**

**SUBJECT: Engineering Consulting Services: Limited Structural Evaluation  
Randolph Hills Recreation Building – Spring, Maryland  
Westmoreland Hills Recreation Building – Bethesda, Maryland  
Ken-Gar Palisades Recreation Building – Kensington, Maryland  
FEA Project No. R01.2006.004801**

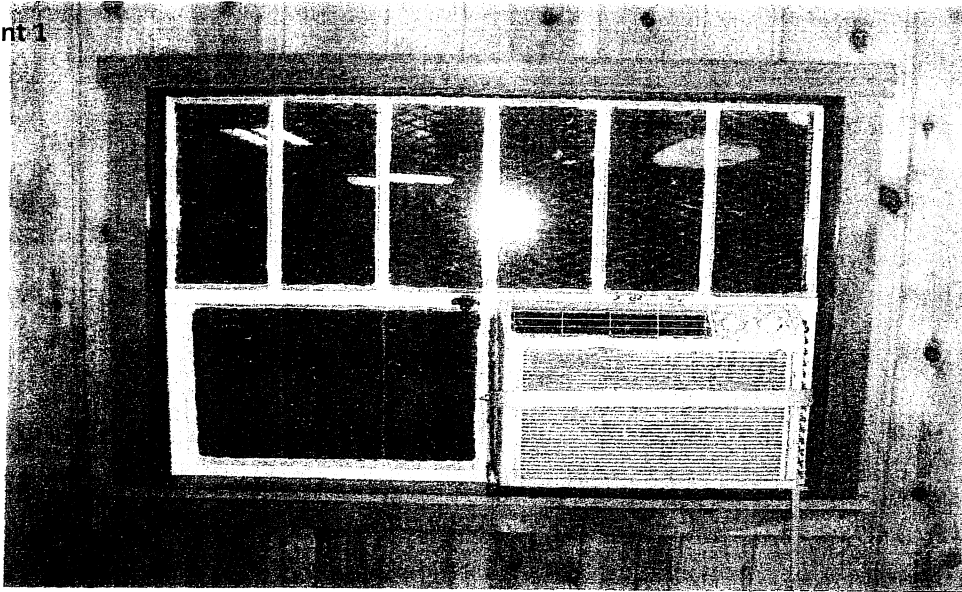
**PHOTOGRAPH 1:**  
Painted Window with Air  
Conditioner Unit

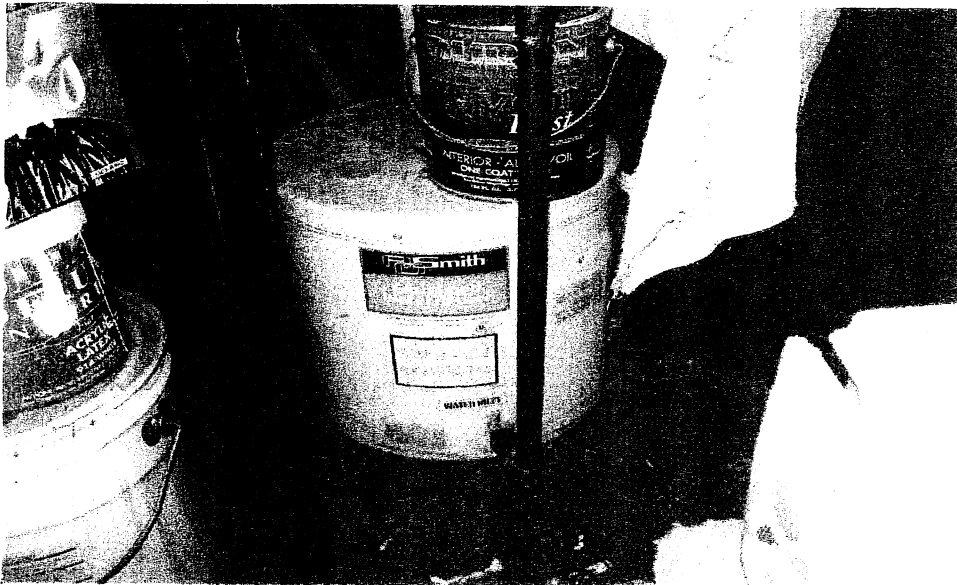
Heating for the building is provided by a natural gas-fired furnace that was installed in 2002, and appeared to be in overall good condition. The six-gallon domestic water heater located in the mechanical room was not functioning and immediate replacement is recommended.

**PHOTOGRAPH 2:**  
Non-operational Domestic  
Water Heater

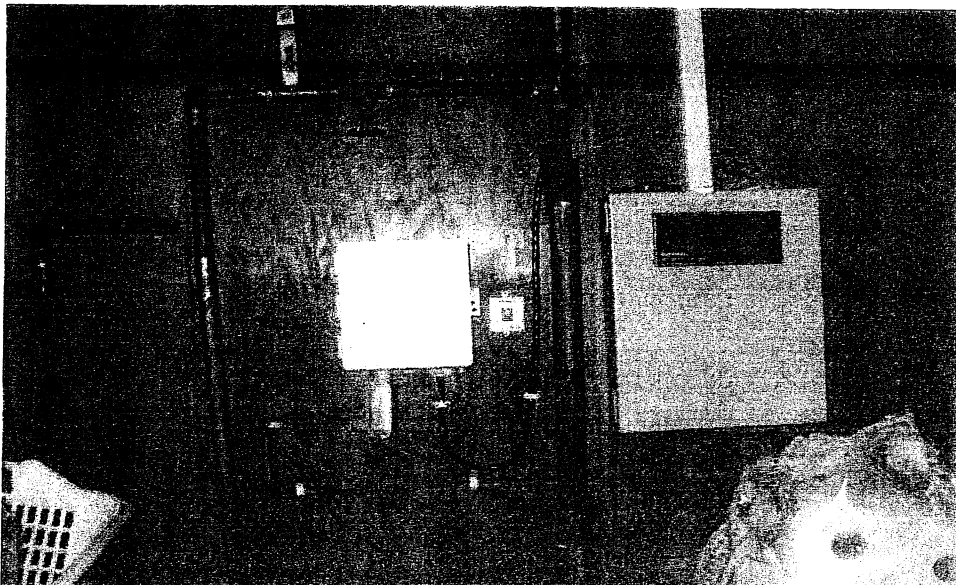
The building is equipped with a security access system that has been abandoned in place. The system was provided to monitor the interior spaces with door sensors and motion detectors. Fire and life safety elements include egress lighting and emergency exit lights. Replacement of the security and fire alarm system is recommended in 2007, as one project.

**PHOTOGRAPH 3:**  
Abandoned Security System  
in Building

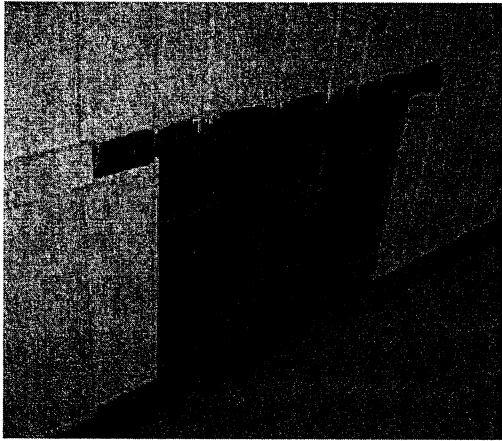
Figure A-2: Interior opening, South-West wall

For the structural evaluation, three exploratory openings were made: one in the wall in the back mechanical room, one in the interior of the north-east wall of the main room, and one in the interior of the south-west wall of the main room. The opening in the mechanical room was made at the reported location of an opening made during the 1995 building study. This opening revealed limited deterioration, but, due to evidence of newer wood from a localized repair, the condition at this location should be considered separately from that of the overall building. In each main room opening, several linear feet of baseboard and wall panels beneath the chair rail were removed. At these locations, FEA observed severe structural deterioration due to water infiltration. The wooden sill plates and studs were in extremely poor condition, and high levels of moisture were found. There appeared to be potential microbial growth in the wall cavity as well as possible insect damage. Our assessment indicated the conditions observed were widespread and not isolated to the exploration locations. Also, deflection of the roof decking was noted, but significant structural defects were not observed.

To correct the deficiencies noted, the recommended repairs would generally include removal of wall finishes, replacement of structural members, and abatement of hazardous materials. Also, modification to roof framing components in order to meet current code requirements may be needed. Essentially, M-NCPPC should expect overall removal, reframing, and reconstruction of building wall elements as well as a possible reconstruction of the foundation in order to restore this building. Based on the extent of deterioration, we recommend reconstruction rather than component repair. Our opinion of cost is based on this approach.

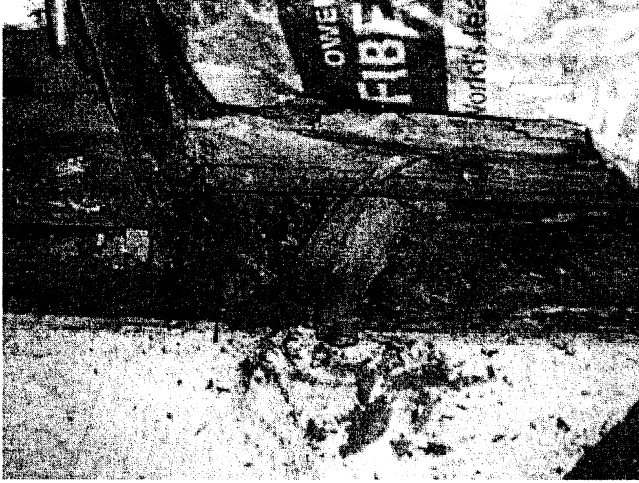
Figure A-5: Interior opening, North-East wall

Figure A-6: Significant deterioration

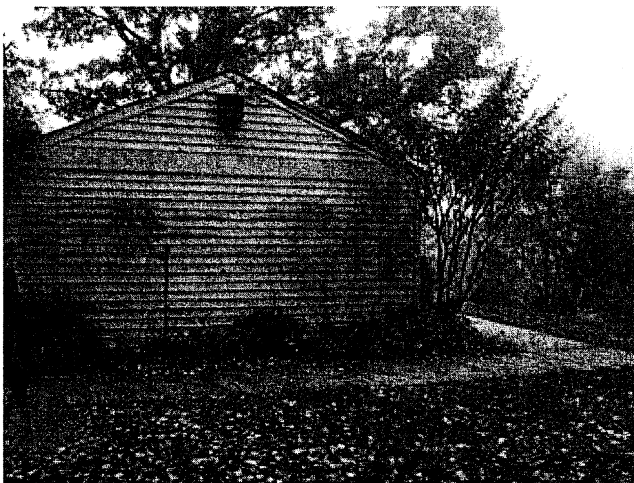
Figure B-2: North wall

For the structural evaluation, exploratory openings were made at the exterior of the north wall and in three interior locations along the base of the walls for a total of four openings. There was minimal evidence of deterioration at the exterior exploratory opening, but the interior locations showed significant structural deterioration. Based on our assessment, deterioration appeared to be widespread rather than isolated in the building. At the interior openings, FEA observed extensive wood element deterioration due to water infiltration, which could have been caused by several potential sources. There also appeared to be potential microbial growth in the wall cavity and possible insect damage.

To correct the deficiencies noted, recommended repairs include removal of wall finishes, replacement of structural members, and abatement of hazardous materials. Also, it is possible that modification of roof framing components in order to meet current code requirements is needed. Essentially, M-NCPPC should expect overall removal, reframing, and reconstruction of building wall elements as well as a possible reconstruction of the foundation in order to restore this building. Based on the extent of deterioration, we recommend reconstruction rather than component repair. Our opinion of cost is based on this approach.

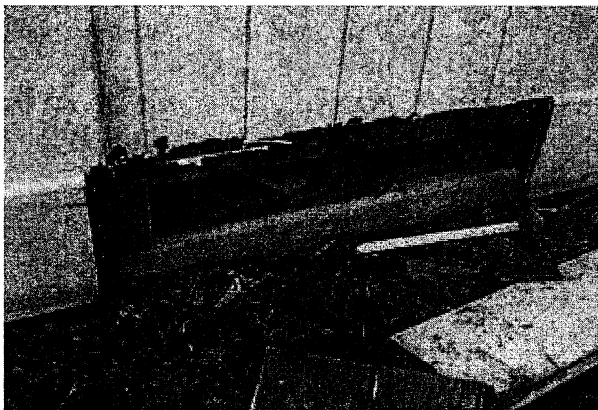
Figure C-2: Exterior wall opening, East wall

During our evaluation, an opening to provide access to the crawl space was installed and an exploratory opening on the exterior of the east wall was made. FEA also observed conditions in the attic. The exterior opening revealed severe deterioration of wood elements at that location of the building perimeter. Foundation sill plates, wall elements, floor elements, and joists supporting the wall plate were all deteriorated where there was close proximity to soil and moisture. However, while the condition was severe, it appeared to be localized; joints and support elements adjacent to deteriorated sections were observed to be in satisfactory condition. There was evidence that modifications to the exterior wall had been made on the east gable. The crawl space investigation revealed that the floor system was well supported by means of a system of concrete block and wood framing. The condition of framing members, as observed from the crawl space, was generally good. Significant deterioration was not observed. Observations from the crawl space indicated that the elevated structure was not exposed to poor drainage on the west half of the building. The deterioration at the east wall was limited to an isolated area.

Overall, this building was in fair condition. To correct the deficiencies noted, we recommend partial-height repairs of the structural framing and replacement of finishes along the east wall (approximately a 20-foot-long area). Also, general framing improvements may be added for stability.

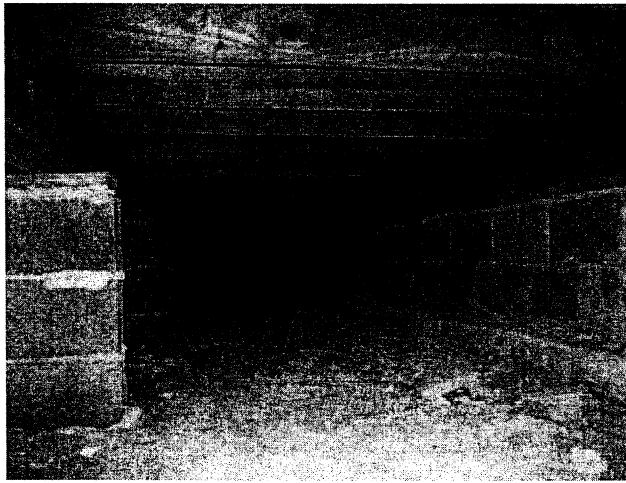
Figure C-6: Crawl space

The presence of soot found in the attic indicated the occurrence of a fire at some point in the building's history. Observations indicated that the roof was not deteriorated. The floor framing was observed to be in good condition.

To improve overall long-term performance of the building, ventilation should be improved in the crawl space and attic.
