APPENDIX A

PHOTOS

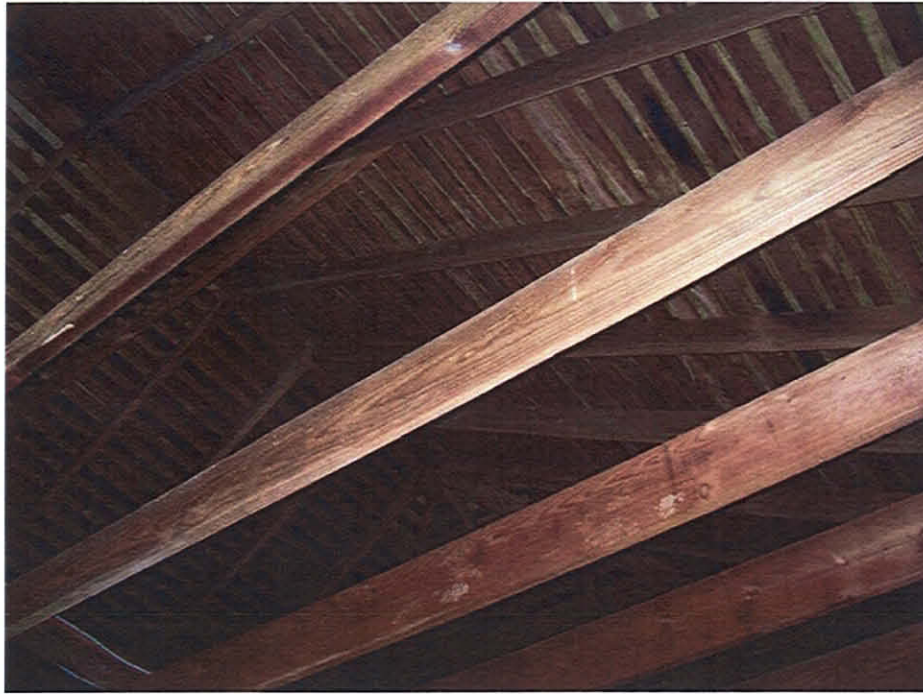
Picture #1: Roof construction system of the historic garage-Maintenance/Vehicle storage

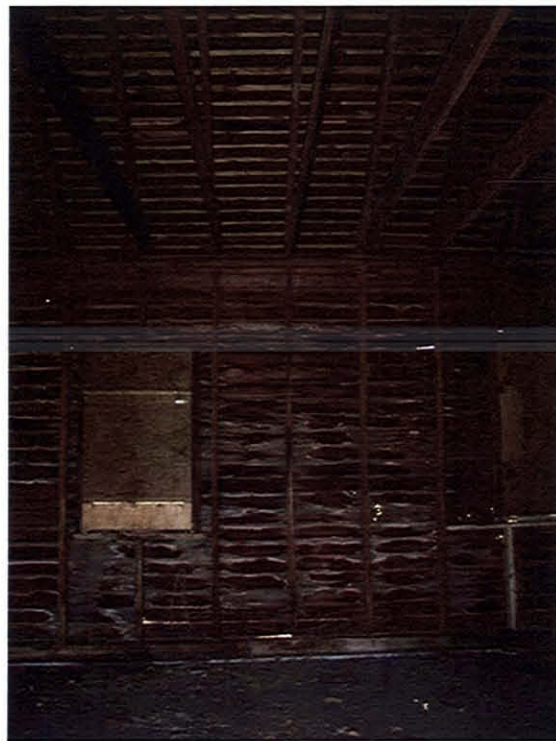
Picture #2: Stud wall, ceiling joists and roof rafters of the historic garage-Maintenance/Vehicle storage. Deteriorations in siding is visible from inside

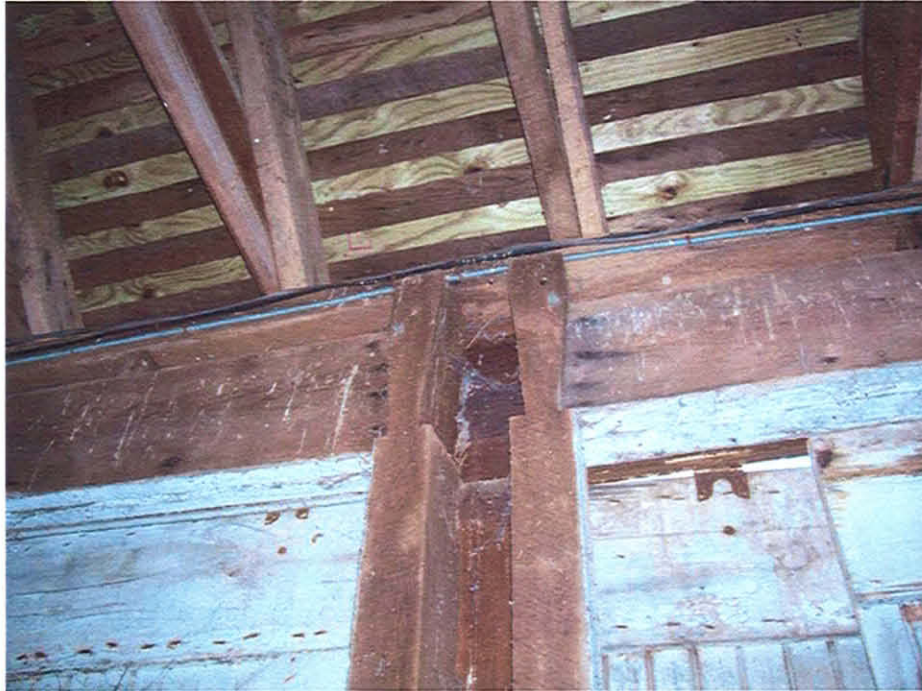
Picture #3: Headers over garage door openings and supporting 4x6 wood posts in the historic garage-Maintenance/Vehicle storage. No hurricane ties at ends of roof rafters.

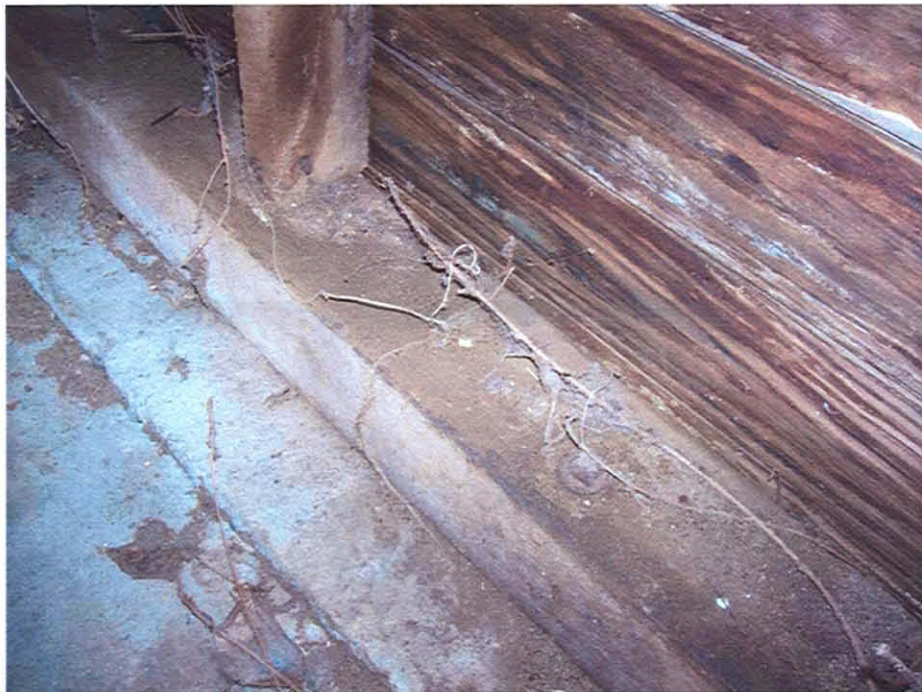
Picture #4: Continuous 4x6 sill plate at perimeter of the historic garage-Maintenance/Vehicle storage. 1/2" diameter anchor is visible in the picture.

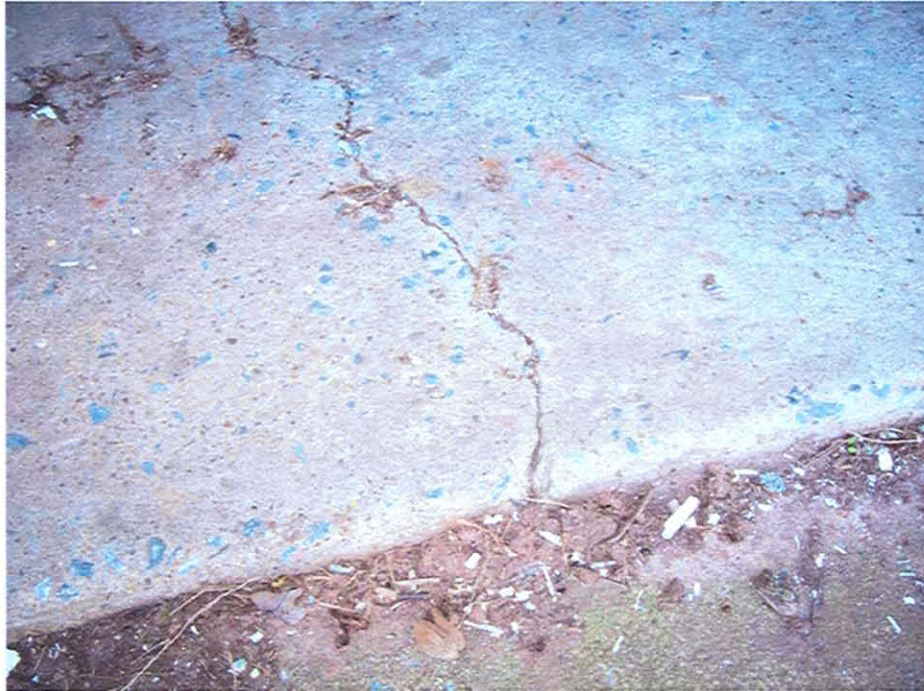
Picture #5: Crack in the concrete garage slab of the historic garage-Maintenance/Vehicle storage.

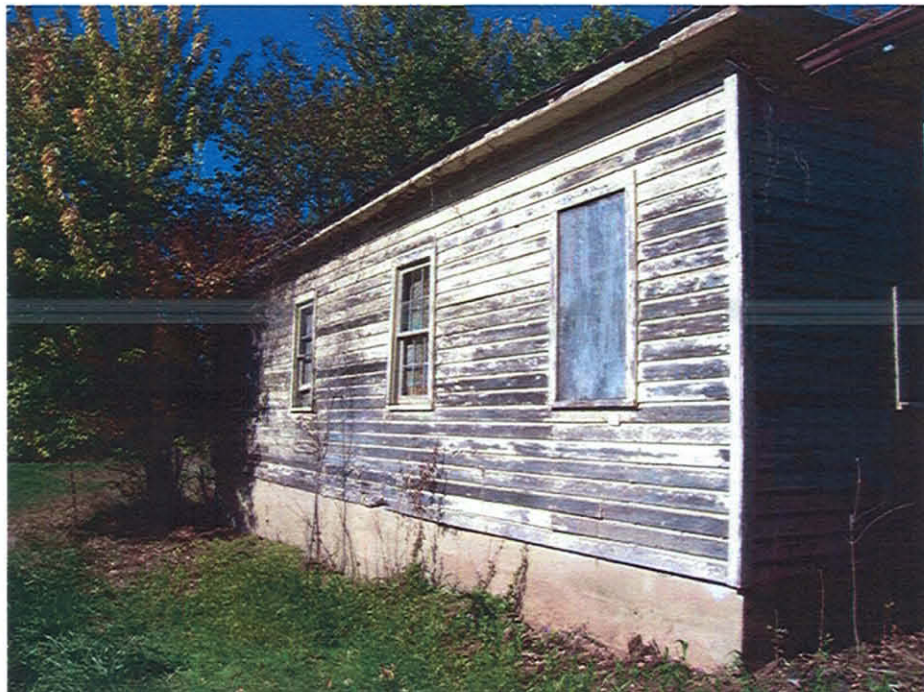
Picture #6: Deterioration of siding at the historic garage-Maintenance/Vehicle storage.

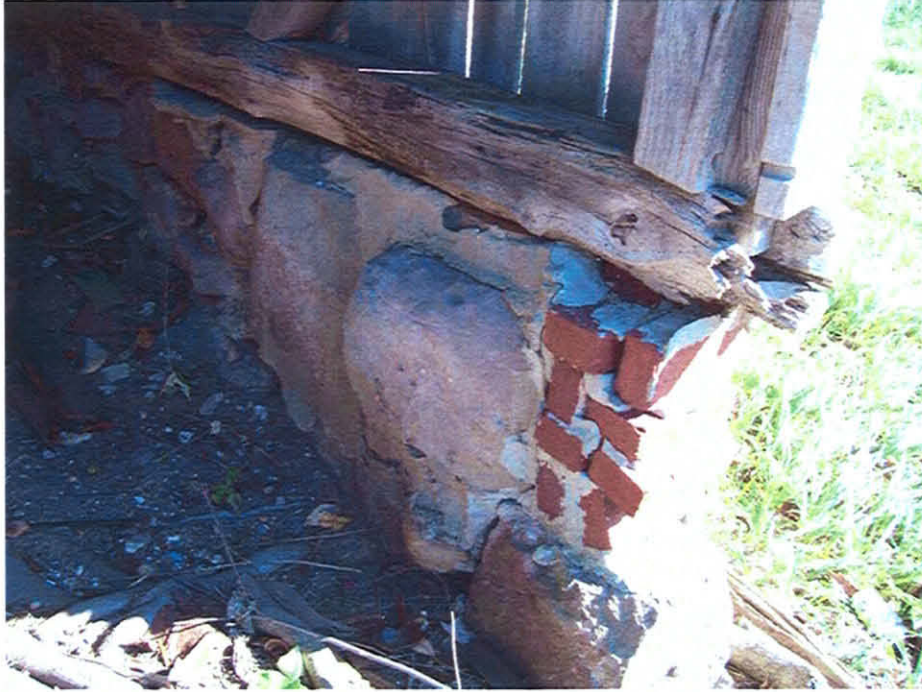
Picture #7: Damaged stone foundation on the south side of the historic barn.

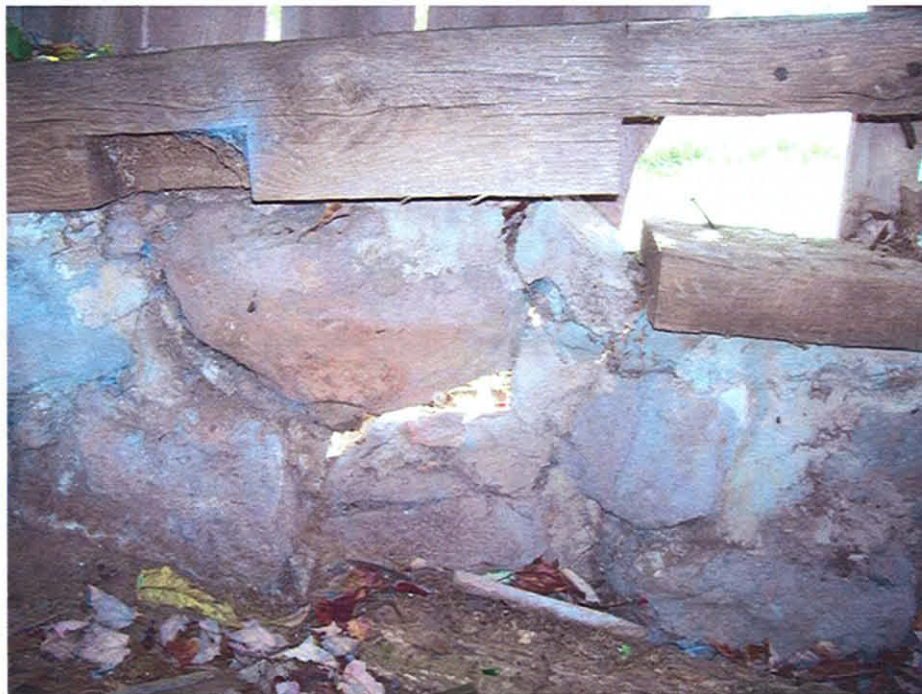
Picture #8: Damaged stone foundation on the south side of the historic barn.

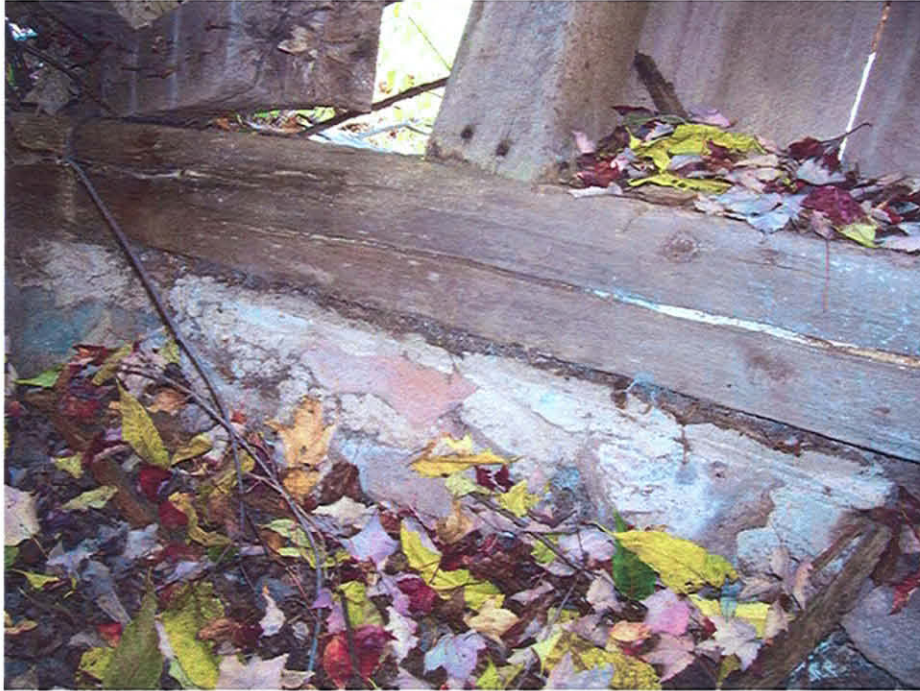
Picture #9: Damaged stone foundation on the south side of the historic barn. Super-Structure is on the verge of collapsing

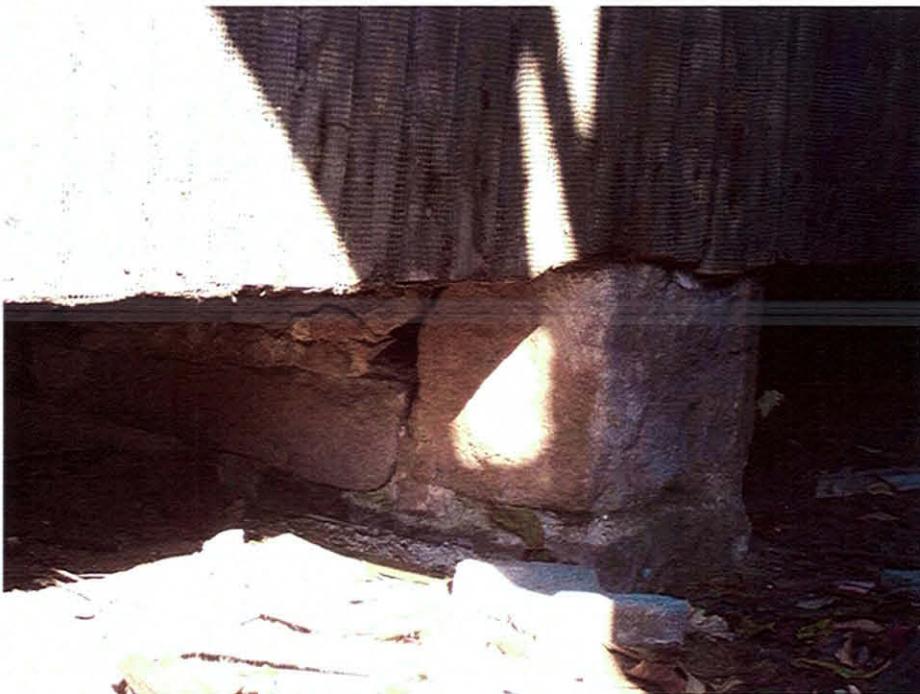
Picture #10: Individual stone piers in the historic barn are in acceptable conditions.

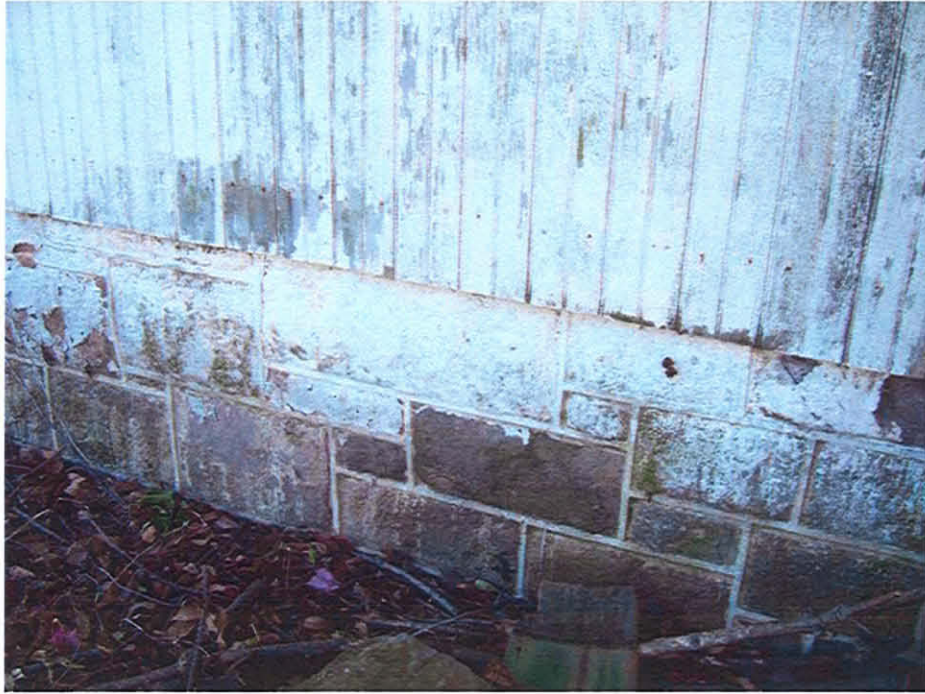
Picture #11: Stone foundation at north side of the historic barn is in acceptable conditions.

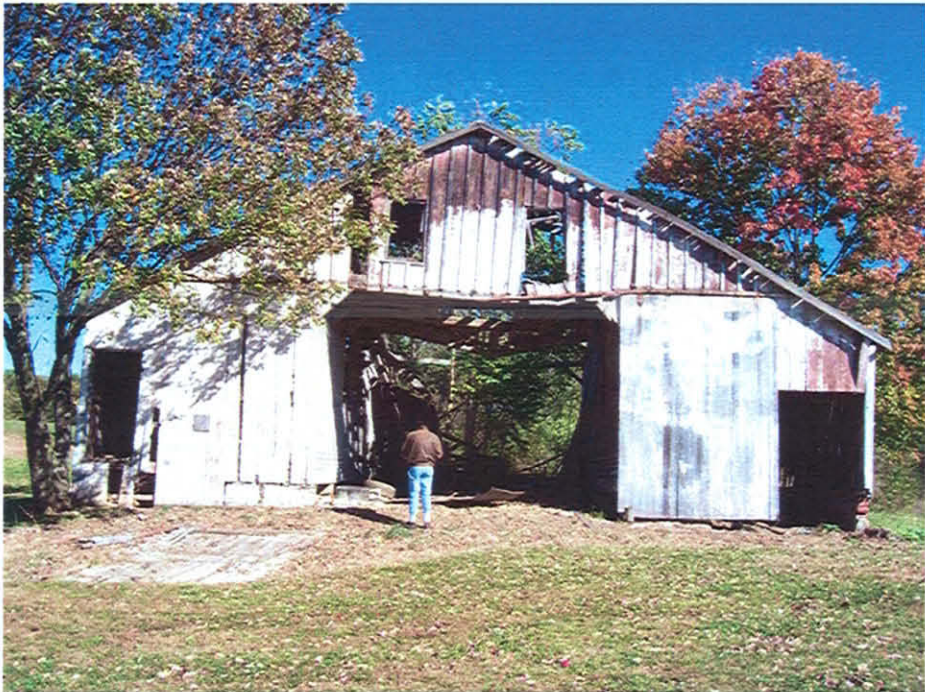
Picture #12: Super-structure of the historic barn is on the verge of collapsing.

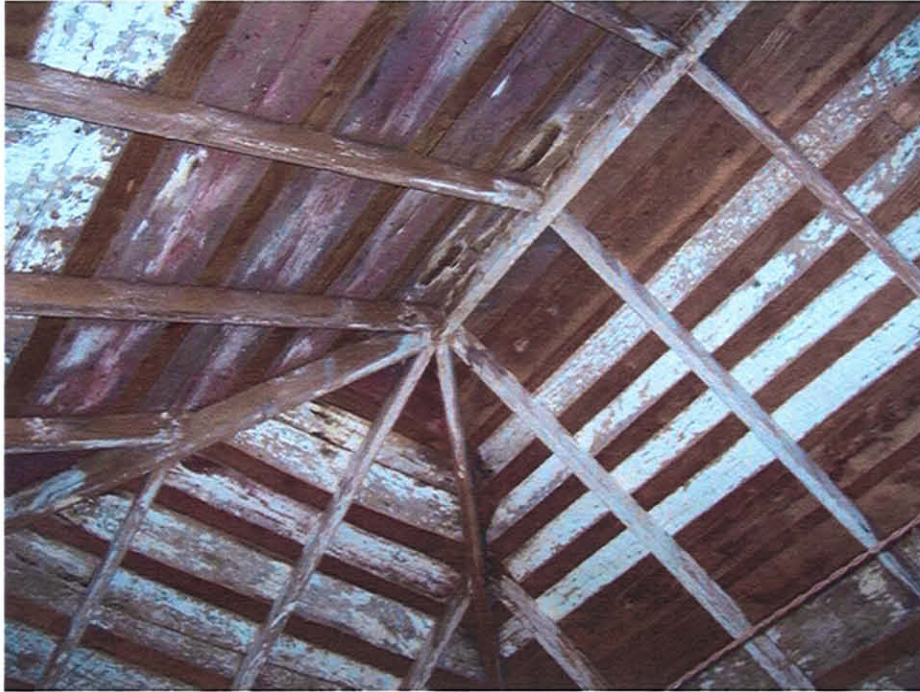
Picture #13: Roof construction system of the historic farm outbuilding

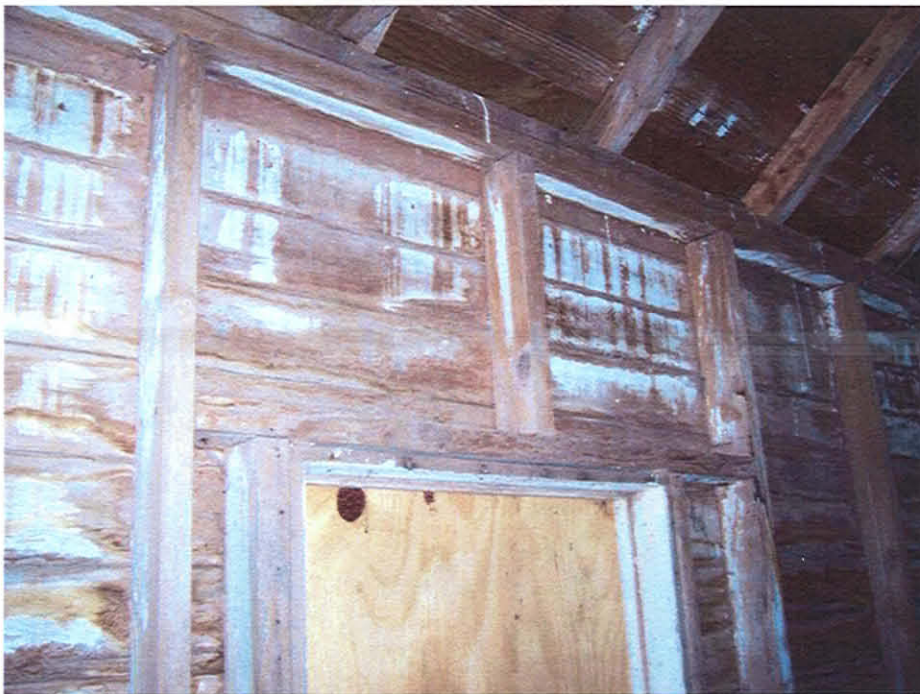
Picture #14: Historic farm outbuilding. No hurricane ties at rafter ends and no headers over openings

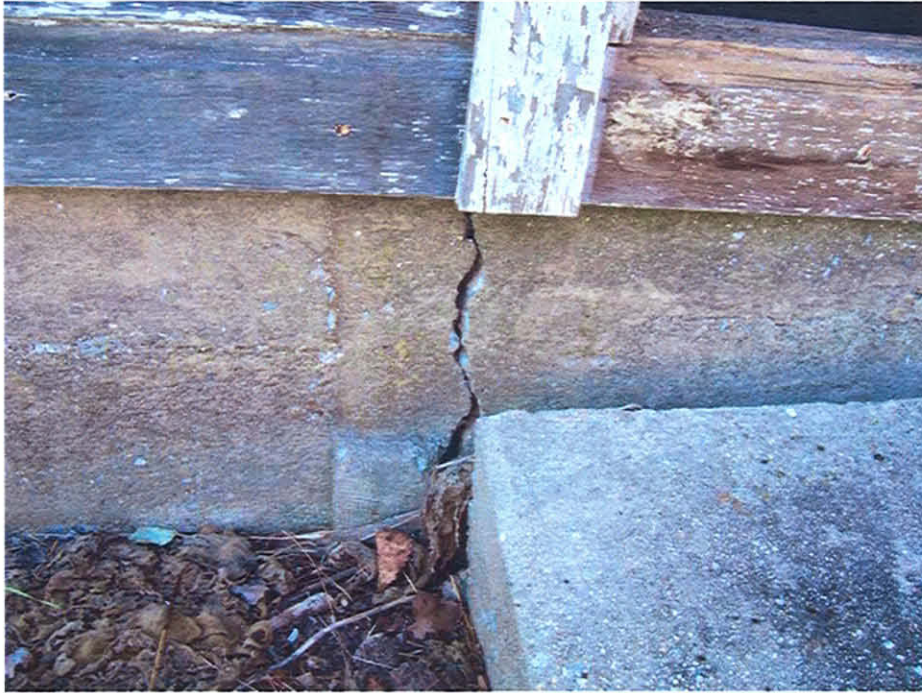
Picture #15: Major structural crack on the foundation wall of the historic farm outbuilding

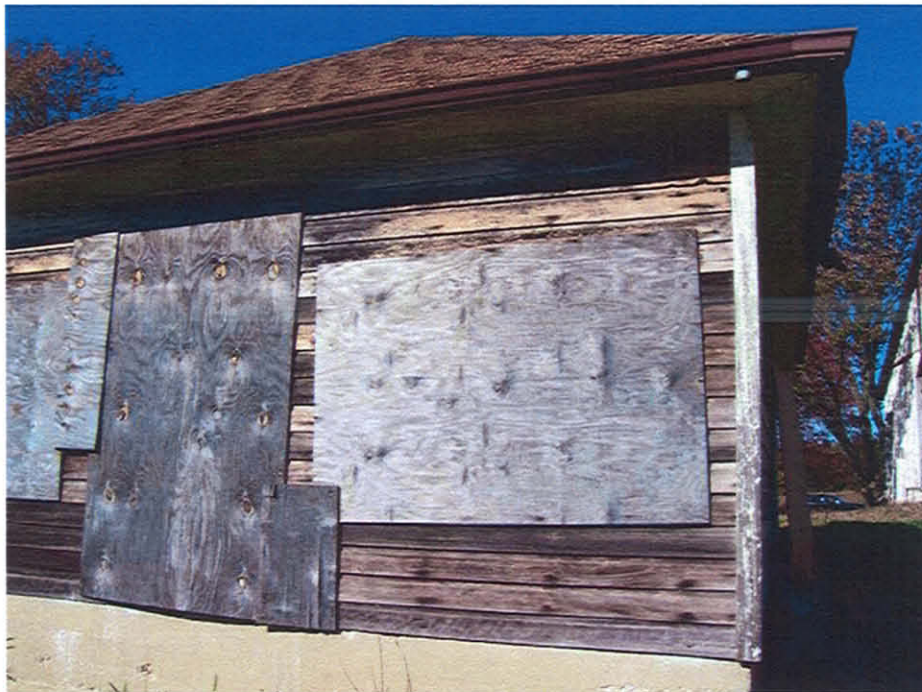
Picture #16: Absence of downspouts in historic farm outbuilding.
