**TALBOT AVENUE BRIDGE
CONDITION ASSESSMENT
SILVER SPRING, MARYLAND
Clark Azar & Associates, Inc.**

Prepare for:
Jason Azar, PE
Vice President
Clark Azar & Associates, Inc
20440 Century Blvd, Suite 220
Germantown, MD 20874
jazar@clarkazar.com
(240) 912-3491

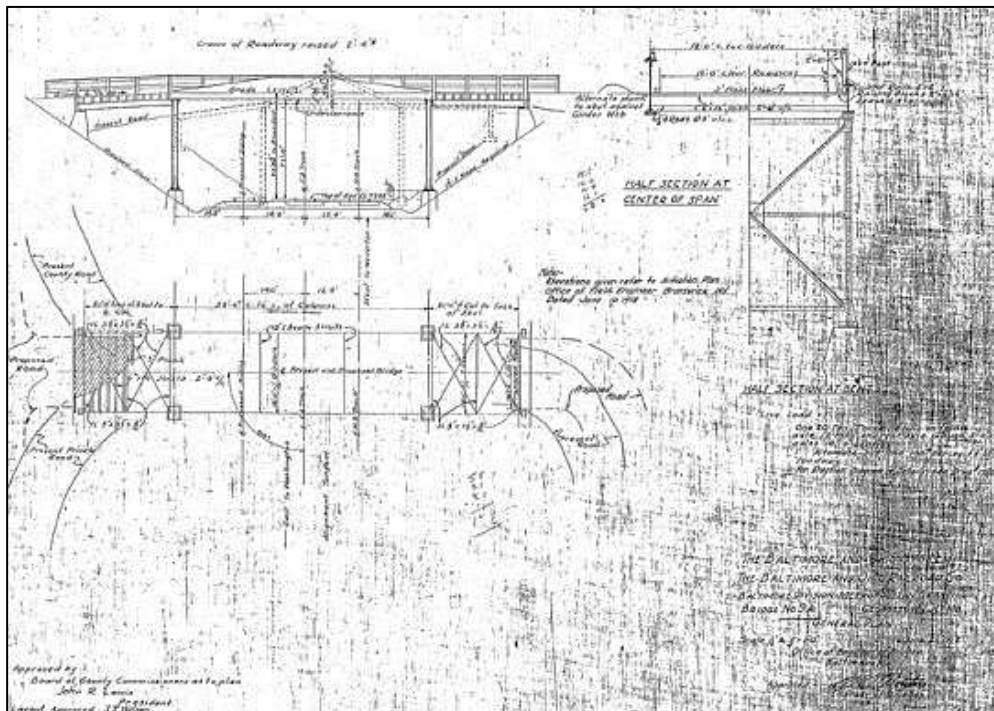
Figure 1: Baltimore and Ohio Railroad Bridge 9A drawing no. 17554, June 21, 2018. (Photo courtesy of Montgomery County Department of Transportation and the Historic American Engineering Record).

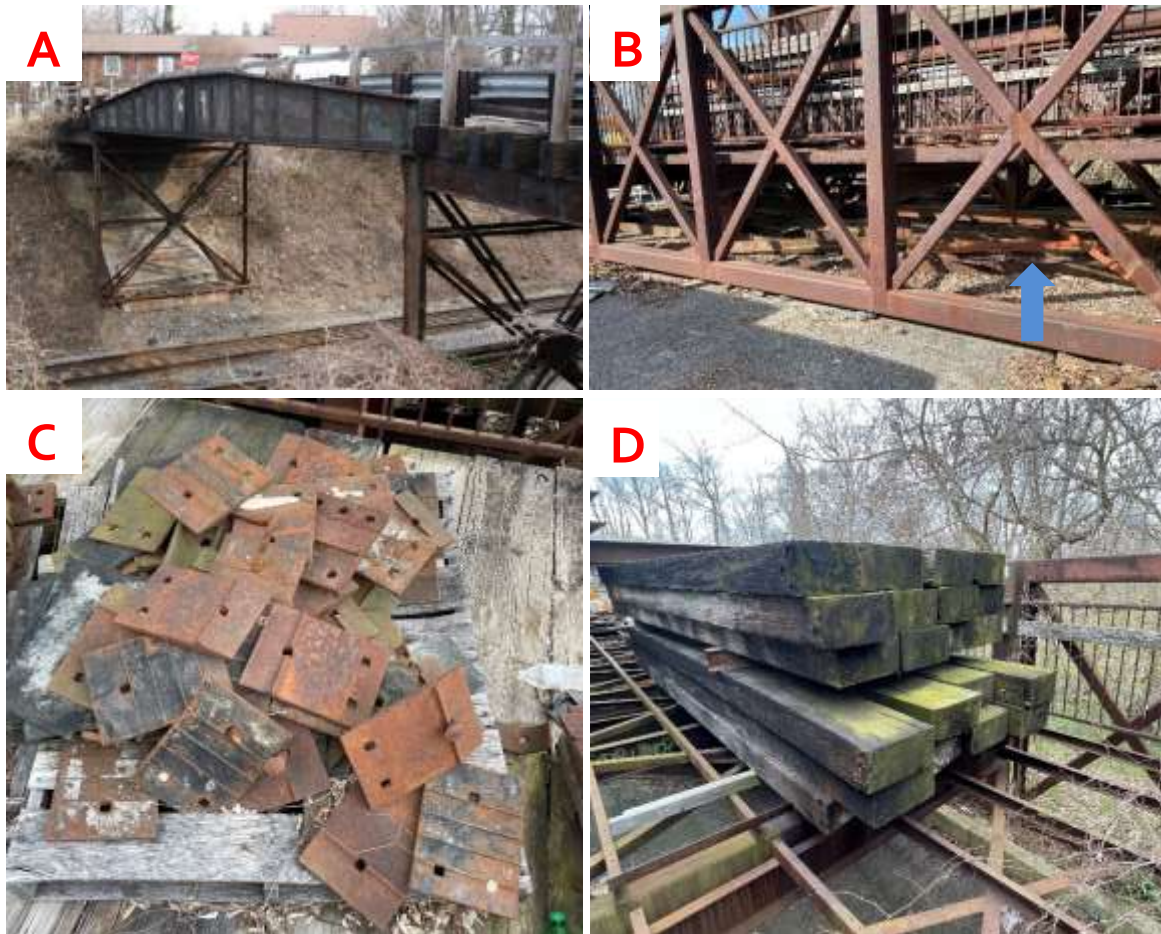
Figure 5 A, B, C, and D: Figures 5A-D are detail images of various parts of the Talbot Avenue Bridge which were not documented as part of the 2023 conservation survey. Figure 5A is a 2015 image of the bridge prior to removal. Figure 5B the blue arrow shows the storage locations for the vertical supports seen in photos 5A. Figure 5C are various metal brackets removed from the Talbot Avenue Bridge. Finally, Figure 5D shows one set of the wooden beams used for the Talbot Avenue Bridge roadway. (Photo A: Talbot Avenue Bridge (<http://gbblog.sluggyjunx.com/2016/10/12/the-famous-talbot-ave-bridge-is-slated-for-demolition>; 2015); Photo B, C, D: EverGreene (March 22, 2023)

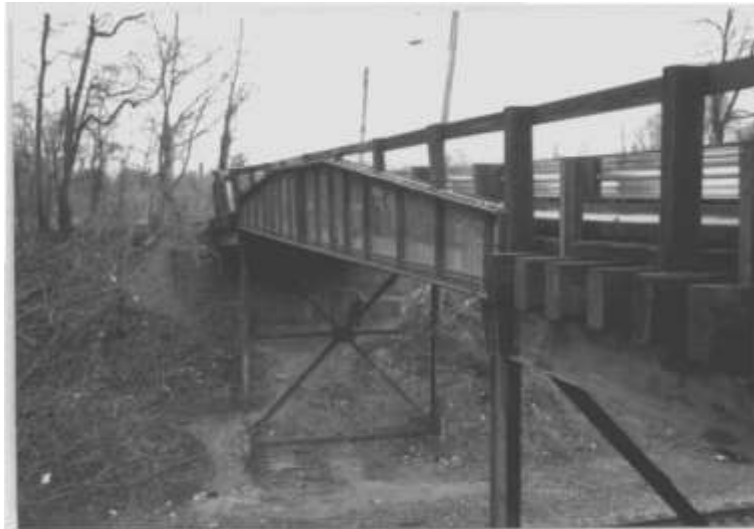
Figure 6: 1995 photograph from the "Maryland Historical Trust Historic Properties State Historic Sites Inventory Form" inventory of the Talbot Avenue Bridge. This is the fourth (4) photograph, and only close up of the South Girder, taken as part of the documentation. (Photo: Maryland Historical Trust Historic Properties State Historic Sites Inventory Form; 1995)

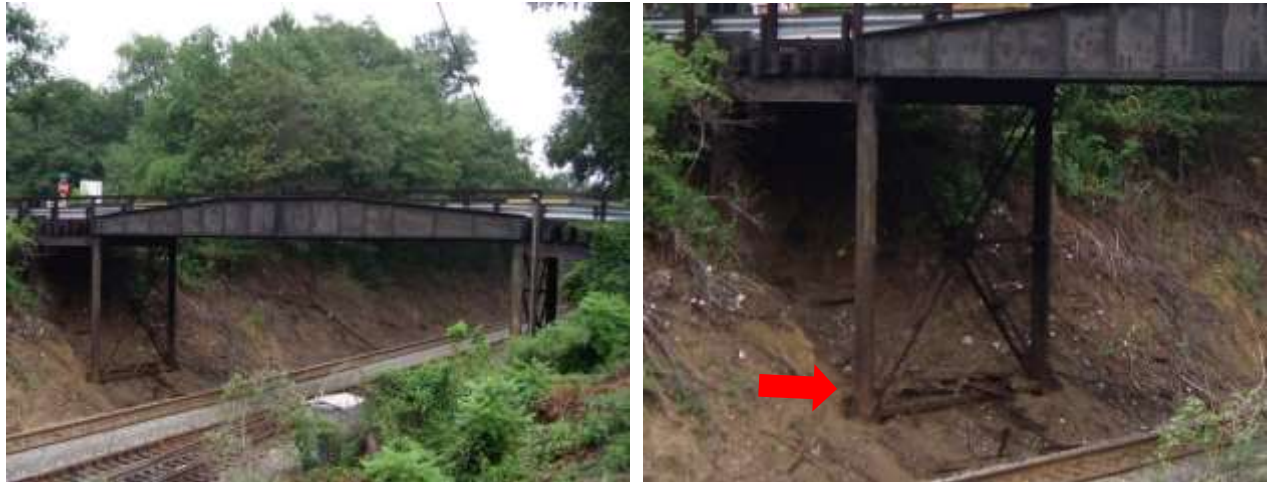
Figure 7: (Left): 2007 color photograph of the talbot avenue bridge. (Photo: 2007 Talbot Avenue bridge. (2023, January 6). In Wikipedia. https://en.wikipedia.org/wiki/Talbot_Avenue_bridge)

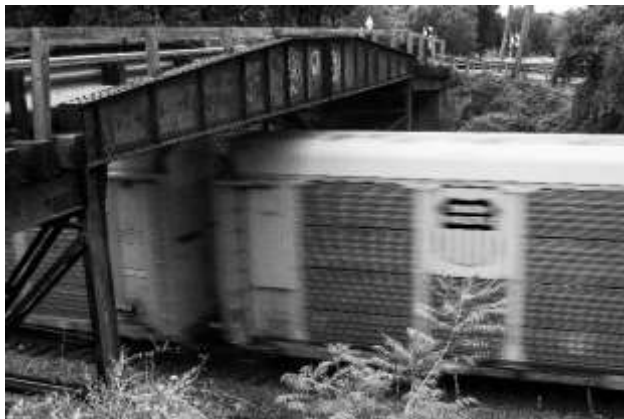
Figure 9: Photograph of the Talbot Avenue Bridge from 2015. This photo is of the North Plate Girder looking West towards Talbot Avenue. When comparing Figure 7 and Figure 9 the most notable change in condition is the addition of graffiti to the North Plate Girder. (Photo: 2015 Talbot Avenue bridge. (2023, January 6). In Wikipedia. https://en.wikipedia.org/wiki/Talbot_Avenue_bridge)

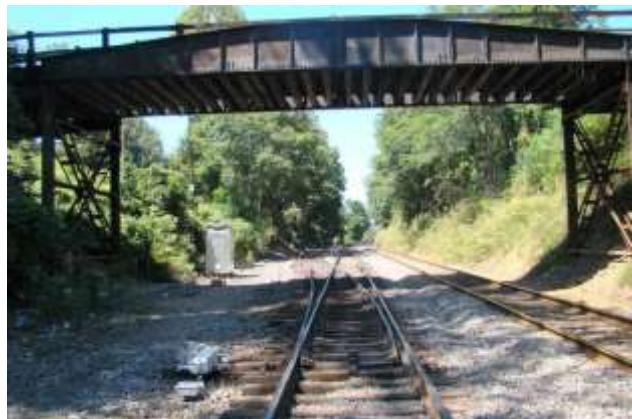
Figure 8: Photograph of the Talbot Avenue Bridge from 2008 looking north at the South Plate Girder. Noticeably the south side has no graffiti present in 2008. (Photo: Talbot Avenue Bridge; <http://www.trainweb.org/oldmainline/metgb1.htm>)

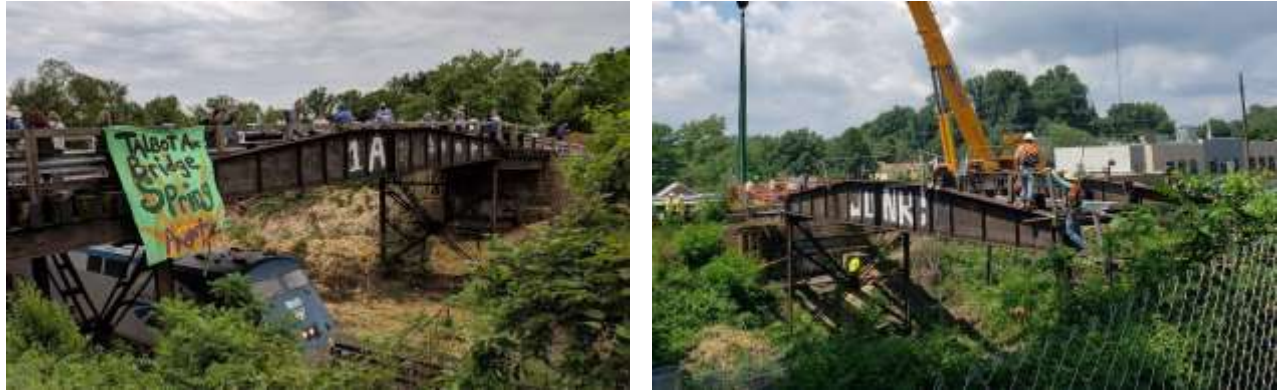
Figure 9 and 10:: Figures 11 (Left) and 12 (Right) are of the Talbot Avenue Bridge in 2019 during the removal. Notes the heavy graffiti on both the North (left) and South (right) sides. (Photos: Talbot Avenue Bridge Facebook Page (2019))

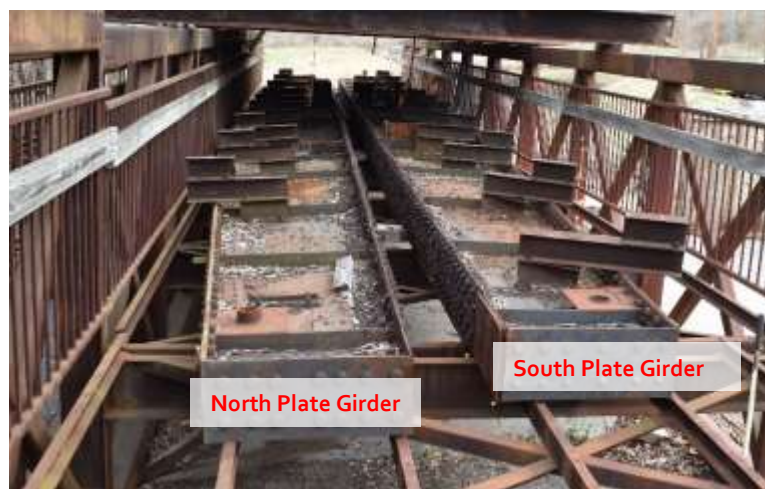
Figure 11: Photograph of the 2023 conditions and orientations of the north and south plate girders. Photograph was taken facing north. The north plate girder is located on the west side of the storage area and the south plate girder is located on the east side. (Photo: EverGreene (March 22, 2023))

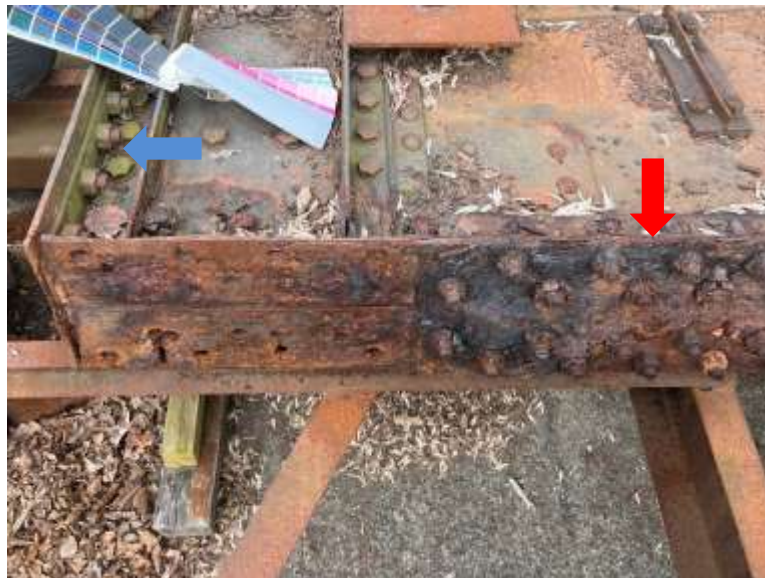
Figure 12: Detail image of Bay 1 of the bottom flange of the north plate girder. The red arrow shows the condition of the corroded flange cover plate and hex bolts and blue arrows shows the area mostly unaffected by the corrosion. (Photo: EverGreene (March 22, 2023))

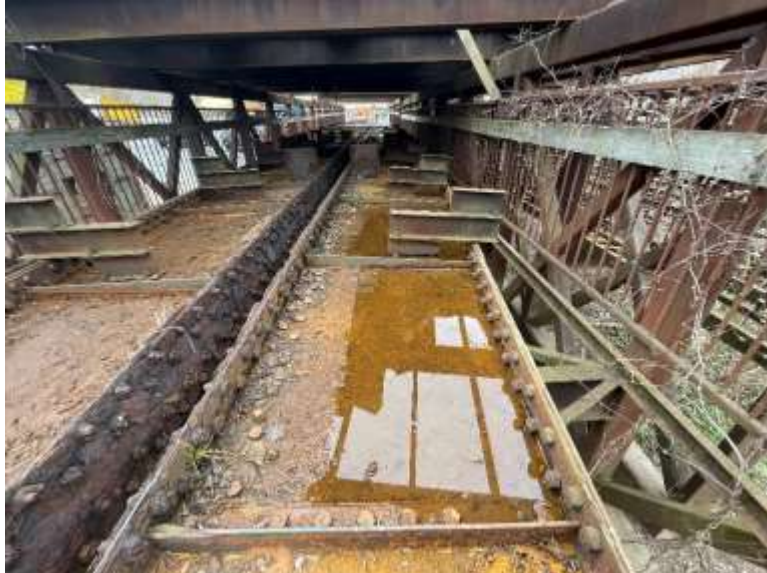
Figure 14: Detail of Bays 12 and 13 of the north plate girder which both have standing water. (Photo: EverGreene (March 22, 2023))

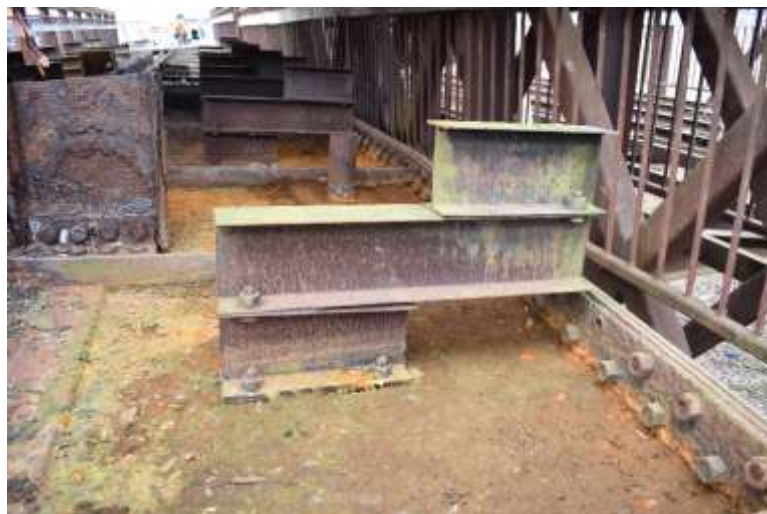
Figure 13: Detail of the guardrail I-beam in Bay 11. Note the bio-growth concentrated on the vertical and skyward facing planes. (Photo: EverGreene (March 22, 2023))

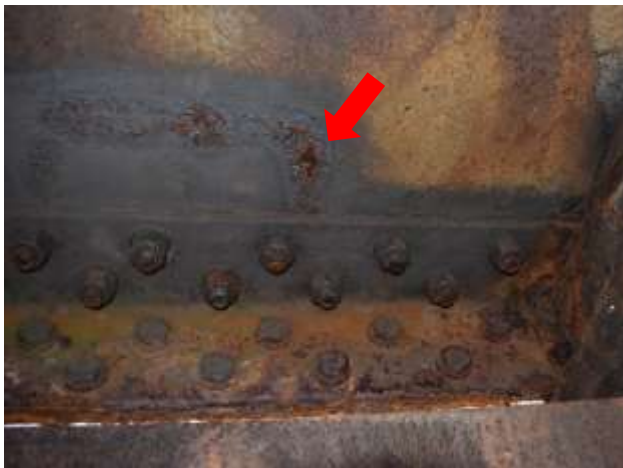
Figure 17: The red arrow shows the weeping or active corrosion found on the underside of the North Plate Girder. (Photo: EverGreene (March 22, 2023))

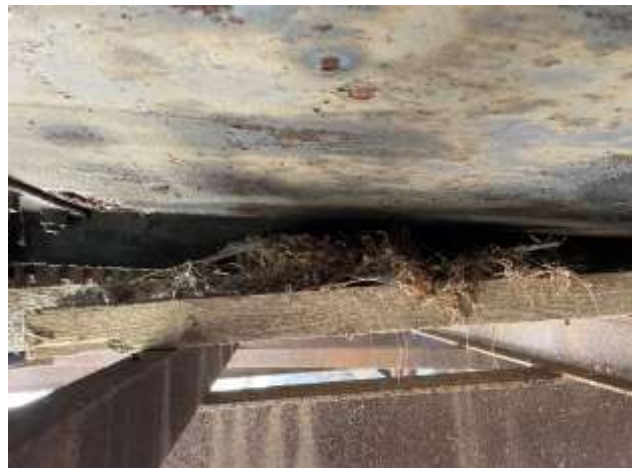
Figure 15: Detail of a bird's nest found on the North side of the North Plate Girder. (Photo: EverGreene (March 22, 2023))

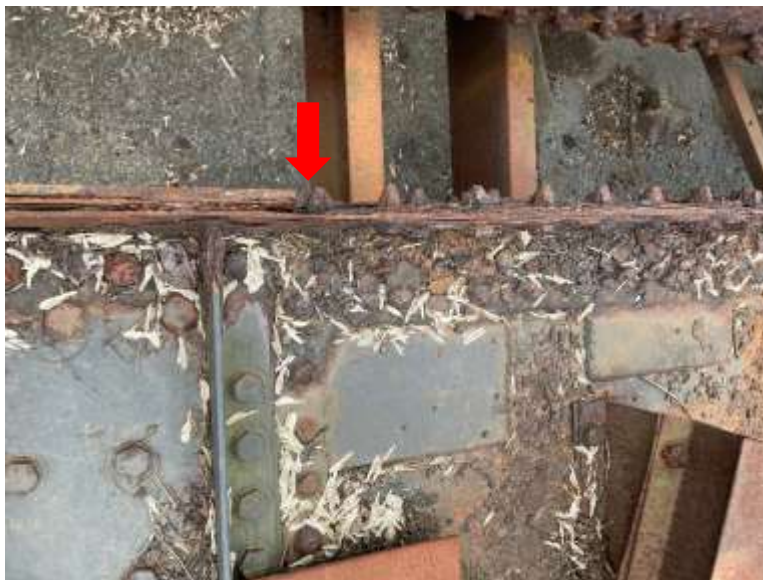
Figure 16: Detail of the lower flange of Bay 1 on the south plate girder. The Red arrow shows where the gusset plate and exploded corrosion are separating from the rest of the flange structure. (Photo: EverGreene (March 22, 2023))

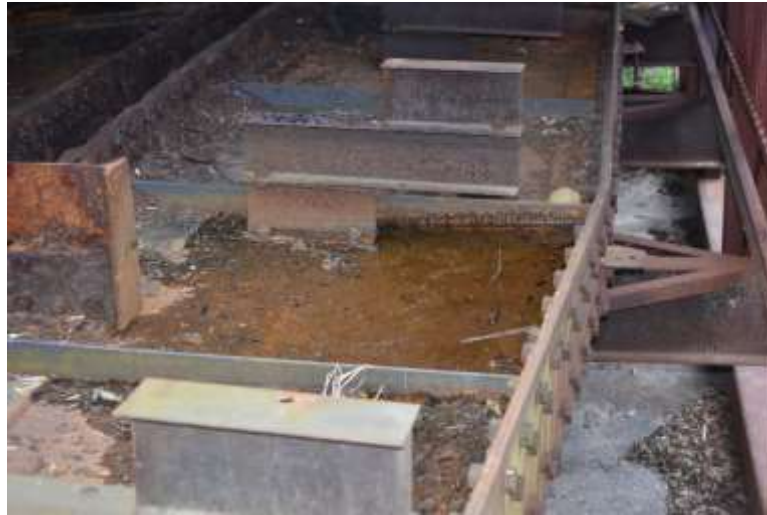
Figure 17: Detail of Bay 5 where water is collecting on the west side of the horizontal plane. (Photo: EverGreene (March 22, 2023))

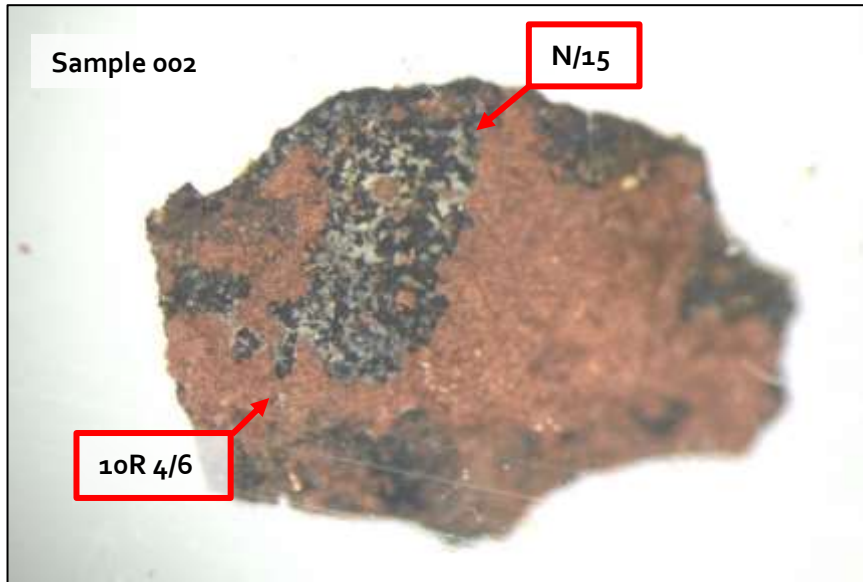
Sample 002, North Plate Girder Bay 3 Vertical Stiffener			
Layer	Color	Munsell No.	Note
Metal	-	-	Substrate
1	Red-Brown	10R 4/6	Primer
2	Black	N/15	Presenting

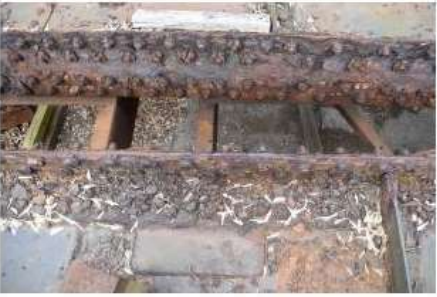
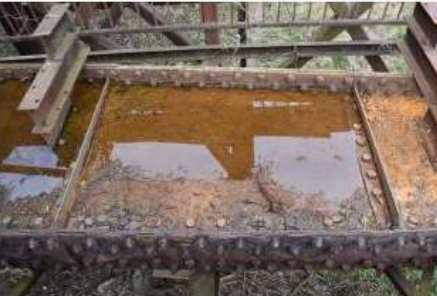
Cut Cross I-beam - Perpendicular to bottom flange and is fixed to the structure as support. Cut during relocation

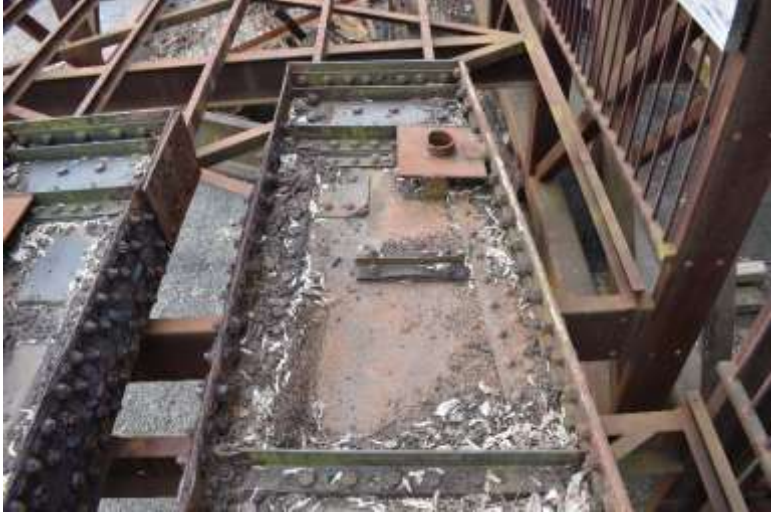
North Plate Girder	Bays South to North
