**MONTGOMERY COUNTY PLANNING DEPARTMENT**  
THE MARYLAND-NATIONAL CAPITAL PARK AND PLANNING COMMISSION

**Staff Report: Limited Site Plan Amendment 82003025B, Lofts 24 – Silver Spring Park**

**APPLICATION DESCRIPTION:** CBD-1/Fenton Village Overlay Zone; 0.38 acres; Limited Amendment to reflect as-built conditions on the site and lighting plans, and minor revisions to the landscape plan; located in the SW quadrant of the intersection of Fenton Street and Bonifant Street, Silver Spring CBD Sector Plan.

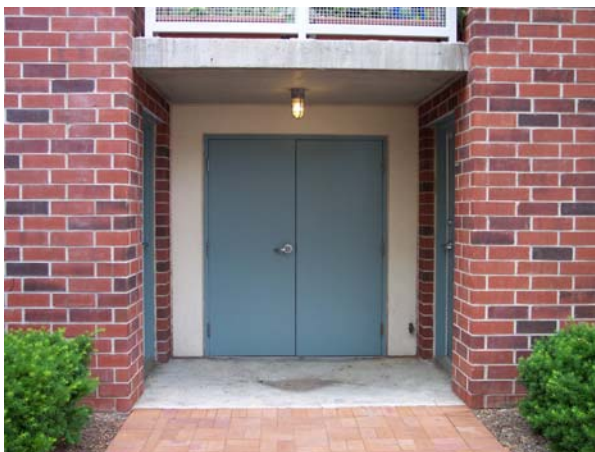
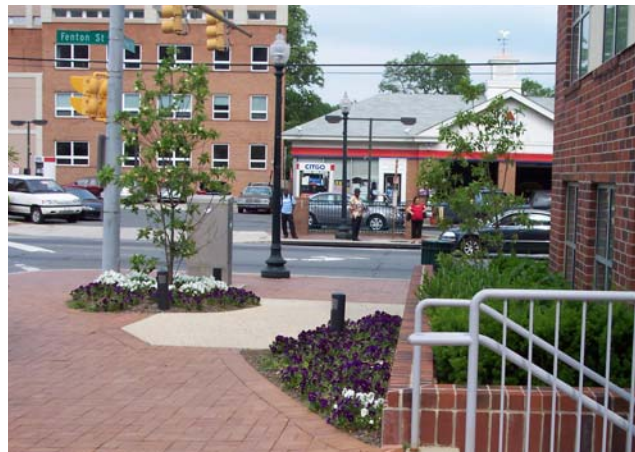
The Certified Site Plan No. 820030250, and subsequent administrative approvals, approved mortared in place 2" x 24" x 24" flamed black granite pavers with a matching border of 2" x 12" x 12" pavers, at the three entrances to the building and at the public use space at the corner of Bonifant and Fenton Streets. The granite pavers were never installed. Instead, the entryways were installed with brick and concrete, and the public use space with textured aggregate concrete.

Building entryway was partly installed with poured in place concrete and partly with brick (left image); the public use space was installed with textured aggregate concrete (right image).

- a. Provide black granite pavers with a 2-inch thickness, mortared in place at the three entryways to the building and public use space at the corner of Bonifant and Fenton Streets. The individual pavers must be 2" x 24" x 24" with a 2" x 12" x 12" matching border as originally approved.

- b. Add note on plans stating "Remove existing tile pavers at entryways and public use space, and excavate the concrete slab to the necessary depth to accommodate the 2-inch thick granite pavers mortared in place." The granite pavers must be installed so that the surface is flush with the surface of the existing surrounding pavement.

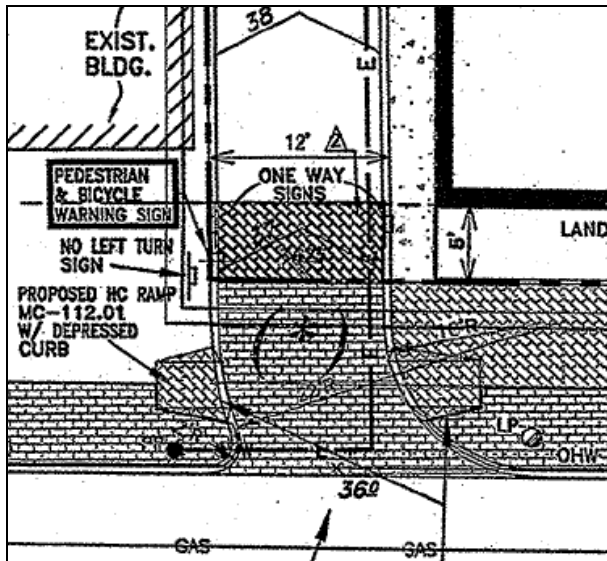
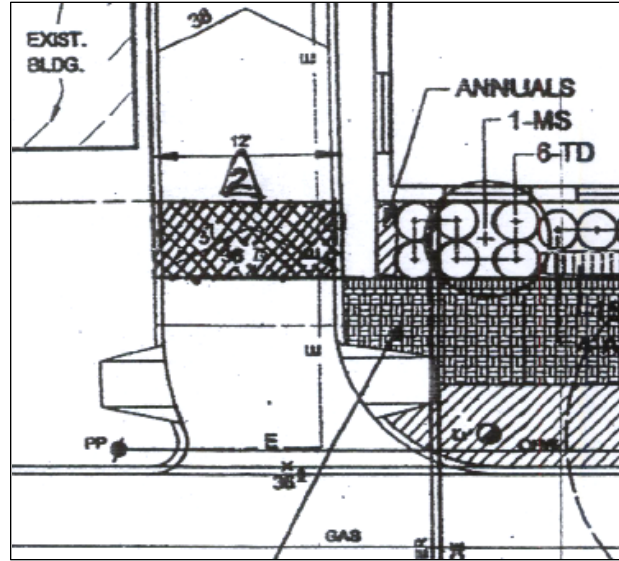
Although the Certified Site Plans No. 820030250 and 82003025A approved a brick crosswalk for the driveway off Fenton Street, it was never installed. Instead, this area was built in concrete.

Driveway off Fenton Street as shown on site plan sheet on 82003025A (left image) and as shown on landscape sheet L-1 on 82003025A (right image).

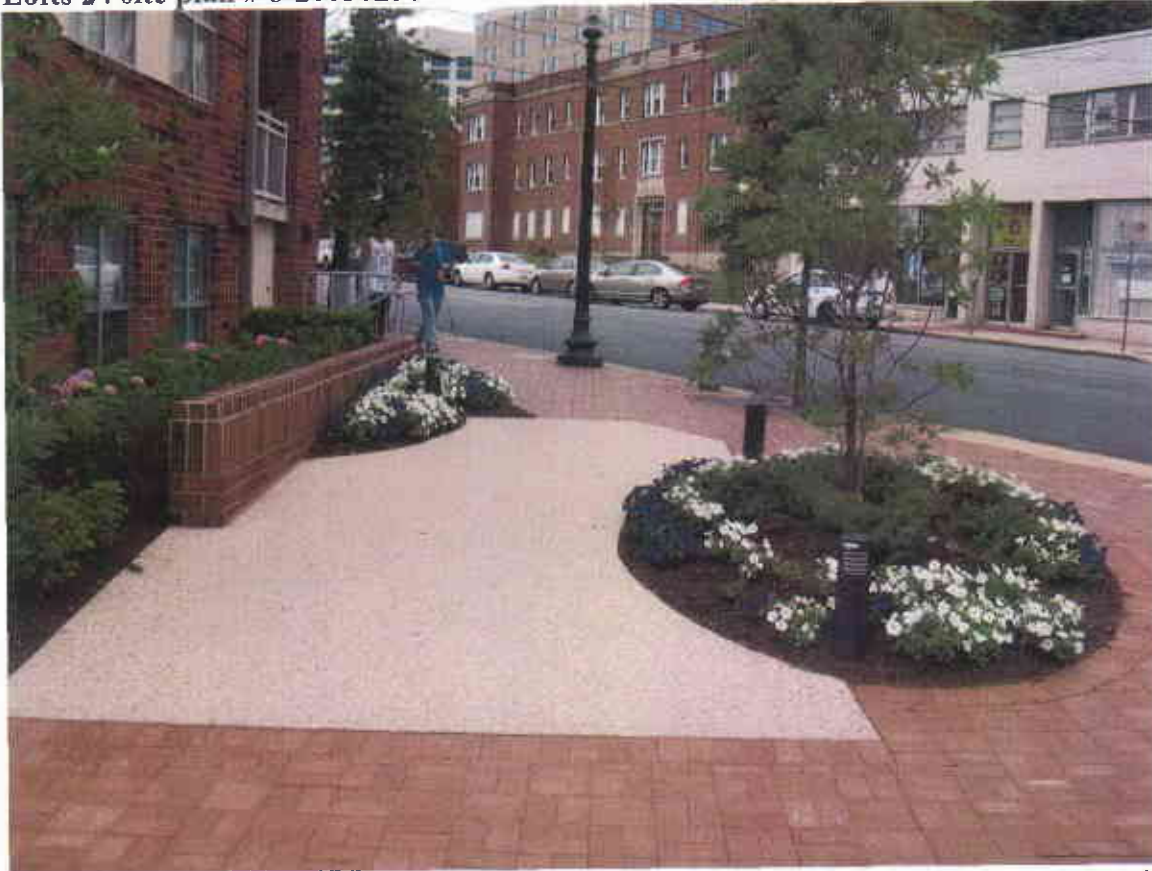
Granite paving has not been installed. Benches not present. Lighting not directed toward seating area.

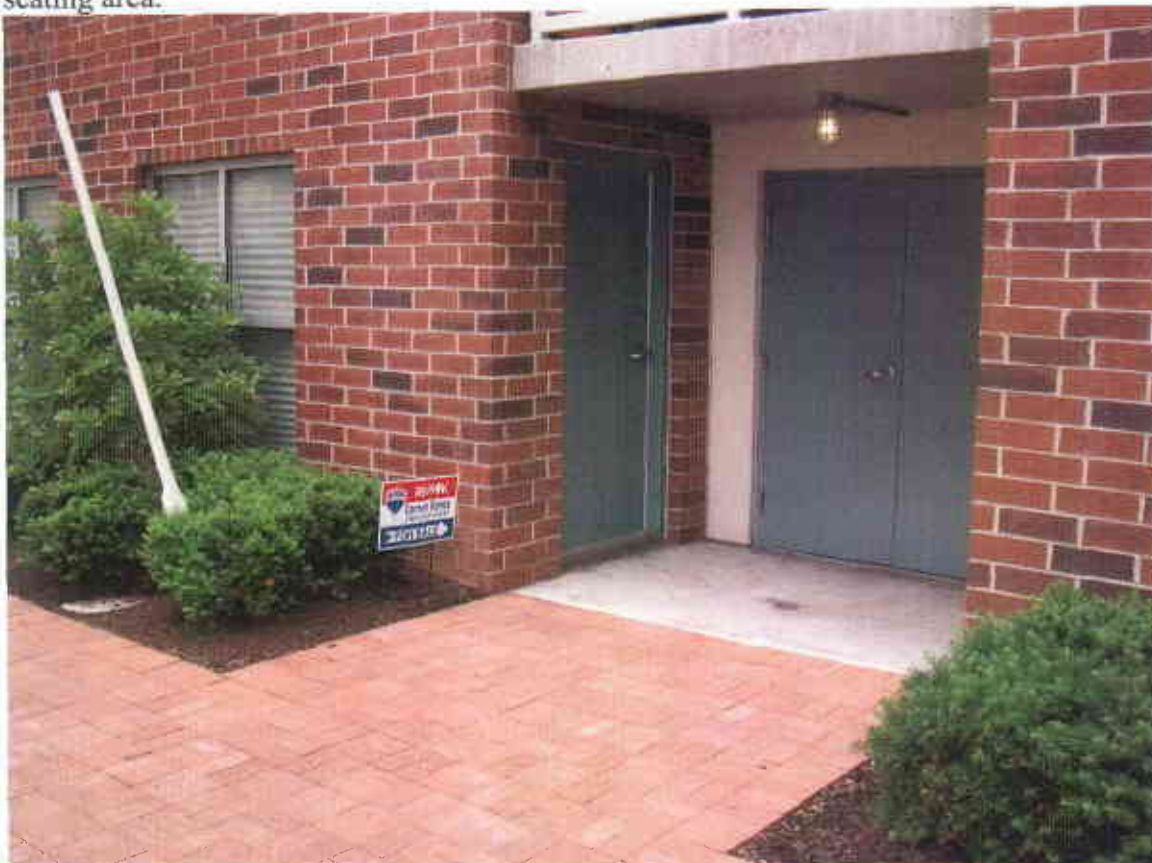
Granite paving has not been installed throughout site (required at entrances).

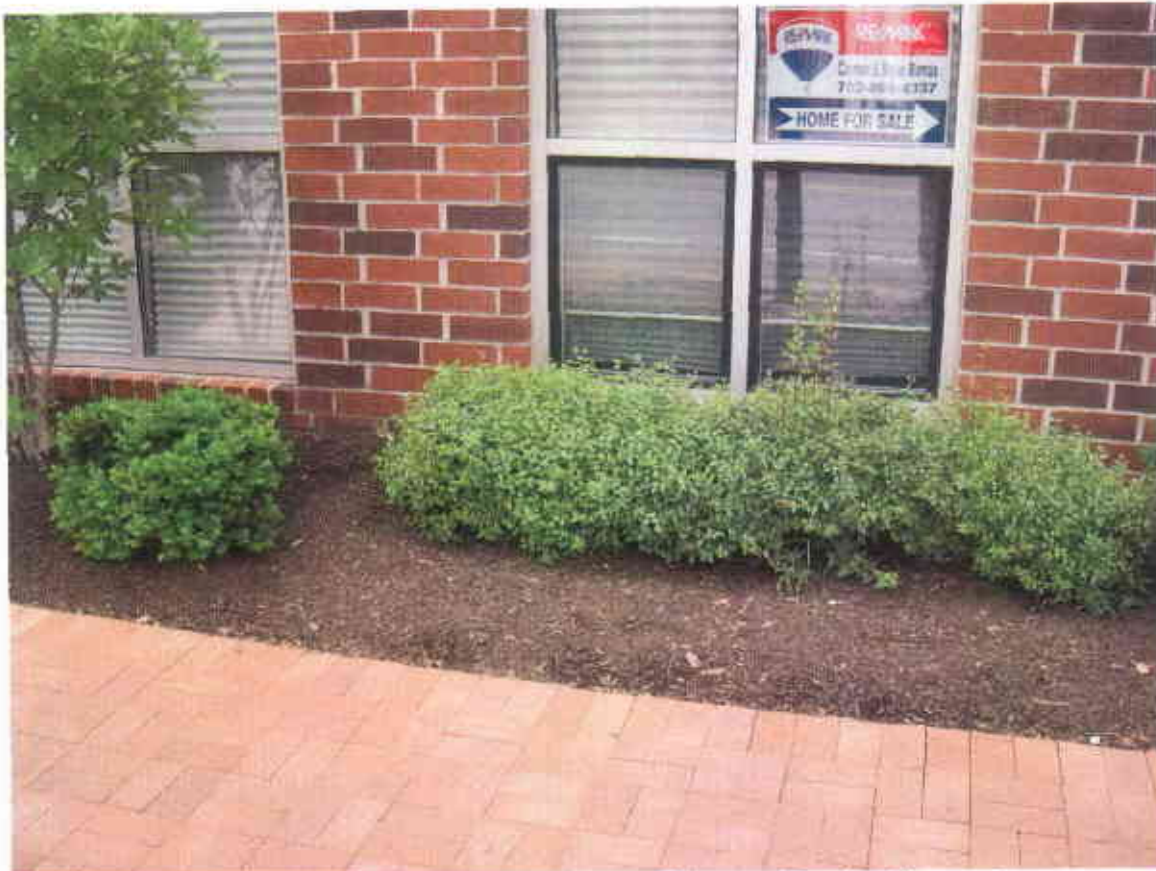
Only 1 of 2 required shrubs is present at left side of image. Candytuft groundcover missing from front of plantings bed and from entire site.

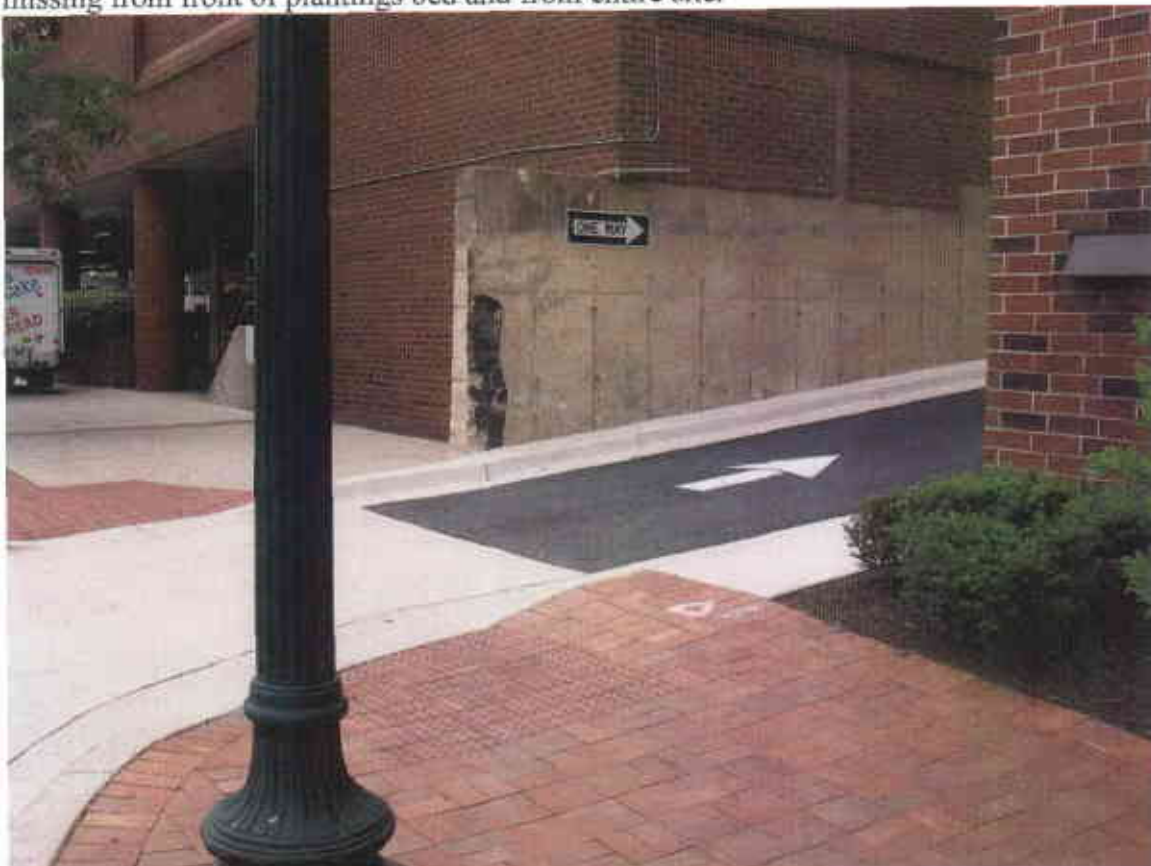
13. Internal walks installed are narrower than the minimum 4' width required (per Planning Board condition of approval item 1.b.)
14. Brick paving has not been installed at Fenton street driveway entrance. Pedestrian and Bicycle warning sign also absent from this location.

Brick paving not installed at crosswalk, sign missing.

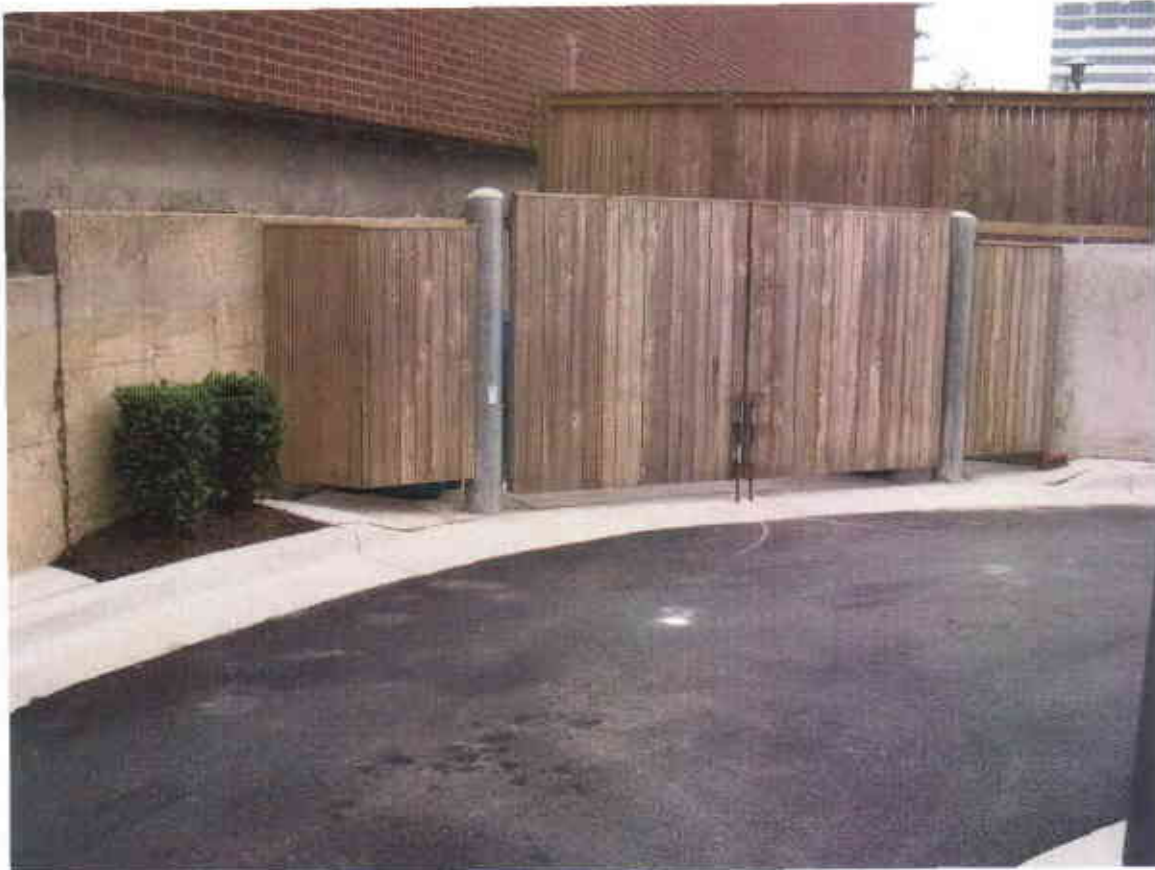
Yew shrubs have been substituted for the required Nandina shrubs.

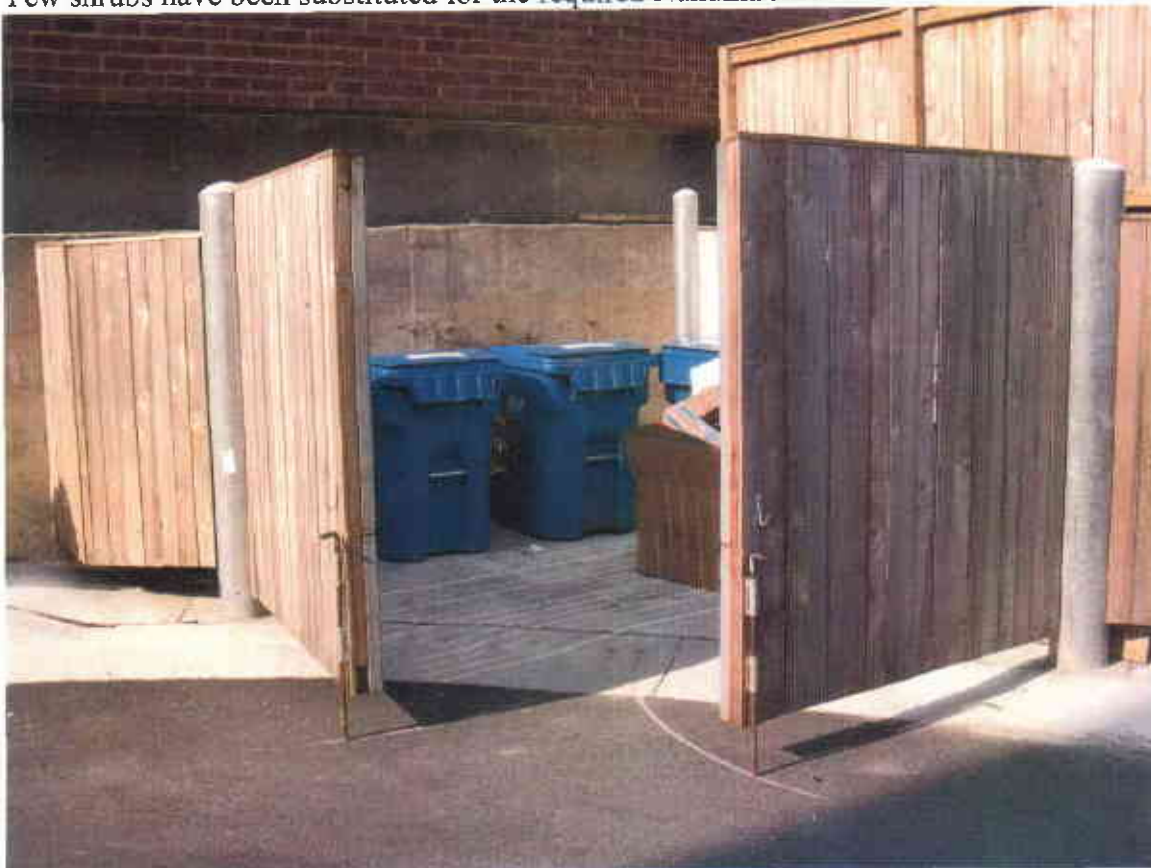
Dumpster not present, doors of enclosure do not open wide enough to accommodate required dumpster. Metal sleeve not installed.

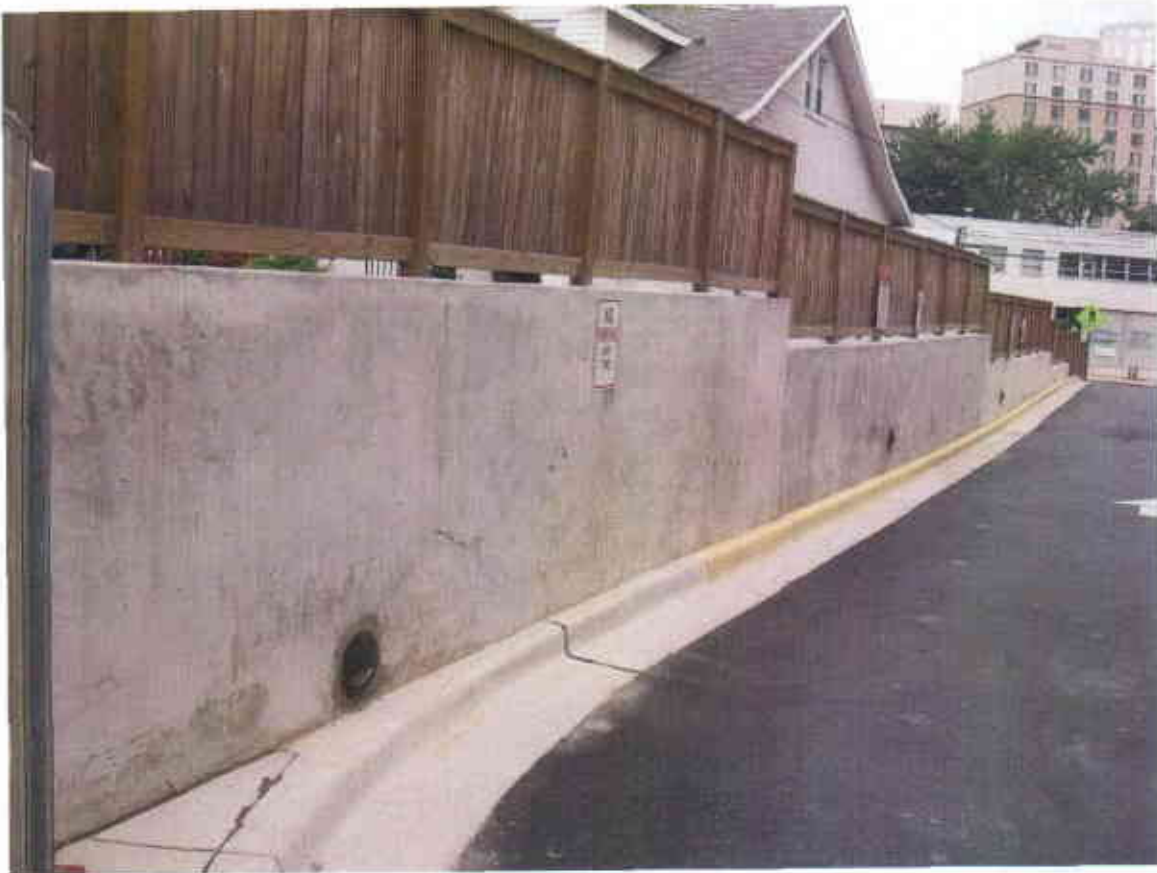
3 of the 4 required lights were installed within retaining wall.

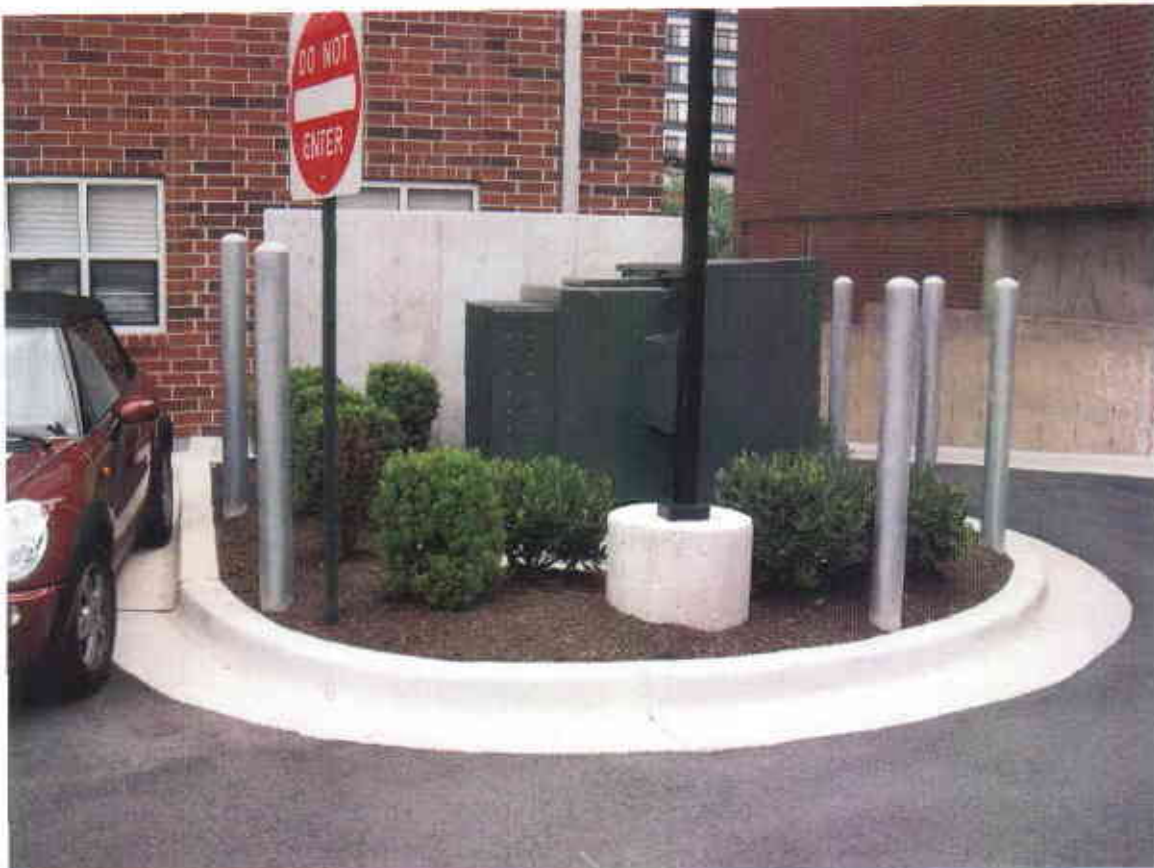
8. The Honey Locust (shade tree) is missing from the landscape bed at the SW corner of the building. The shrub species and locations installed at this location also differ from approved landscape plan.

Large transformer box present; required tree absent from bed. Species and locations of landscape shrubs differ from approved plans.

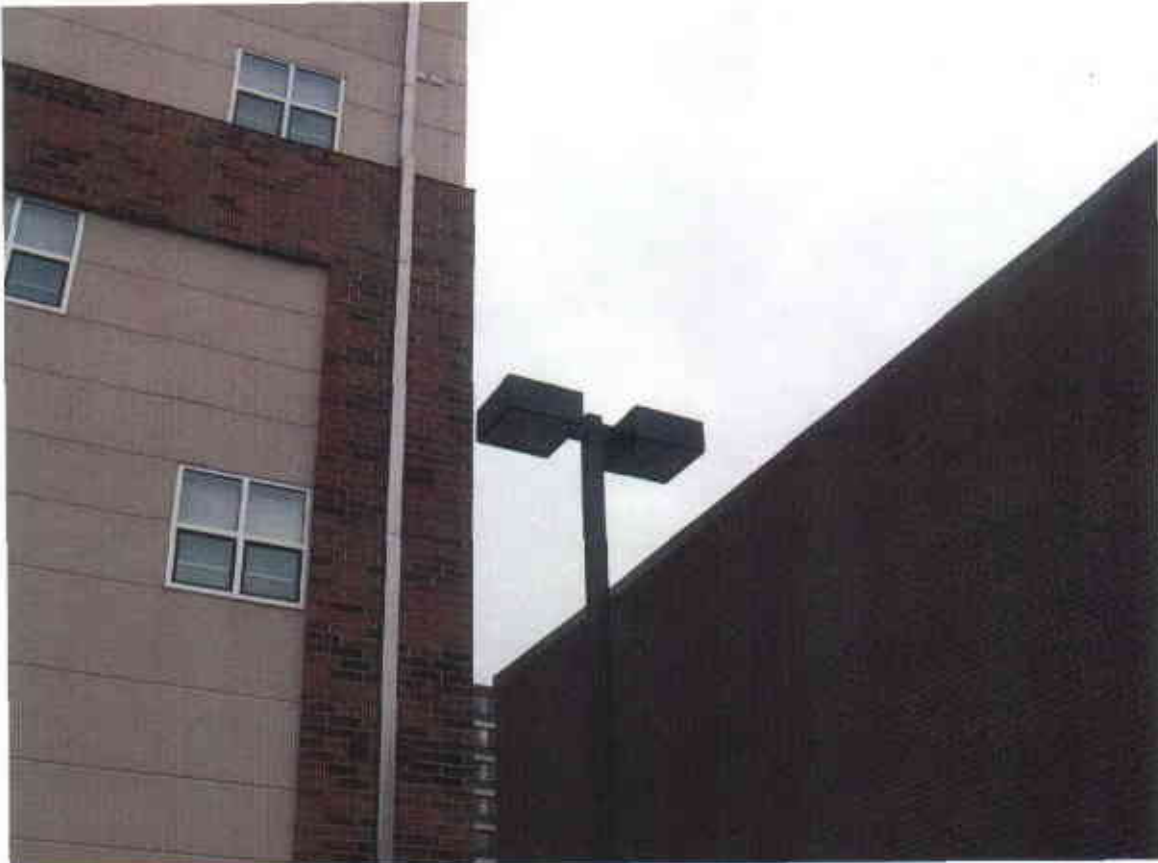
Installed lighting fixtures do not match style per plan details.

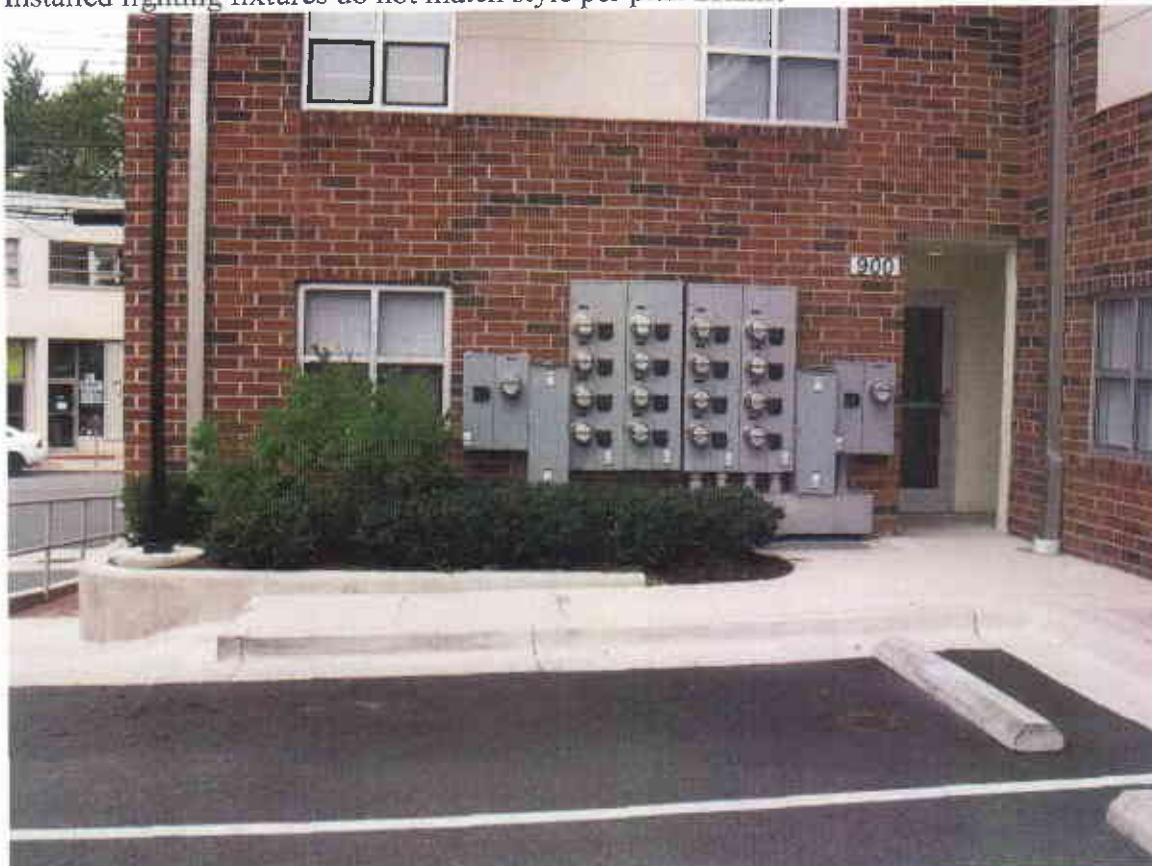
Magnolia tree missing from right side of landscape bed.

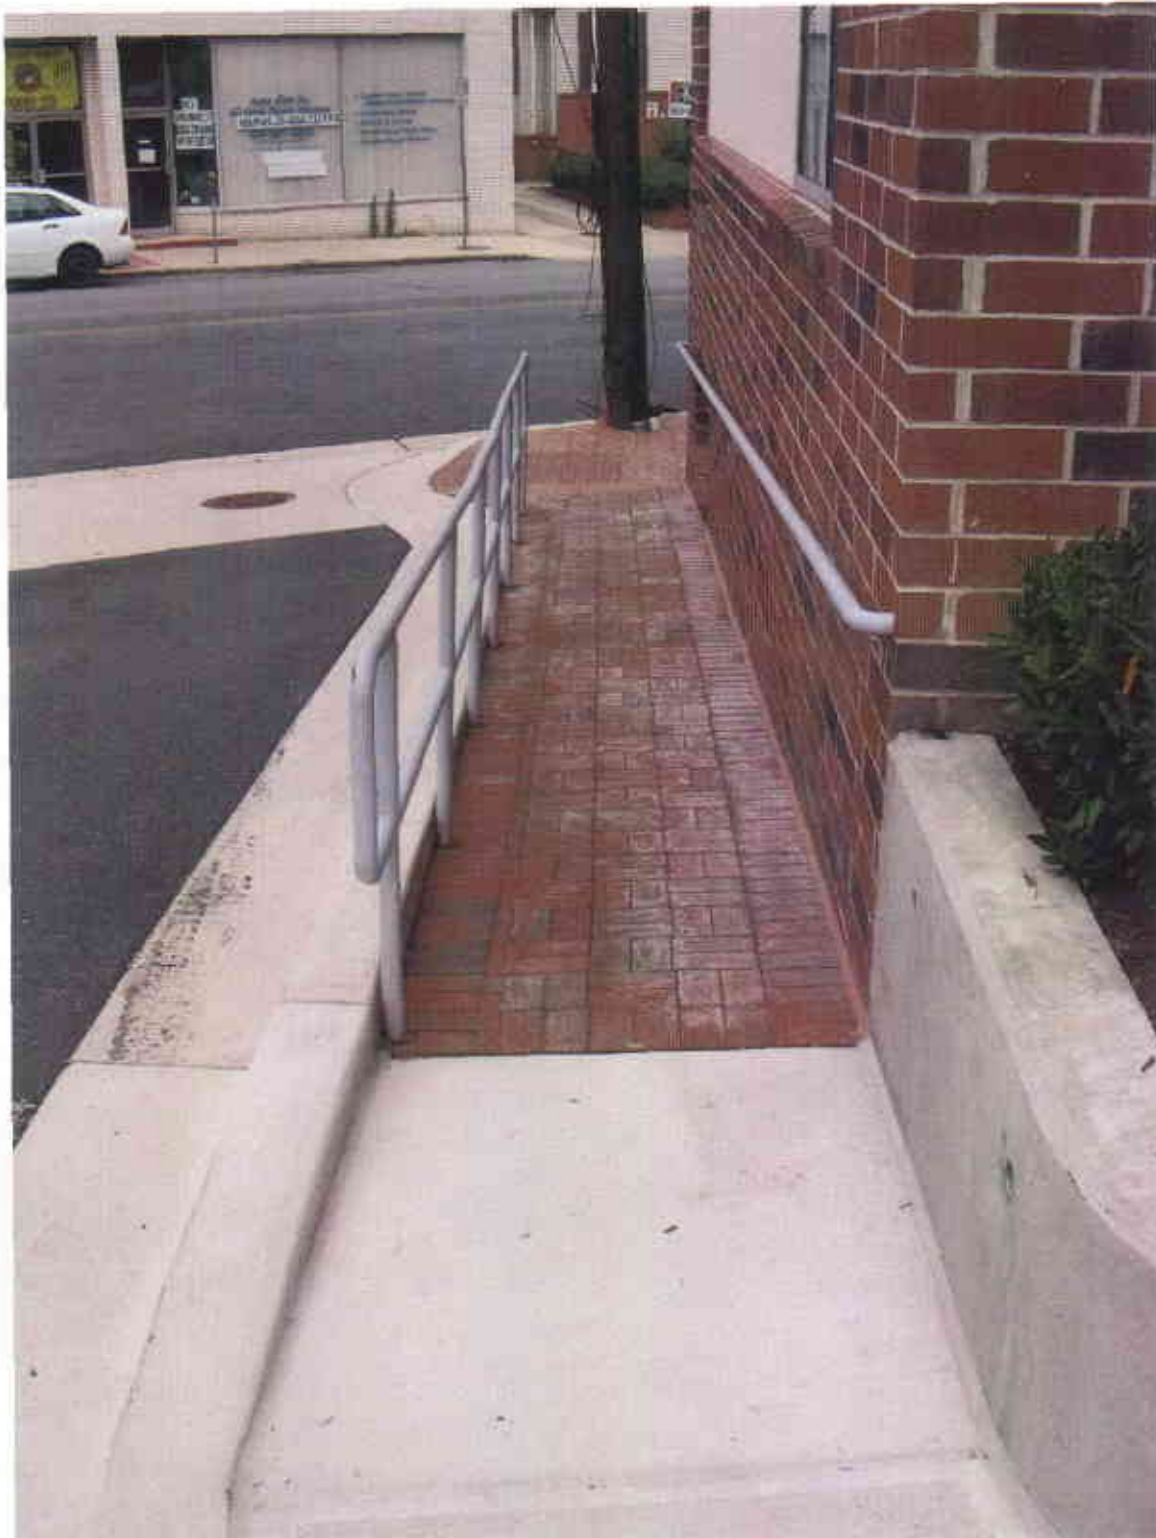
Internal walkways installed are narrower than the minimum 4' width required.

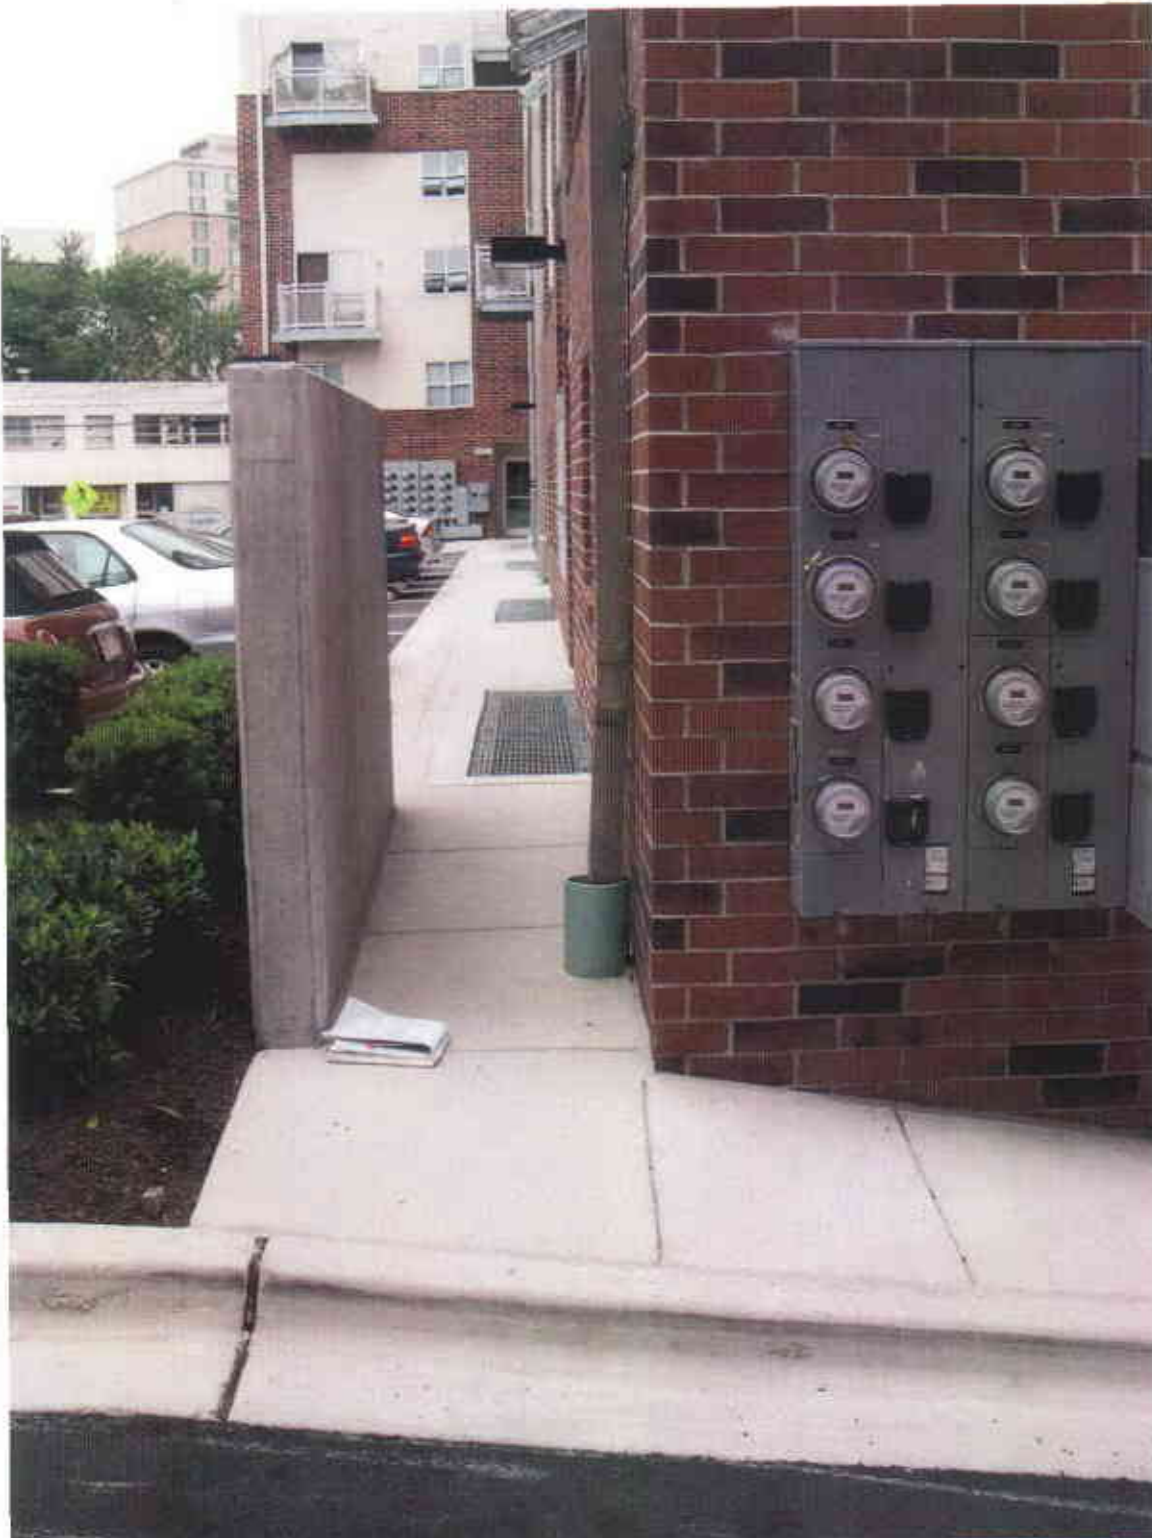
Internal walkways installed are narrower than the minimum 4' width required.
