Sandy Spring Townhomes: Limited Site Plan Amendment No. 82016001B in Response to a Violation

Staff Report Date: 1/17/20

Limited Site Plan Amendment No. 82016001B:
Request to modify the layout of the turnaround plaza with associated seating and pergolas, modify condition 7b to require a 5'-0" sidewalk, modify condition 8 to update lot numbers that require special treatment and allow beaded vinyl siding at the end walls of highly visible facades, modify steel fencing details, modify the cap on brick piers; located on the south side of Olney Sandy Spring Road (MD Route 108) in between Norwood Road and Meeting House Road; 2.31 acres zoned CRN-0.75 C-0.25 R-0.75 H-45; *2015 Sandy Spring Rural Village Plan*.

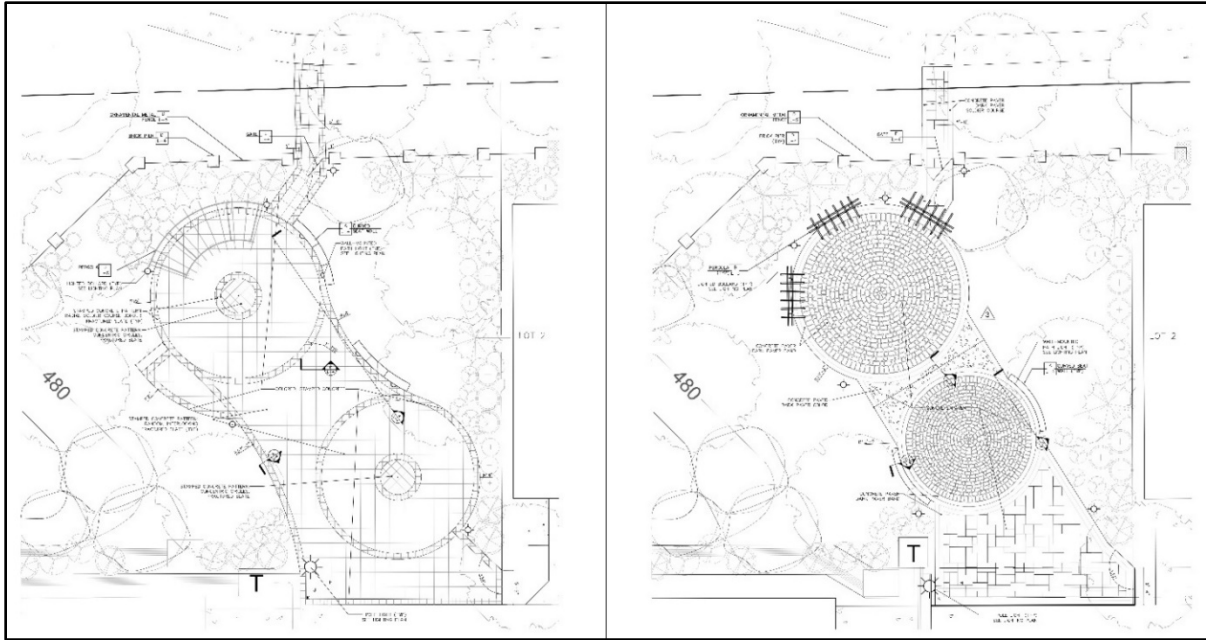
Figure 3: Emergency Vehicle Turnaround Plaza with Seating and Pergolas
(left previously approved, right proposed)

2. Layout and configuration of the emergency vehicle turnaround differs from the CSP in terms of geometry, materials, and paving patterns and details.	Amend CSP

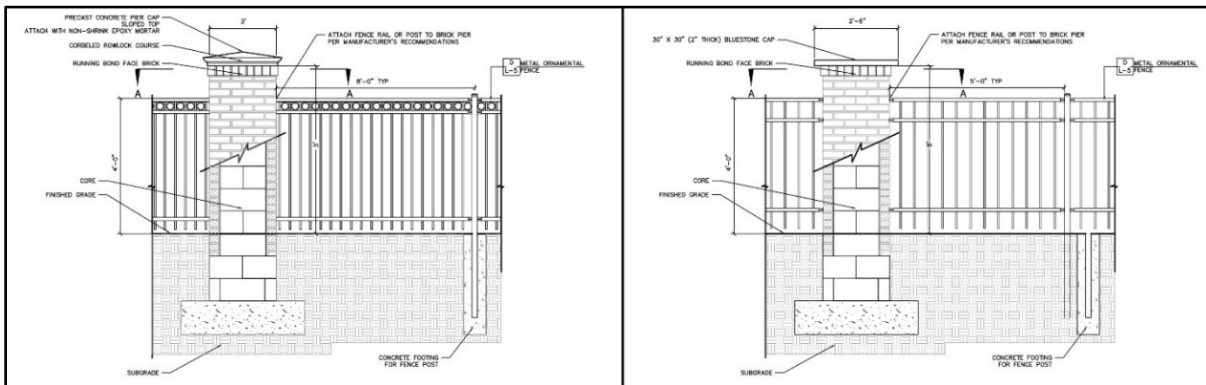
Figure 4: Metal Fencing and Pier Cap (left previously approved, right proposed)

3. A building permit is required for all fencing installed on-site.	N/A
4. The caps on the brick piers are bluestone instead of precast concrete.	Amend CSP

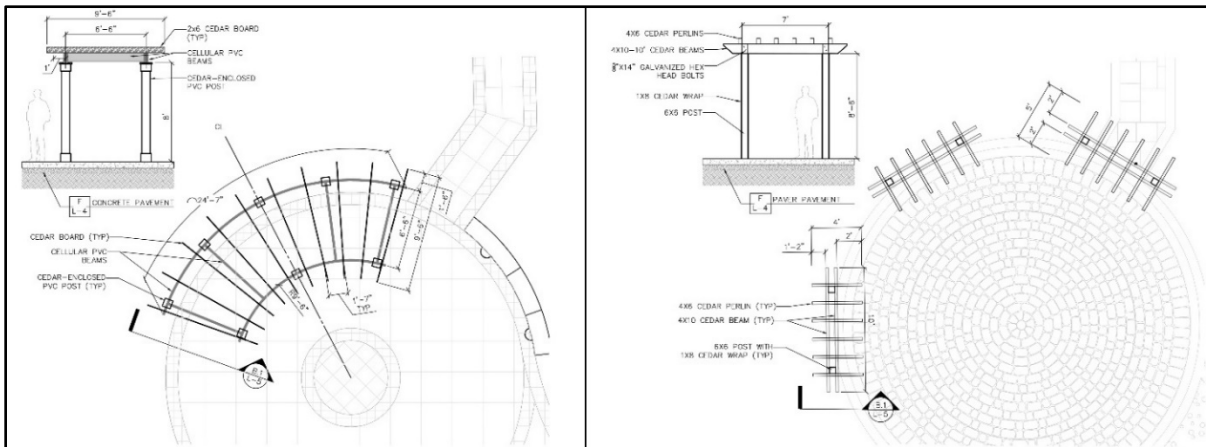
Figure 5: Pergola Layout (left previously approved, right proposed)

5. The single curved pergola was installed as three separate smaller pergolas.	Amend CSP
6. Seat walls were replaced with non-continuous arched walls which differ in locations, size, height, and length.	Amend CSP

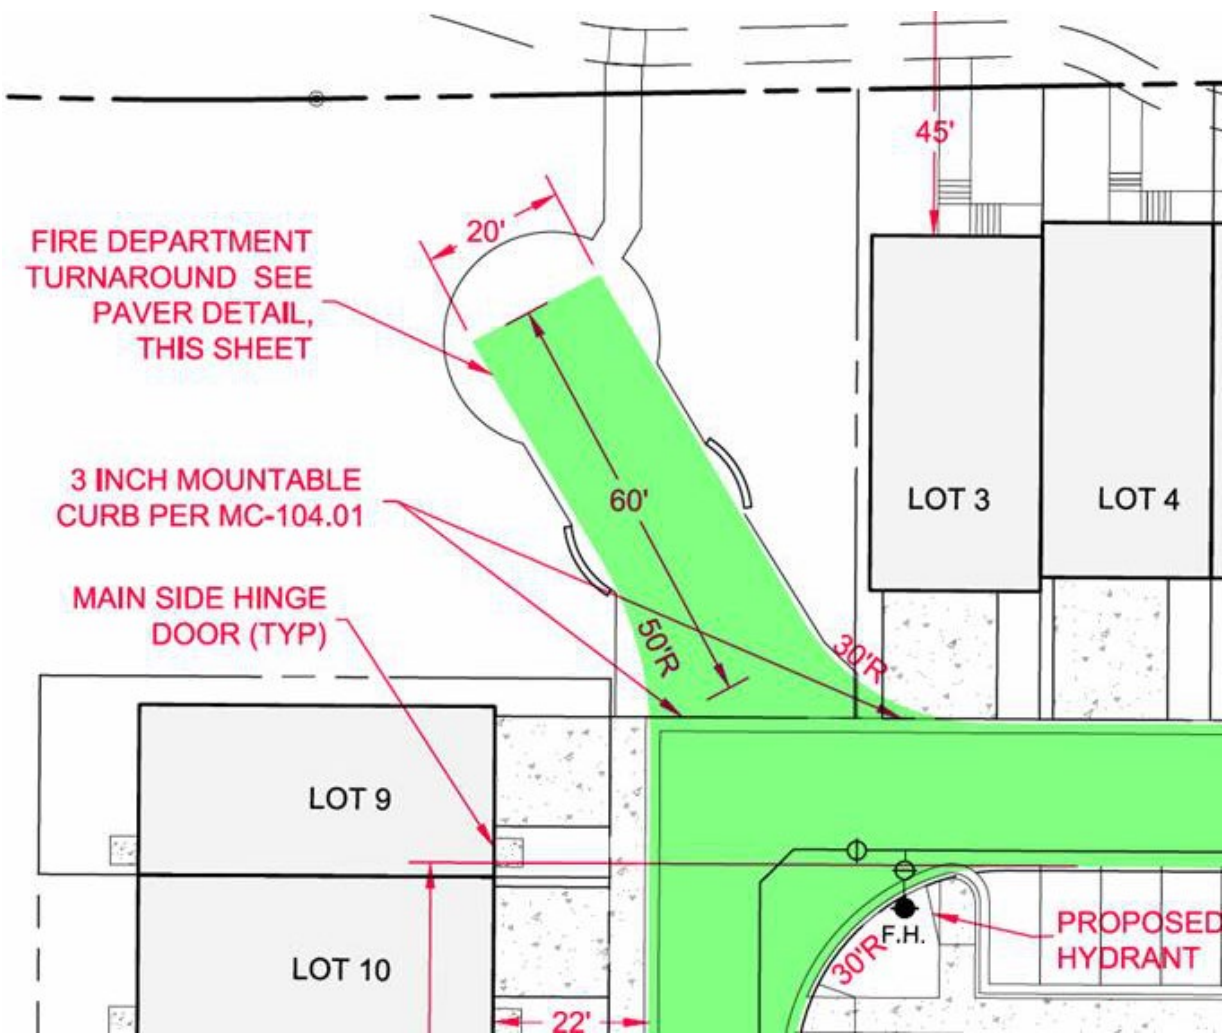
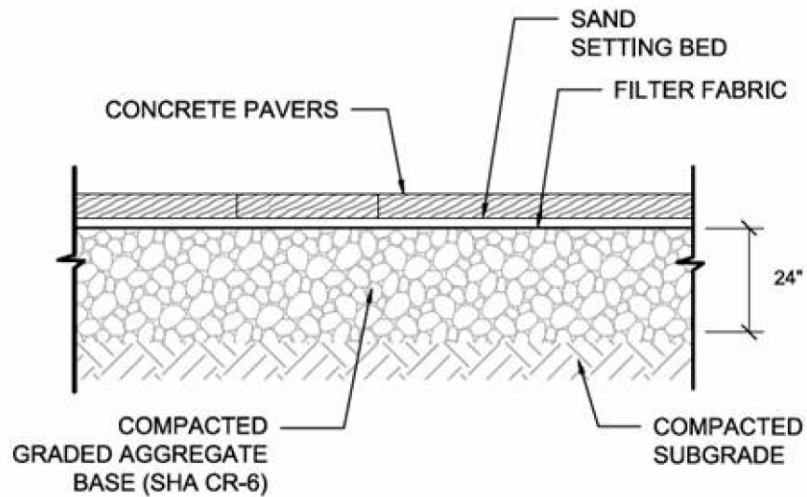
PAVEMENT SECTION - FIRE DEPT. TURNAROUND
TYPICAL FOR ENTIRE PLAZA
 NTS

- DPS Fire Department Access and Water Supply does not support the Applicant's proposed change to the subgrade pavement section of the emergency vehicle turnaround plaza because the submitted design and installation has not been certified by a geotechnical engineer or sealed by a professional engineer to meet minimum load bearing requirements for either Montgomery County tertiary road standard or MCFRS apparatus.

You will notice a significant difference in the subgrade section. The latest submittal was not certified by a geotechnical engineer or sealed by a professional engineer as able to meet required load bearing minimums.

- 14. Prior to Certified Site Plan, the Applicant must submit a Fire Department Access Plan that is certified by a geotechnical engineer or sealed by a professional engineer as able to meet minimum load bearing requirements for either Montgomery County tertiary road standards or MCFRS apparatus, or as approved by DPS Fire Department Access and Water Supply.

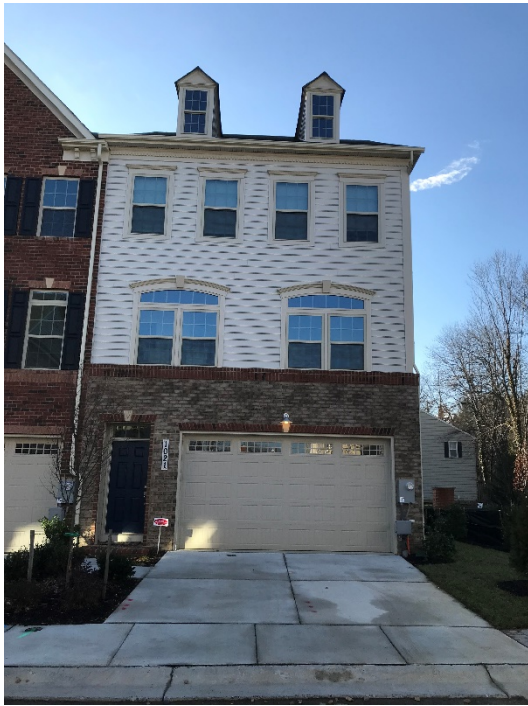
Front of Lot 9 (originally Lot 8)
1021 Mutual Place, Sandy Spring, MD 20860

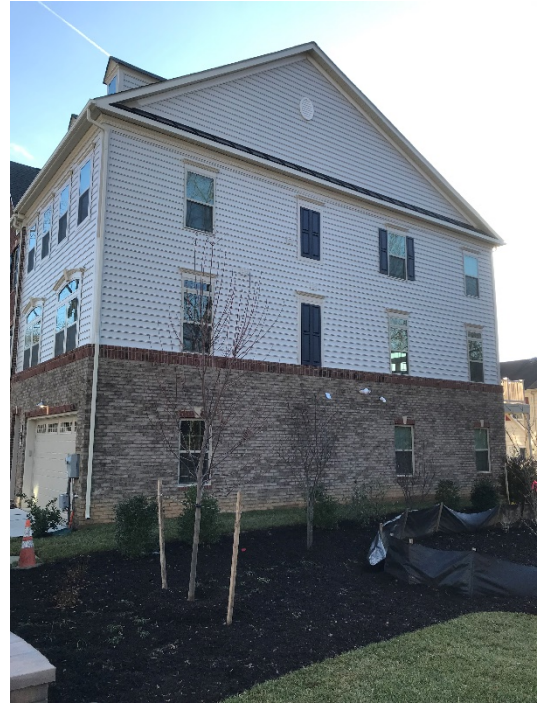
Right side (facing Route 108) and front of Lot 9
1021 Mutual Place, Sandy Spring, MD 20860

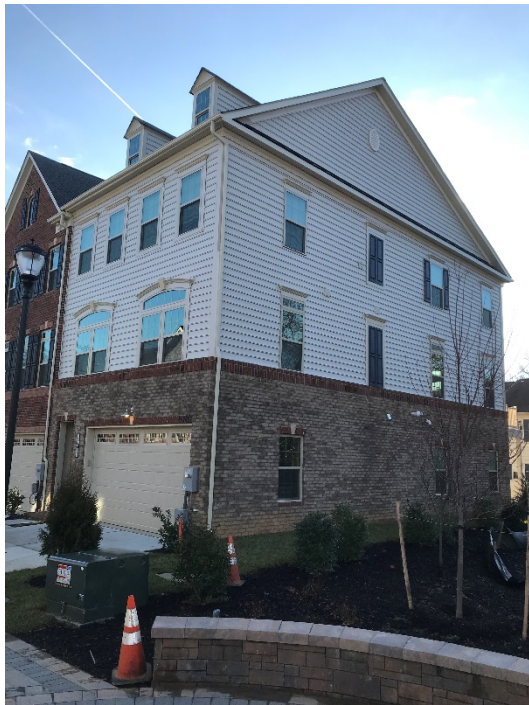
Right side (facing Route 108) and front of Lot 9
1021 Mutual Place, Sandy Spring, MD 20860

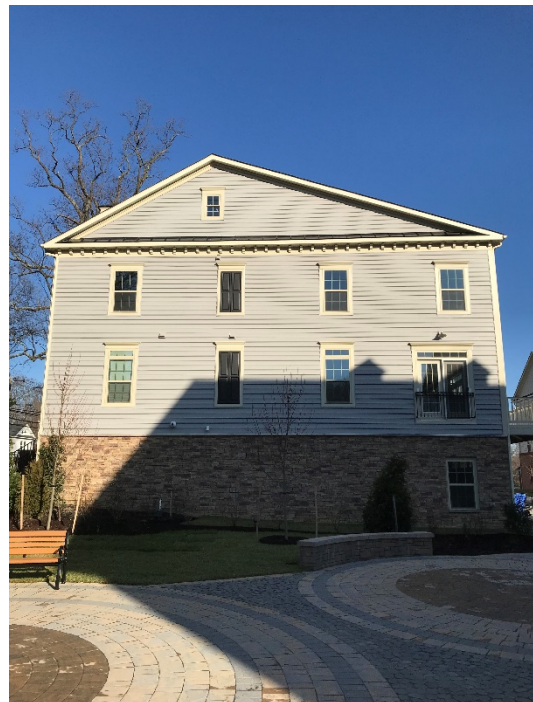
Right side of Lot 3 (originally Lot 2)
1014 Olney Sandy Spring Road, Sandy Spring, MD 20860

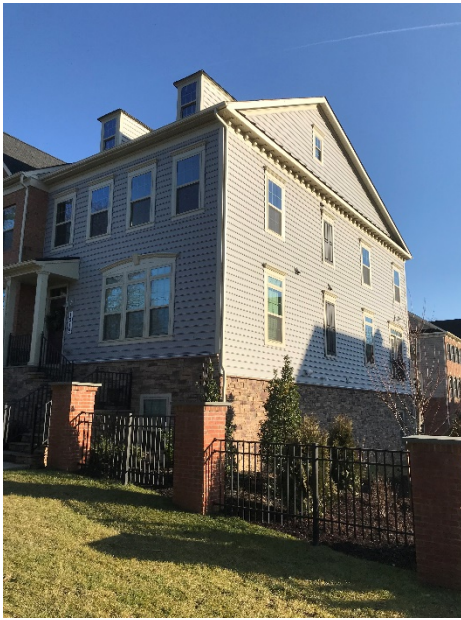
Front and right side of Lot 3
1014 Olney Sandy Spring Road
Sandy Spring, MD 20860

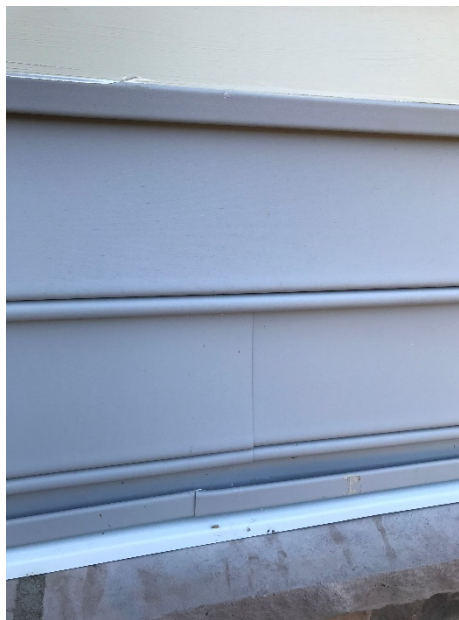
There are other requirements, but they all appear in compliance. The biggest discrepancy appears to be the use of vinyl siding in lieu of "hardy/cement plank siding". The following is the "A" Amendment Sheet C-1, with Original ["O"] & Final ["F"] Lot designations as indicated:

Beaded vinyl siding on front of Lot3; NOTE: Typical for all 3 Lots where "hardy/ cement plank siding is required per Resolution.

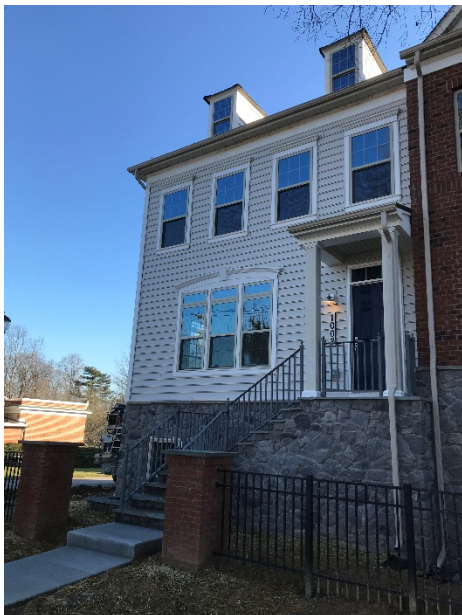
Front of Lot 8 (originally Lot 7)
1002 Olney Sandy Spring Road
Sandy Spring, MD 20860

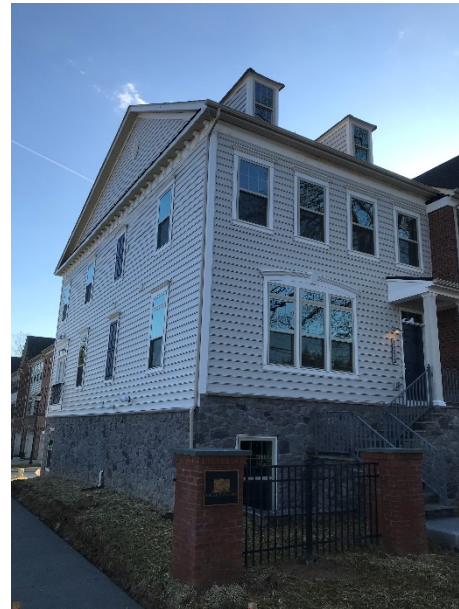
Front of Lot 8 (originally Lot 7)
1002 Olney Sandy Spring Road
Sandy Spring, MD 20860

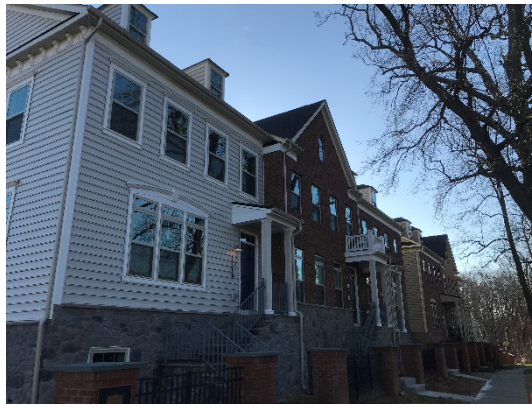
Front view of townhouses along Olney Sandy Spring Road with Lot 8 on left

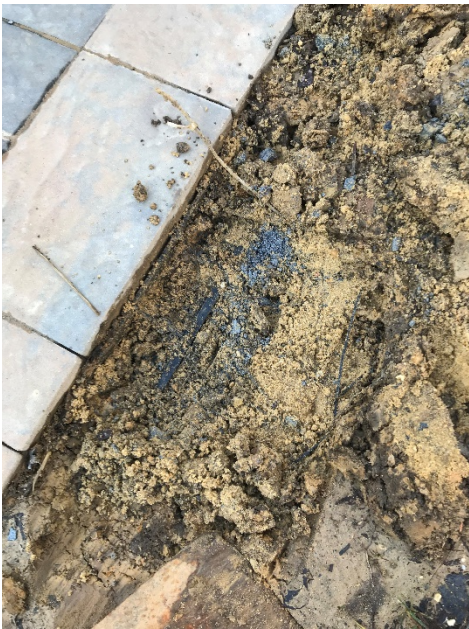
1. Changed emergency vehicle "turn-around plaza" area to typical pavers. This does not meet the stamped concrete requirement (changed to stamped concrete in 82016001A amendment). The installed pavers do not comply with CSP 820160010 in size or color (see details on Sheets L-3 & L-4, etc.) and concrete base (gravel and sand base installed). Refer to photos on pages 5 – 7.

No evidence of a concrete base as required in the Certified Site Plan (See details provided on Sheet L-4)

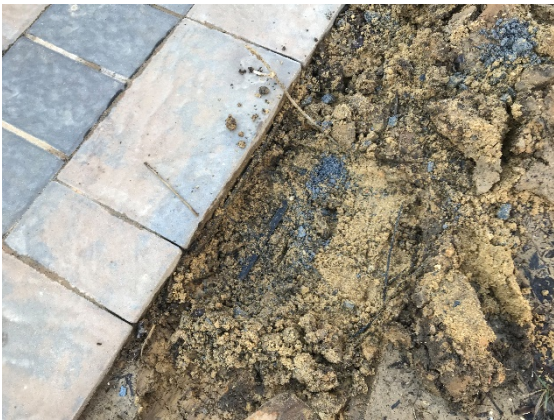
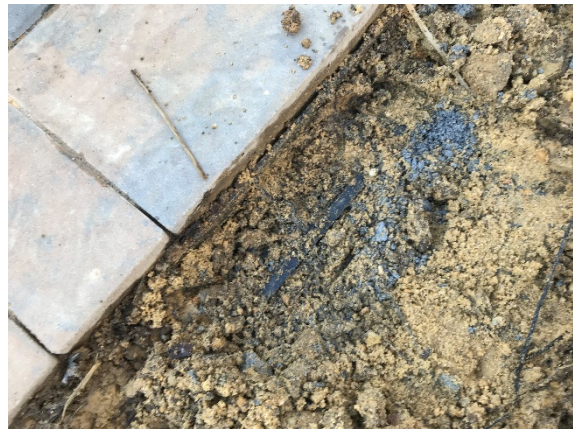
No evidence of required concrete base (Sheet L-4) – only CR6 base with sand setting bed

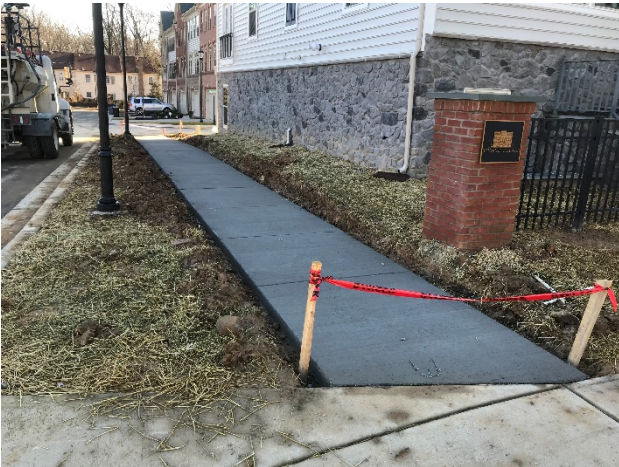
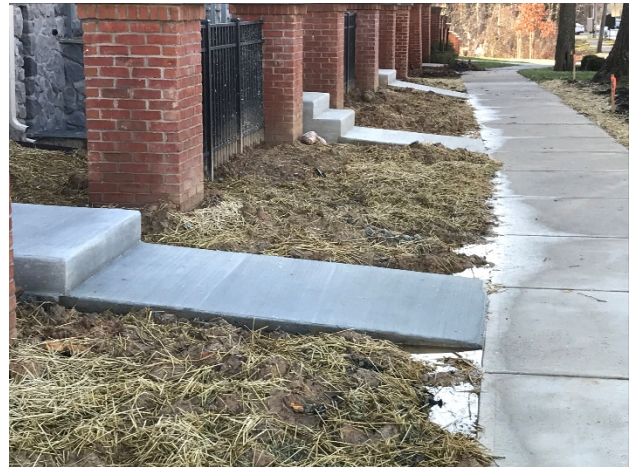
Sidewalk at east/left side of Lot 8/1002 Olney Sandy Spring Road (Route 108) and Lead walks at townhouses along Route 108
