Re: **Lot 21, Block 4, Edgemoor**
7611 Fairfax Road, Bethesda, MD 20814
Proposed Lots 23 – 24, Block 4, Edgemoor
Forest Conservation (Chapter 22A) Variance Request
MNCPPC # 620230060

Variance Justification

TREE VARIANCE EXHIBIT (APPENDIX A) - M-NCP&PC No. 620230060

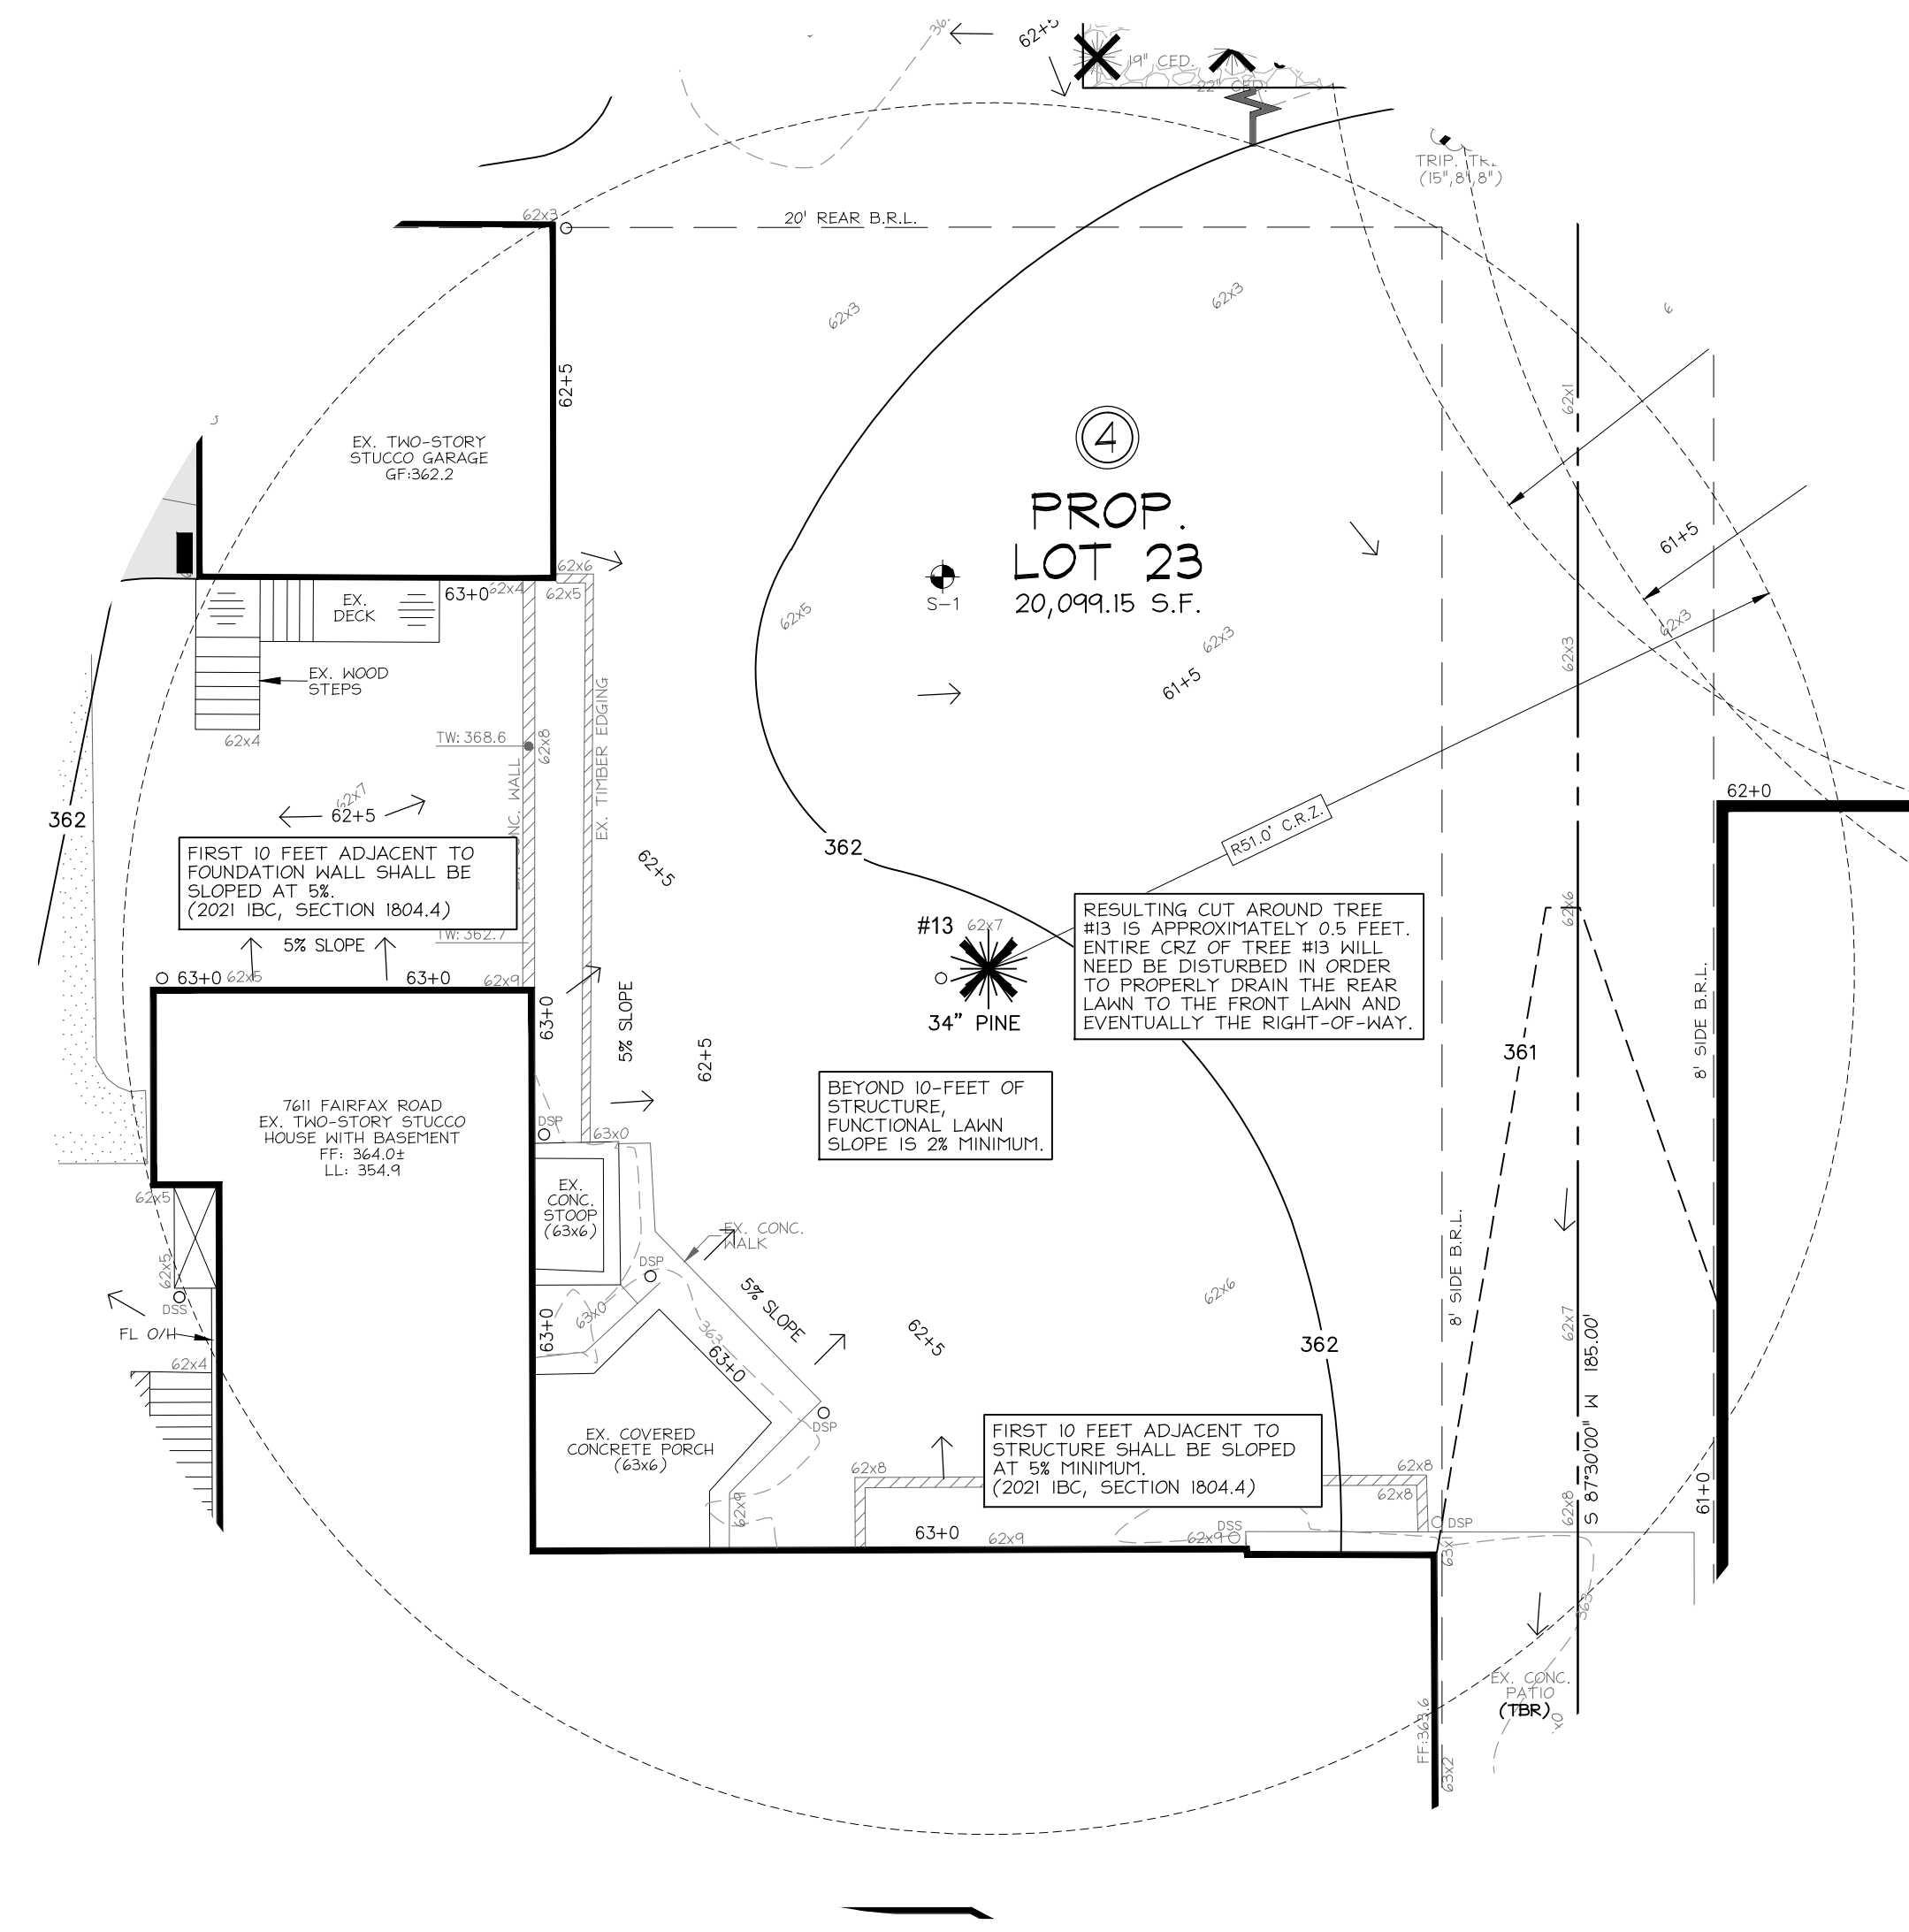
TREE NO. 13 GRADING EXHIBIT

Tree #13, a 33” short leaf pine is in the center of proposed Lot 23 and the further development of this property would not be feasible unless the tree is approved for removal. More specifically, the subject property as it exists today has drainage issues. Due to a lack of slope from the rear yard to front yard, water ponds in the rear yard after rain events. Regardless of any proposed improvements to the property, drainage must first be addressed. The only way this can be accomplished is through regrading most of the property including the rear yard where Tree #13 exists. To further exemplify the grading impacts to Tree #13, an exhibit has been prepared in which all proposed improvements have been removed (See Appendix A). The impacts from grading alone will result in the removal of Tree #13. Additionally, the applicant or future property owner will need to obtain a sediment control permit for proposed Lot 23; whether it be for site grading to improve drainage, improvements to the property (i.e. addition, pool, patio, stormwater facilities, etc.) or a combination of both. It will be their responsibility to satisfy all requirements of the sediment control permit including COMCOR Section 19.10.02.06, which states *For finished grading, the permittee must provide adequate gradients so as to: (1) prevent water from standing on the surface of lawns more than twenty-four (24) hours after the end of a rainfall, except in swale flow areas which may drain as long as forty eight (48) hours after the end of a rainfall, and (2) provide positive drainage away from all building foundations or openings.* This section of COMCOR cannot be satisfied unless Tree #13 is approved for removal. This would clearly cause a hardship for the applicant as it would not only remove their ability to obtain a sediment control permit, but it would also take away their right to improve a back yard that does not drain. No matter what improvements are planned for proposed Lot 23 it is not be feasible to develop a grading plan that could save Tree #13 while providing adequate drainage for the property.

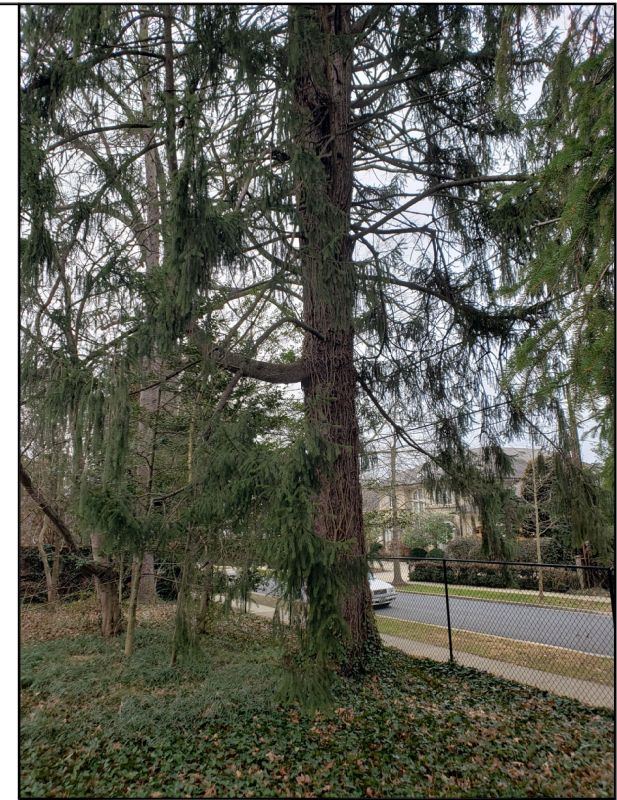
Tree 4

Tree Tag: 4
 Species: Norway Spruce (*Picea abies*)
 Size (DBH): 30.5"
 Location: Front of Property approximately 25 feet from Fairfax Road.
 Date of Evaluation: January 23, 2023
 Assessment Type: Level 2 (ANSI A300, Part 9)

A visual "walk-around" evaluation was performed to determine the overall condition/health of the tree. As part of this evaluation we have determined that this tree is in good condition. Although, this tree may be in decline due to vine strangling (English Ivy). The severity of english ivy can be seen in the attached photograph. Slight deadwood was noted within the canopy, which is typical for this species, but the presence of strangling vines could also be contributing. We observed a twin stem at approximately 30-feet with included bark (with a potential seam). The included bark and seam is a weak point within the union which could be subject to failure. Due to this, we noted this tree to have a high probability of failure. Mitigation can be provided for the weak tree branch union and the english ivy can be trimmed from the tree. These measures would improve the trees likelihood of stability and longevity.

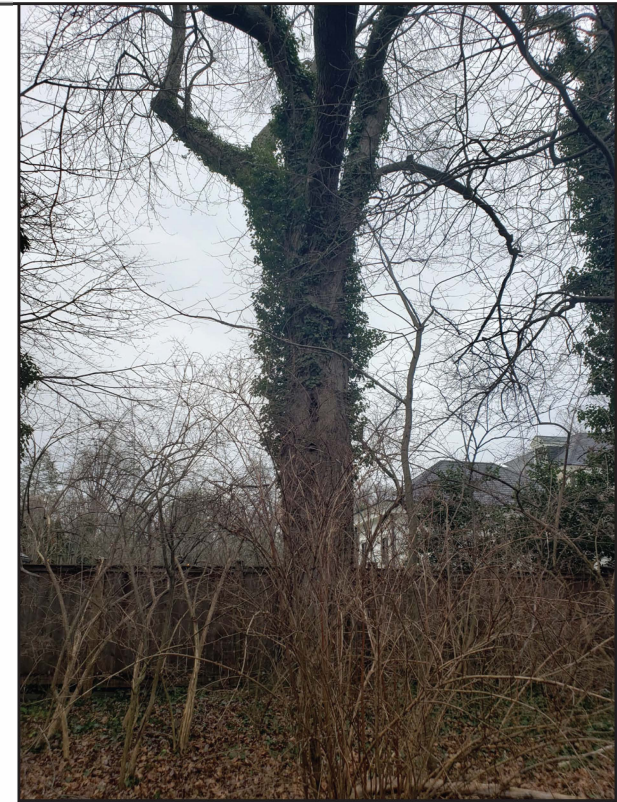
Tree 11

Tree Tag: 11
 Species: Silver Maple (Acer saccharinum)
 Size (DBH): 41.5"
 Location: Several Feet from a joint property line with the adjoining neighbor. See location exhibit, this page.
 Date of Evaluation: January 23, 2023
 Assessment Type: Level 2 (ANSI A300, Part 9)

A visual "walk-around" evaluation was performed to determine the overall condition/health of the tree. As part of this evaluation we have determined that this tree is in poor condition due to decline, hollowing, and moderate defoliation (limb/caopy loss). Removal is recommended. We believe vine strangling (English Ivy) and species suscepability to decline/decay has contributed to the current condition. We observed significant decline, decay, hollowing (cavity and sounding), and dieback due to invasive vines. This tree has been classified as a hazard tree due to condition and proximity to an offsite structure (target).

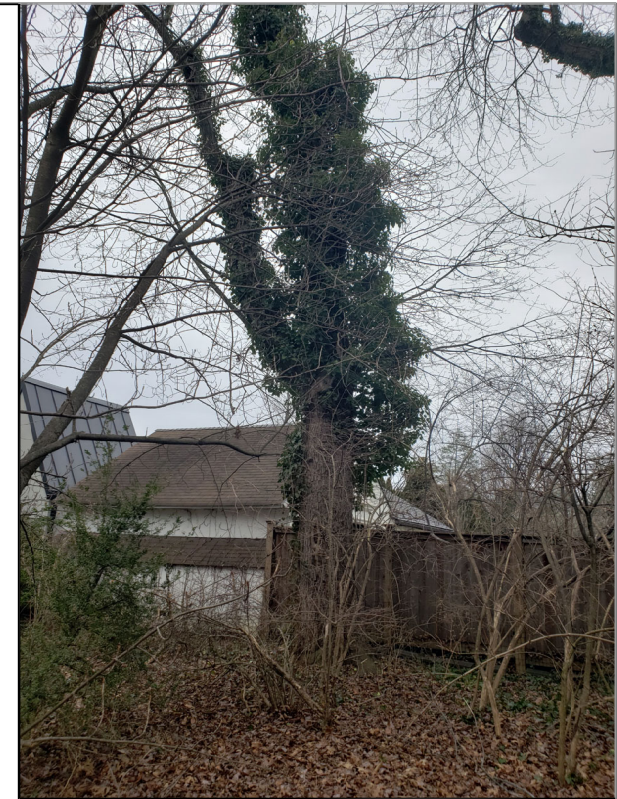
Tree 12

Tree Tag: 12
 Species: Silver Maple (*Acer saccharinum*)
 Size (DBH): 34"
 Location: Several Feet from a joint property line with the adjoining neighbor. See location exhibit, this page.
 Date of Evaluation: January 23, 2023
 Accessment Type: Level 2 (ANSI A300, Part 9)

A visual "walk-around" evaluation was performed to determine the overall condition/health of the tree. As part of this evaluation we have determined that this tree is in poor condition due to decline and defoliation (limb/caopy loss). Removal is recommended. We believe vine strangling (English Ivy) and species succpeability to decline/decay has contributed to the current condition. We observed significant decline, apparent internal decay, and a severe loss of canopy. This tree has been classified as a hazard tree due to condition and proximity to an offsite structure (target).

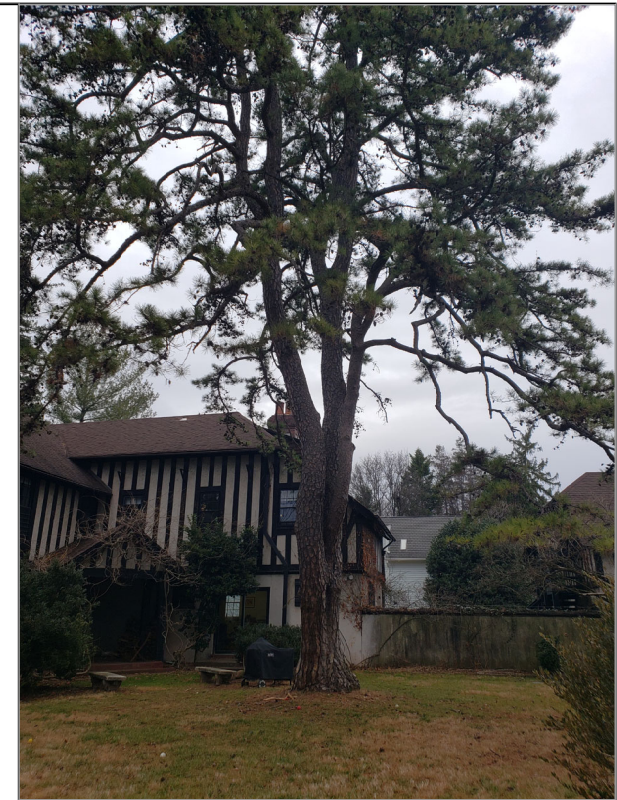
Tree 13

Tree Tag: 13
 Species: Shortleaf Pine (Pinus echinata)
 Size (DBH): 34"
 Location: Rear of the subject property roughly 25-feet from the existing house.
 Date of Evaluation: January 23, 2023
 Assessment Type: Level 2 (ANSI A300, Part 9)

A visual "walk-around" evaluation was performed to determine the overall condition/health of the tree. As part of this evaluation we have determined that this tree is in good condition. We did not observe decline, dieback, decay, hollowing or other indicators of stress. The canopy of the tree appears open and well maintained. Structurally, this tree has multiple leaders which may consist of include bark. This would create a weak point within the structure of the tree that increases the risk of failure. Although, mitigation could be provided to reduce such risk.

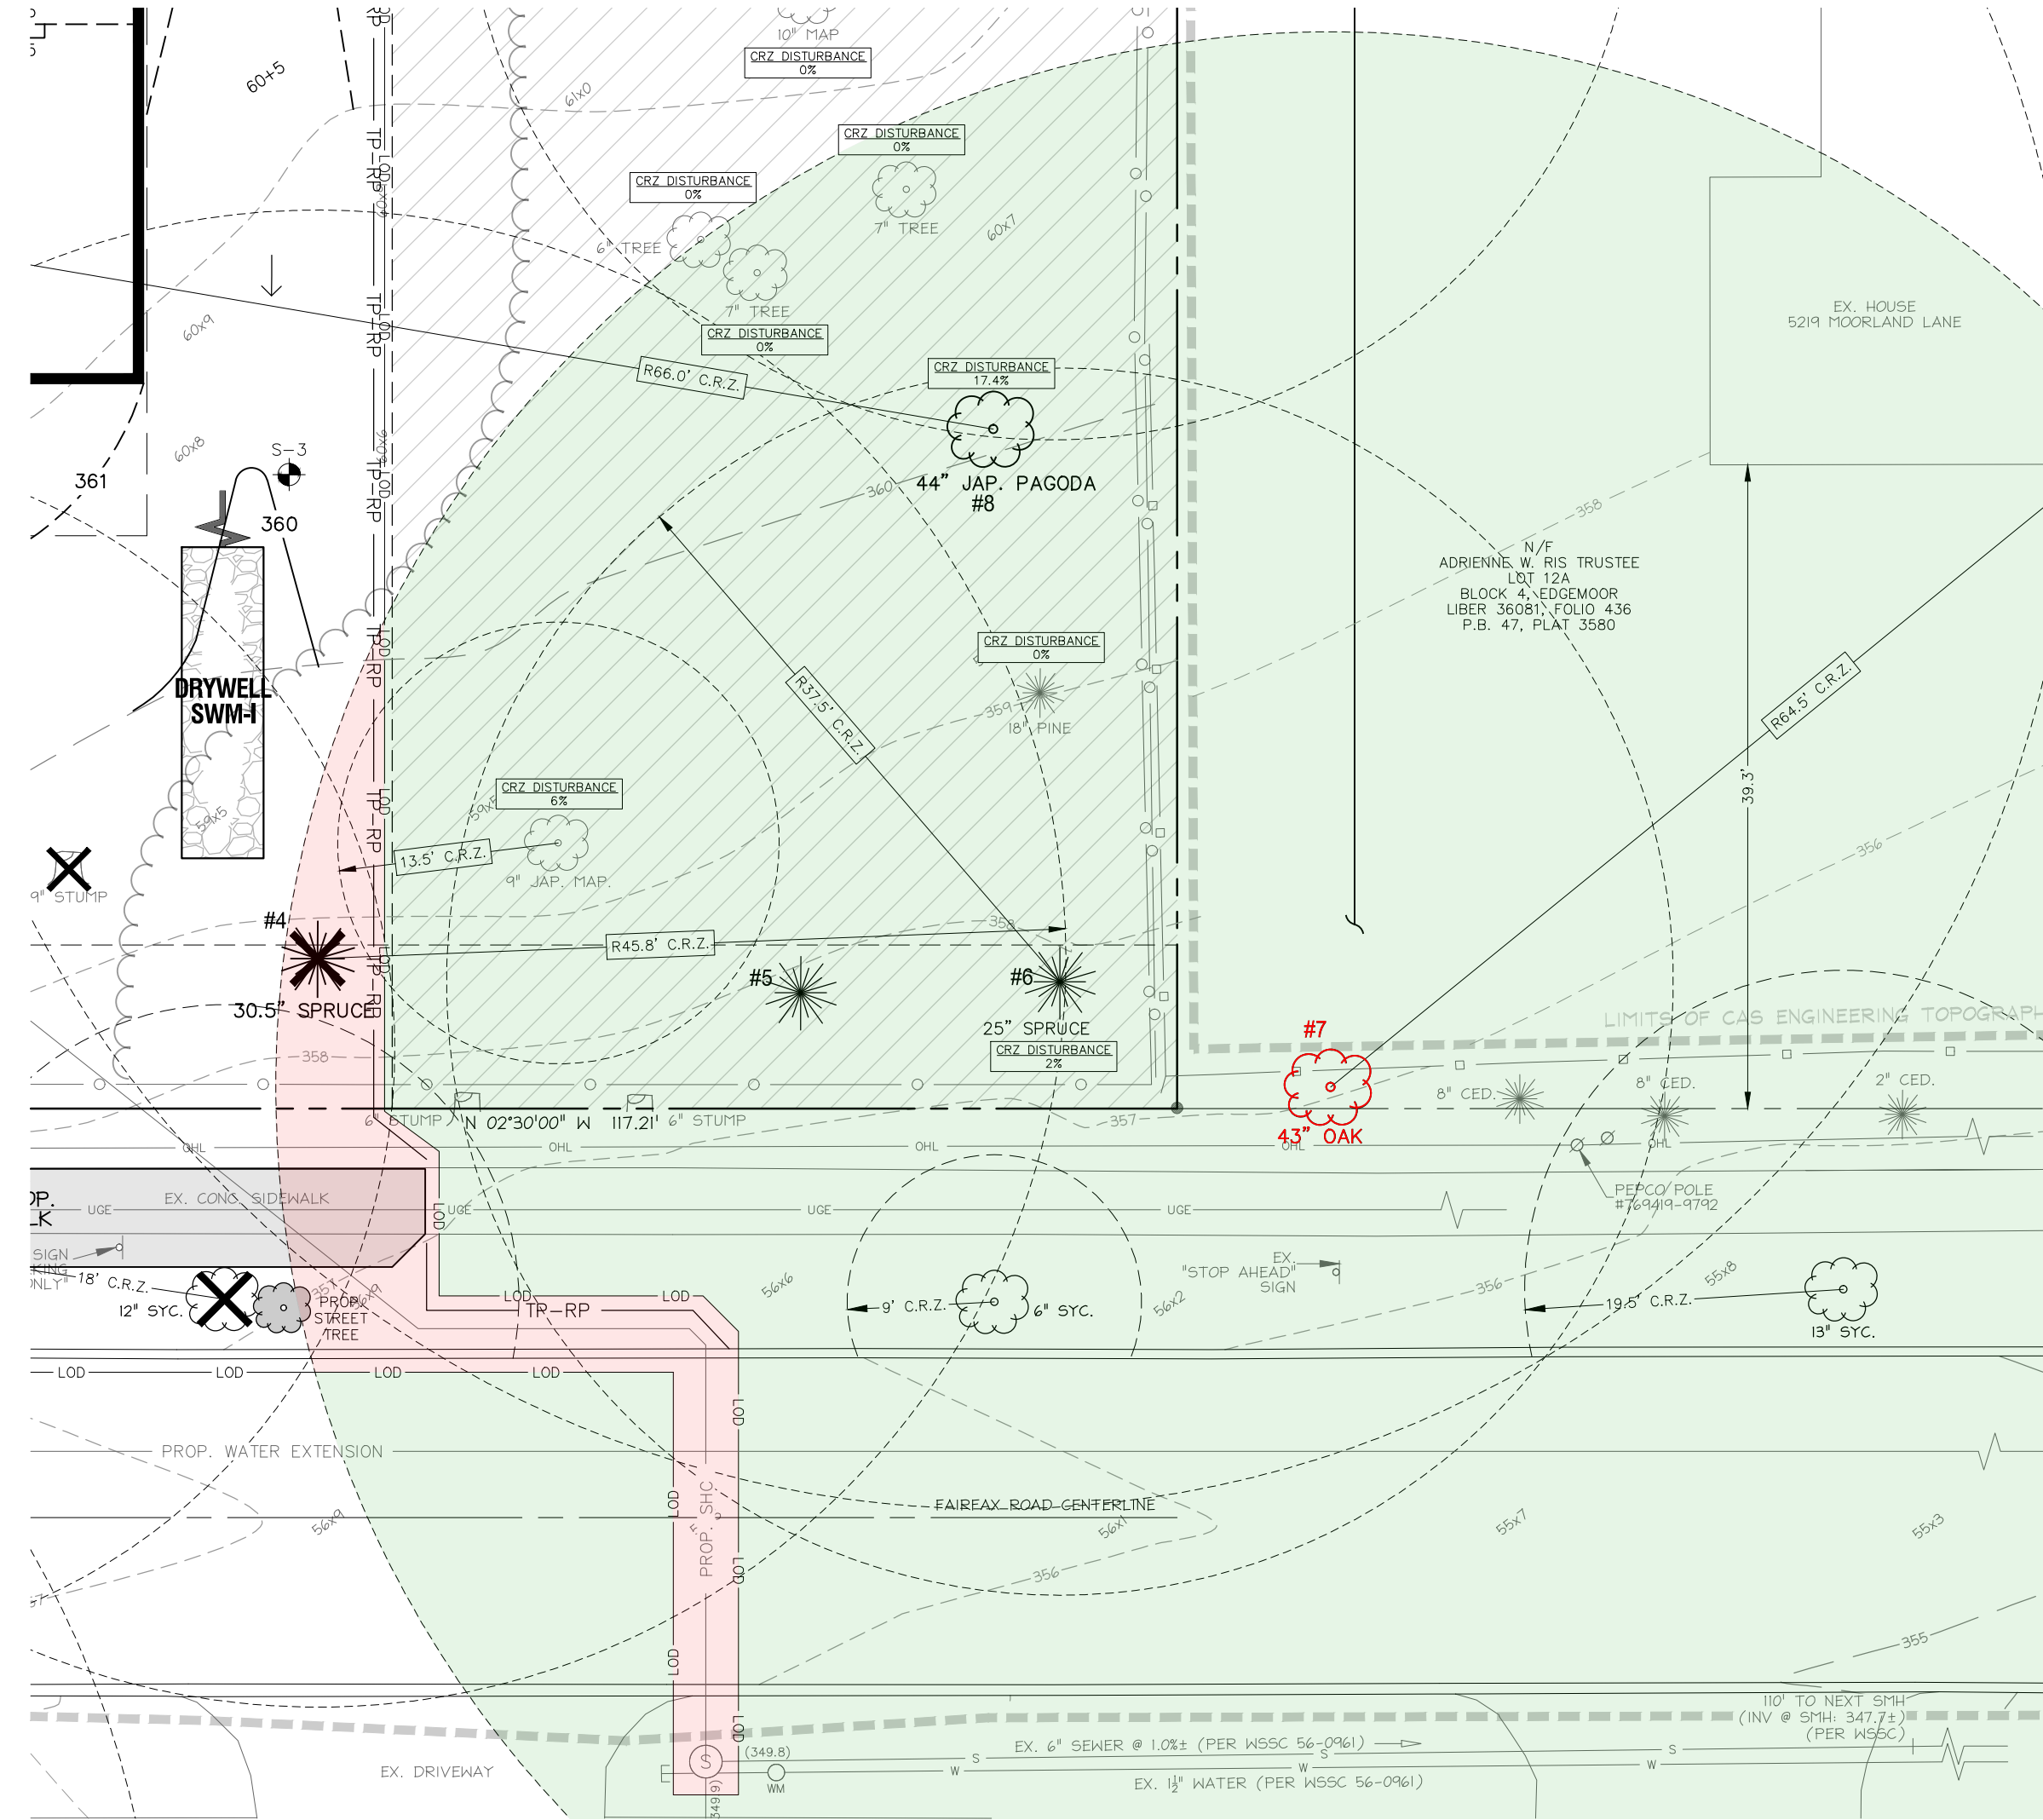
TREE NO. 7 CRZ DISTURBANCE EXHIBIT

CRZ DISTURBANCE
457 SF / 13,069 SF = 3.5%

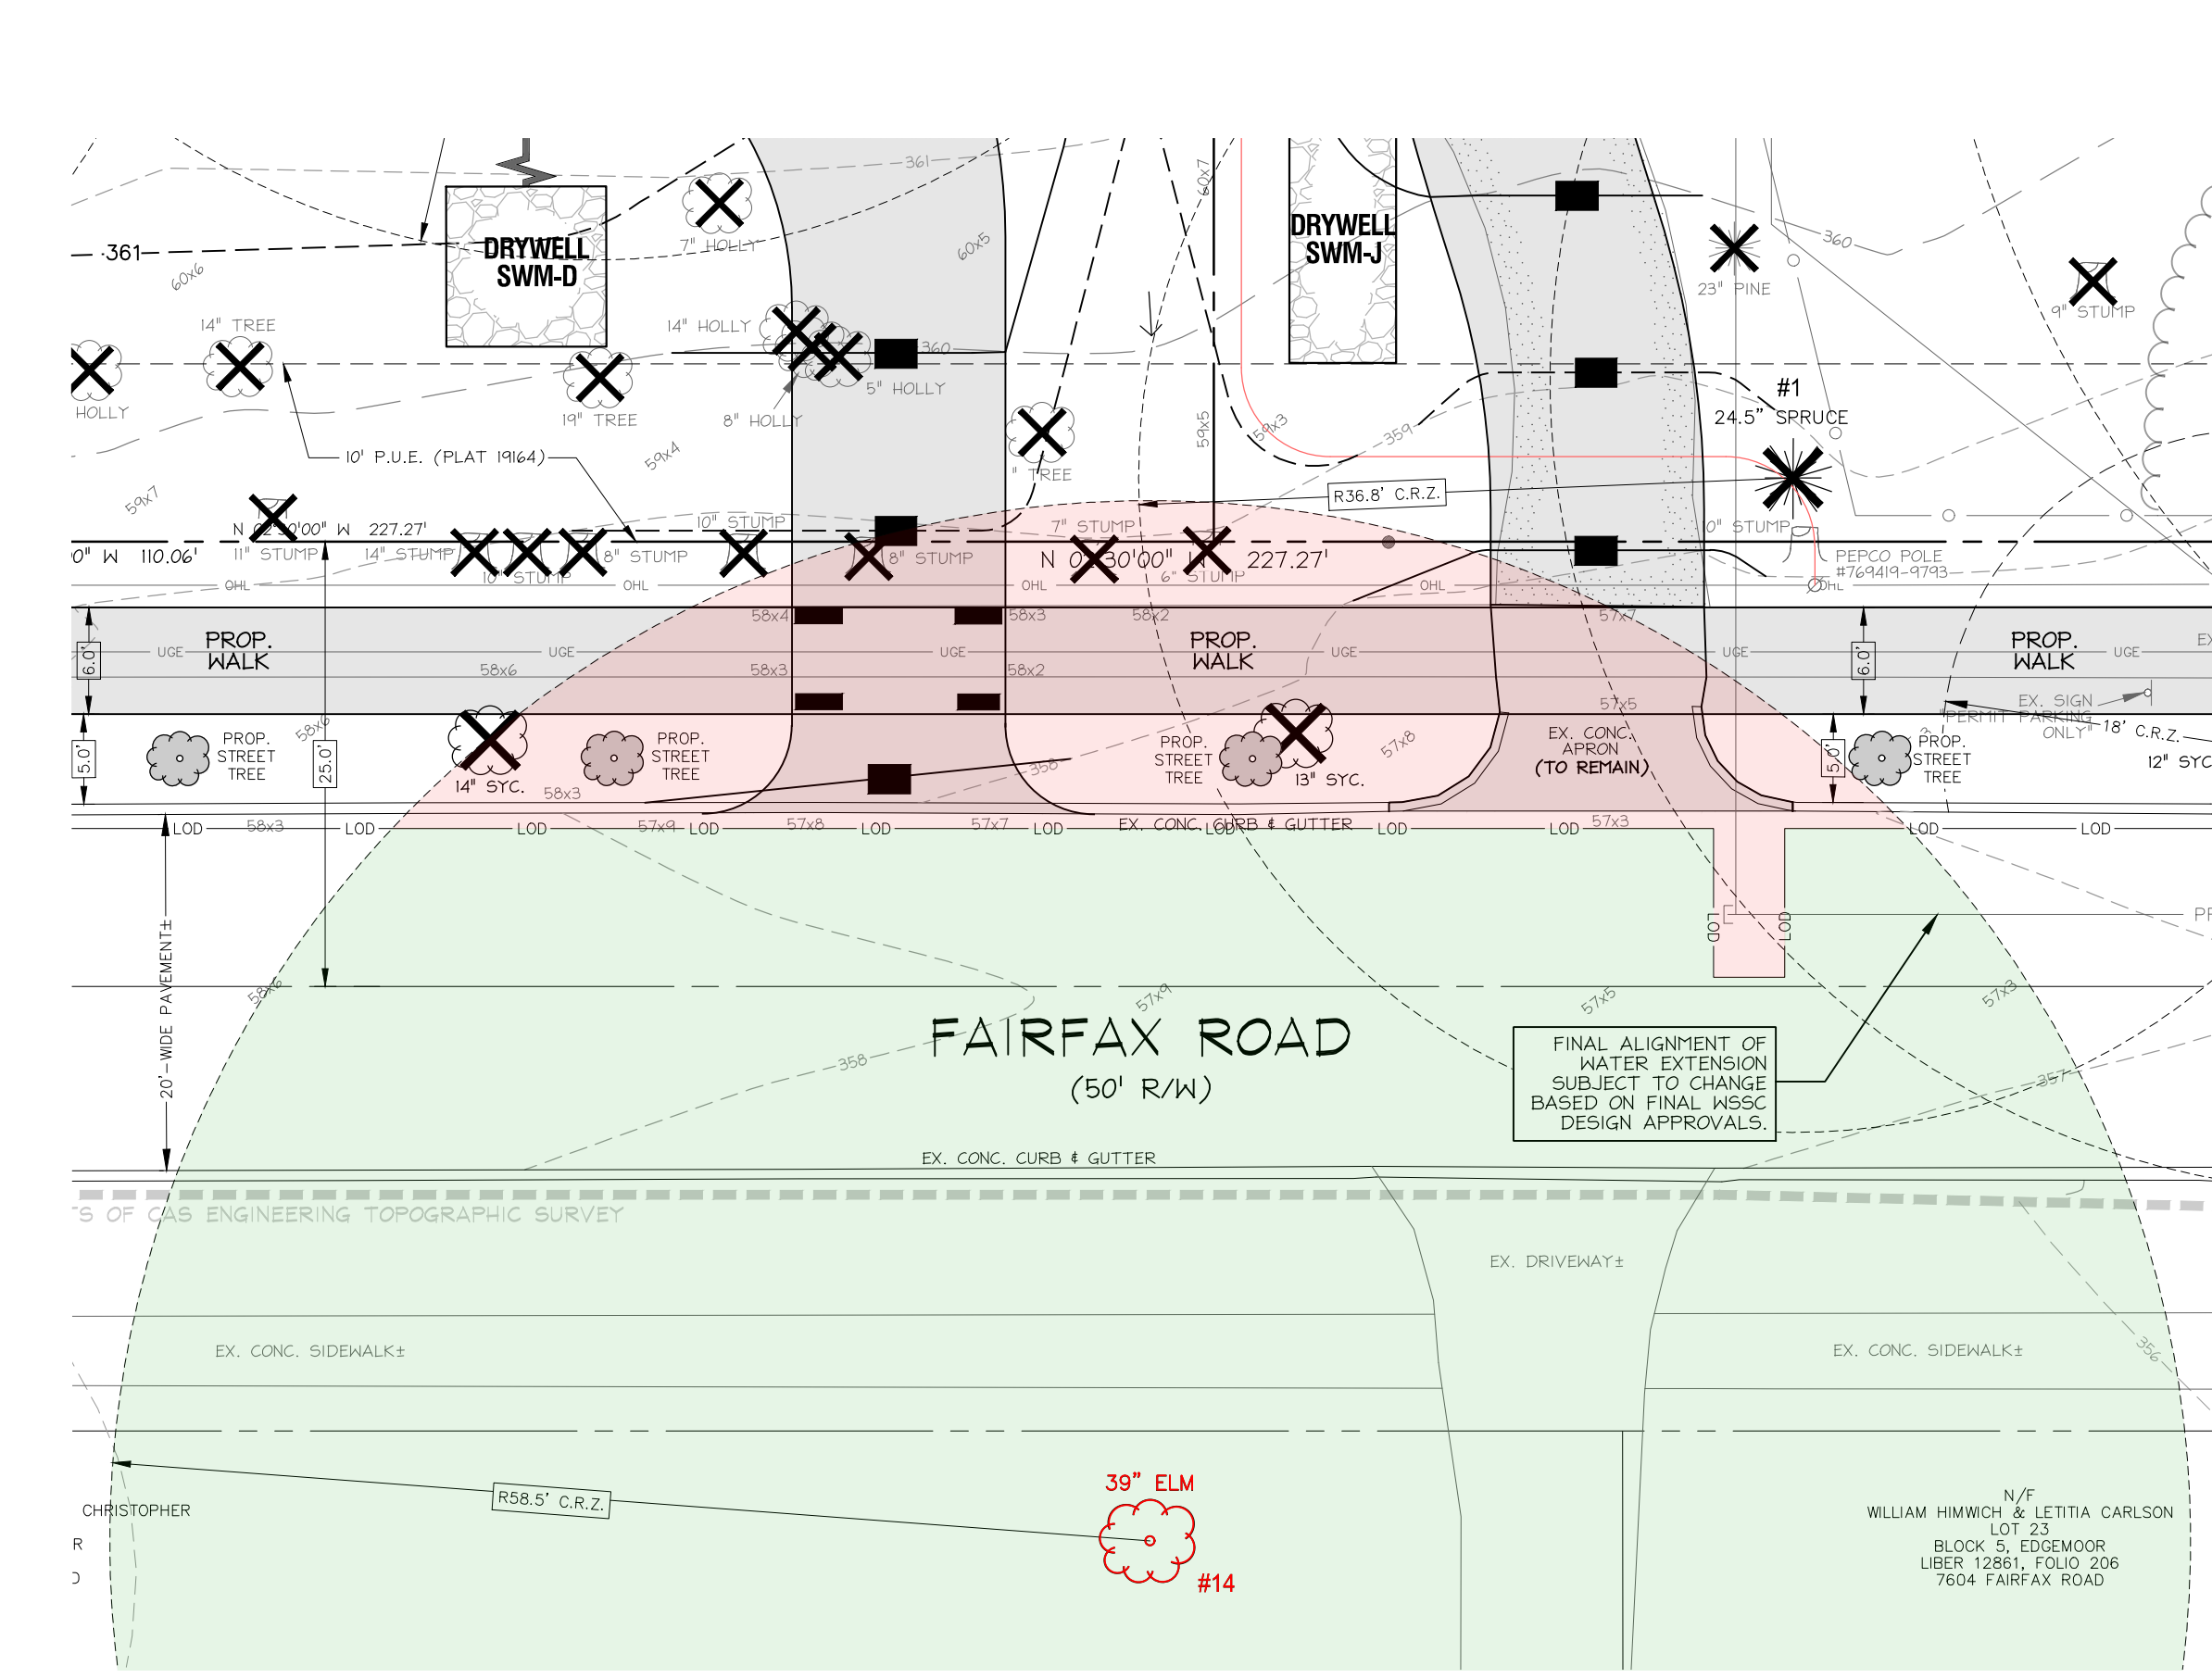
TREE NO. 14 CRZ DISTURBANCE EXHIBIT

CRZ DISTURBANCE
1,118 SF / 10,751 SF = 10.4%

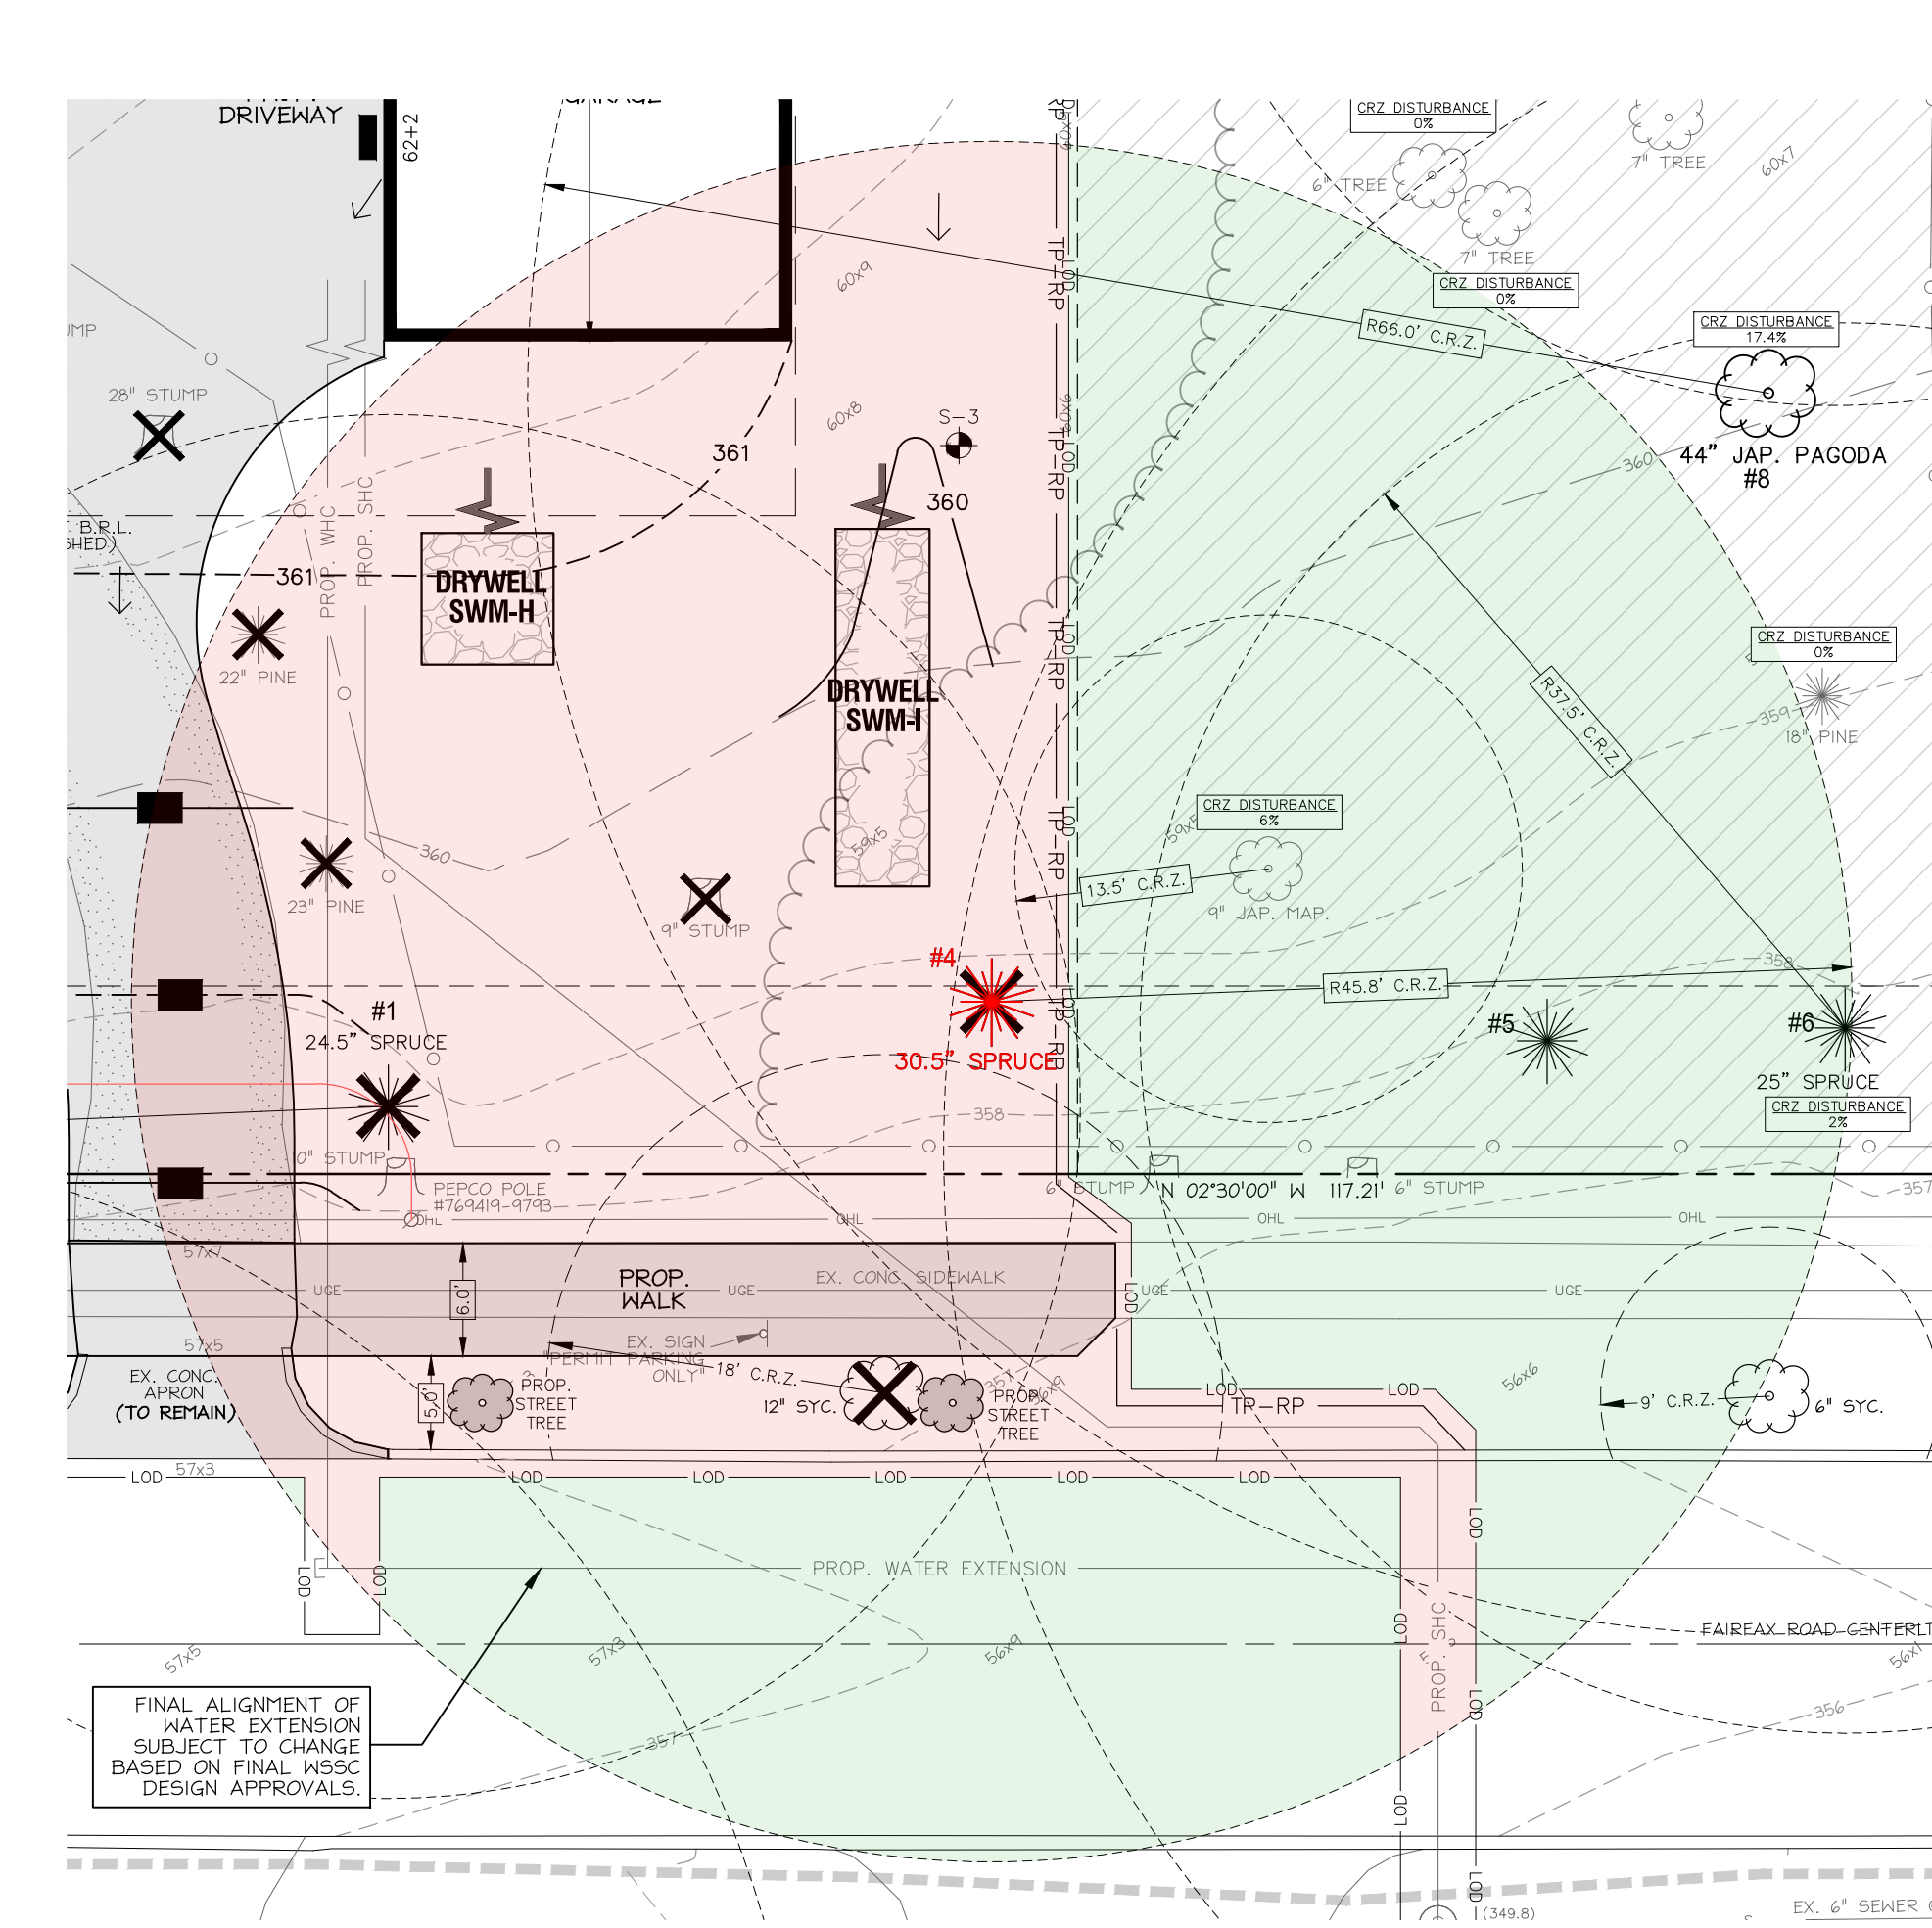
TREE NO. 4 CRZ DISTURBANCE EXHIBIT

The other on-site specimen tree proposed for removal is Tree #4. Retaining this tree would prohibit the construction of necessary stormwater management facilities for future development on this property. As shown on the Forest Conservation Plan, the proposed stormwater management facilities (gravel drywells) are spaced as close together as current regulations allow (15 feet from each other and 10 feet from slab on grade structures). Smaller setbacks and spacing cannot be explored for these types of facilities. Alternate SWM facilities were considered in the front yard but were found to result in just as much disturbance as gravel drywells or more in some cases. More specifically, surface facilities (i.e. landscape infiltration, rain garden, and micro-bioretenion) were explored but were found to result in excessive grading as needed to construct the level surface of the facility and the non-erosive overflow berm around it. The protection of Tree #4 could not be implemented under any alternate scenario in which a surface facility was proposed. Permeable pavement was also explored as an alternate solution to gravel drywells. It was determined that permeable pavement was not appropriate for the proposed driveway due to soil restrictions (pavers cannot be located in compacted fill; majority of proposed driveway near the house will be in compacted fill), setback requirements (pavers must be located at least 10 feet from the house), and driveway slope restrictions (pavers cannot be installed on driveway slopes that exceed 5%, driveway slope leading up to garage is approximately 10%).

CRZ DISTURBANCE
3,222 SF / 6,576 SF = 49.0%

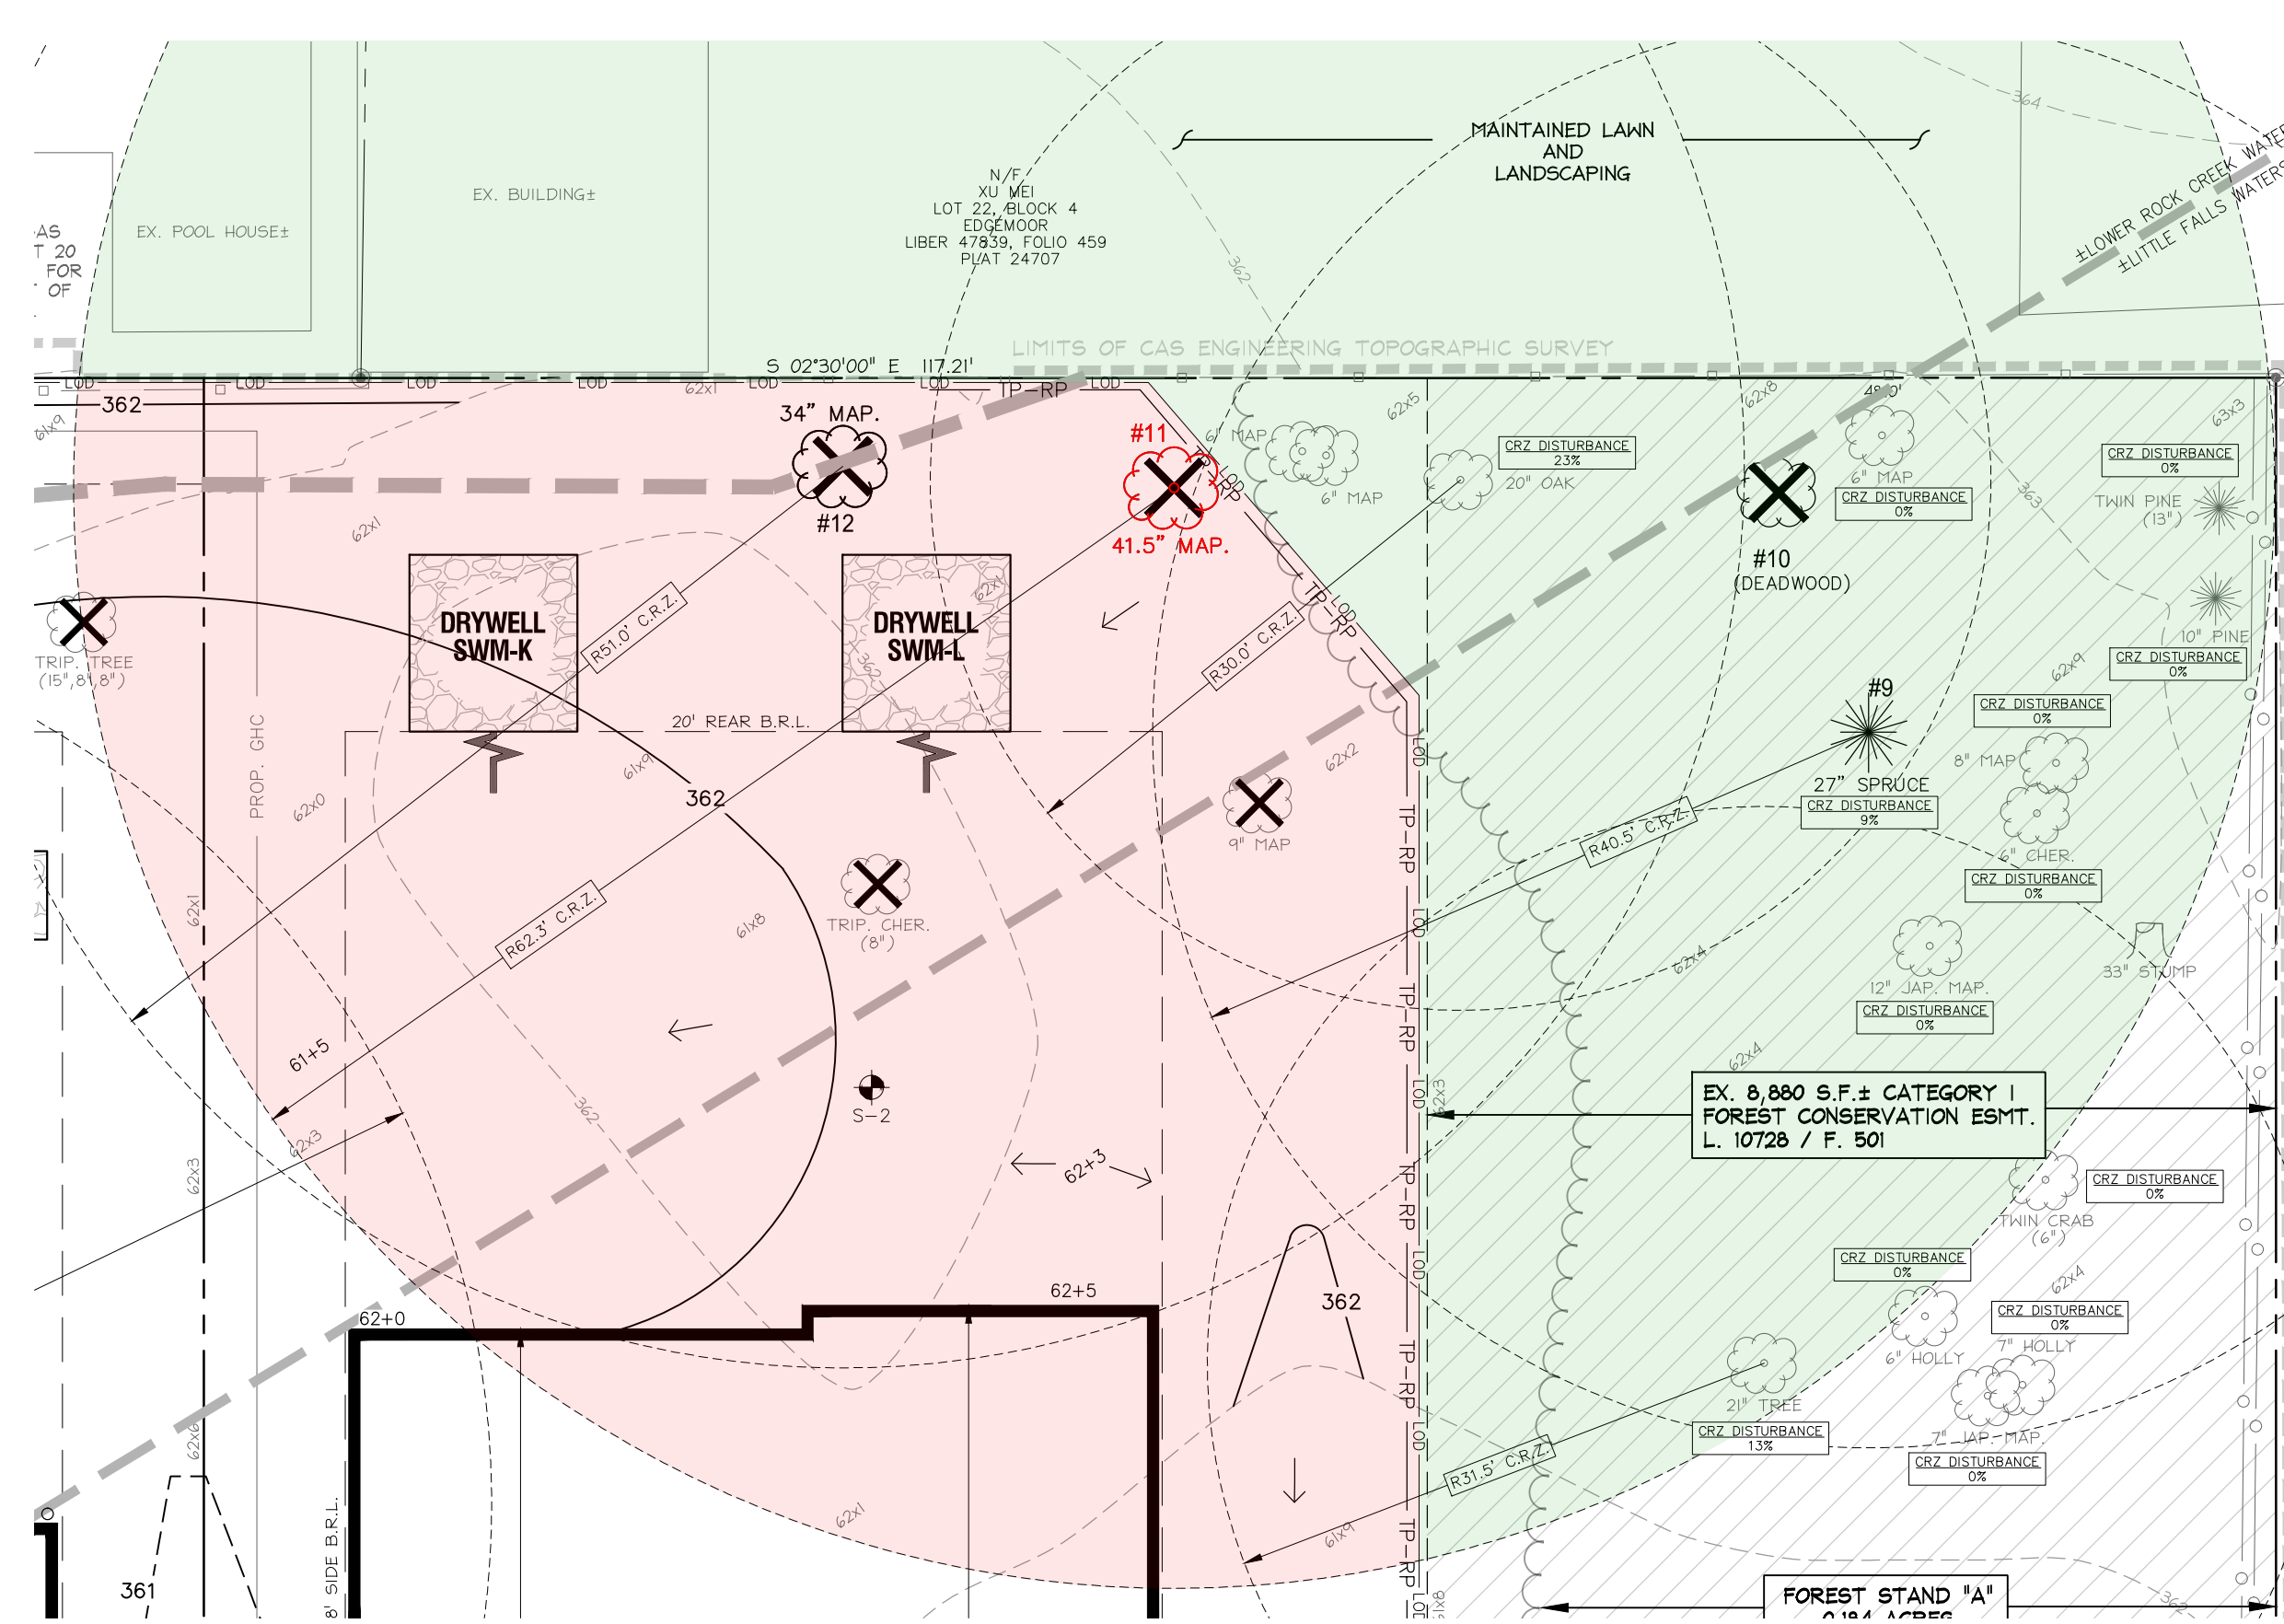
TREE NO. 11 CRZ DISTURBANCE EXHIBIT

CRZ DISTURBANCE
4,261 SF / 12,174 SF = 35.0%
