Re: **Lot 21, Block 4, Edgemoor**
7611 Fairfax Road, Bethesda, MD 20814
Proposed Lots 23 – 24, Block 4, Edgemoor
Forest Conservation (Chapter 22A) Variance Request
MNCPPC # 620230060

Variance Justification

TREE VARIANCE EXHIBIT (APPENDIX A) - M-NCP&PC No. 620230060

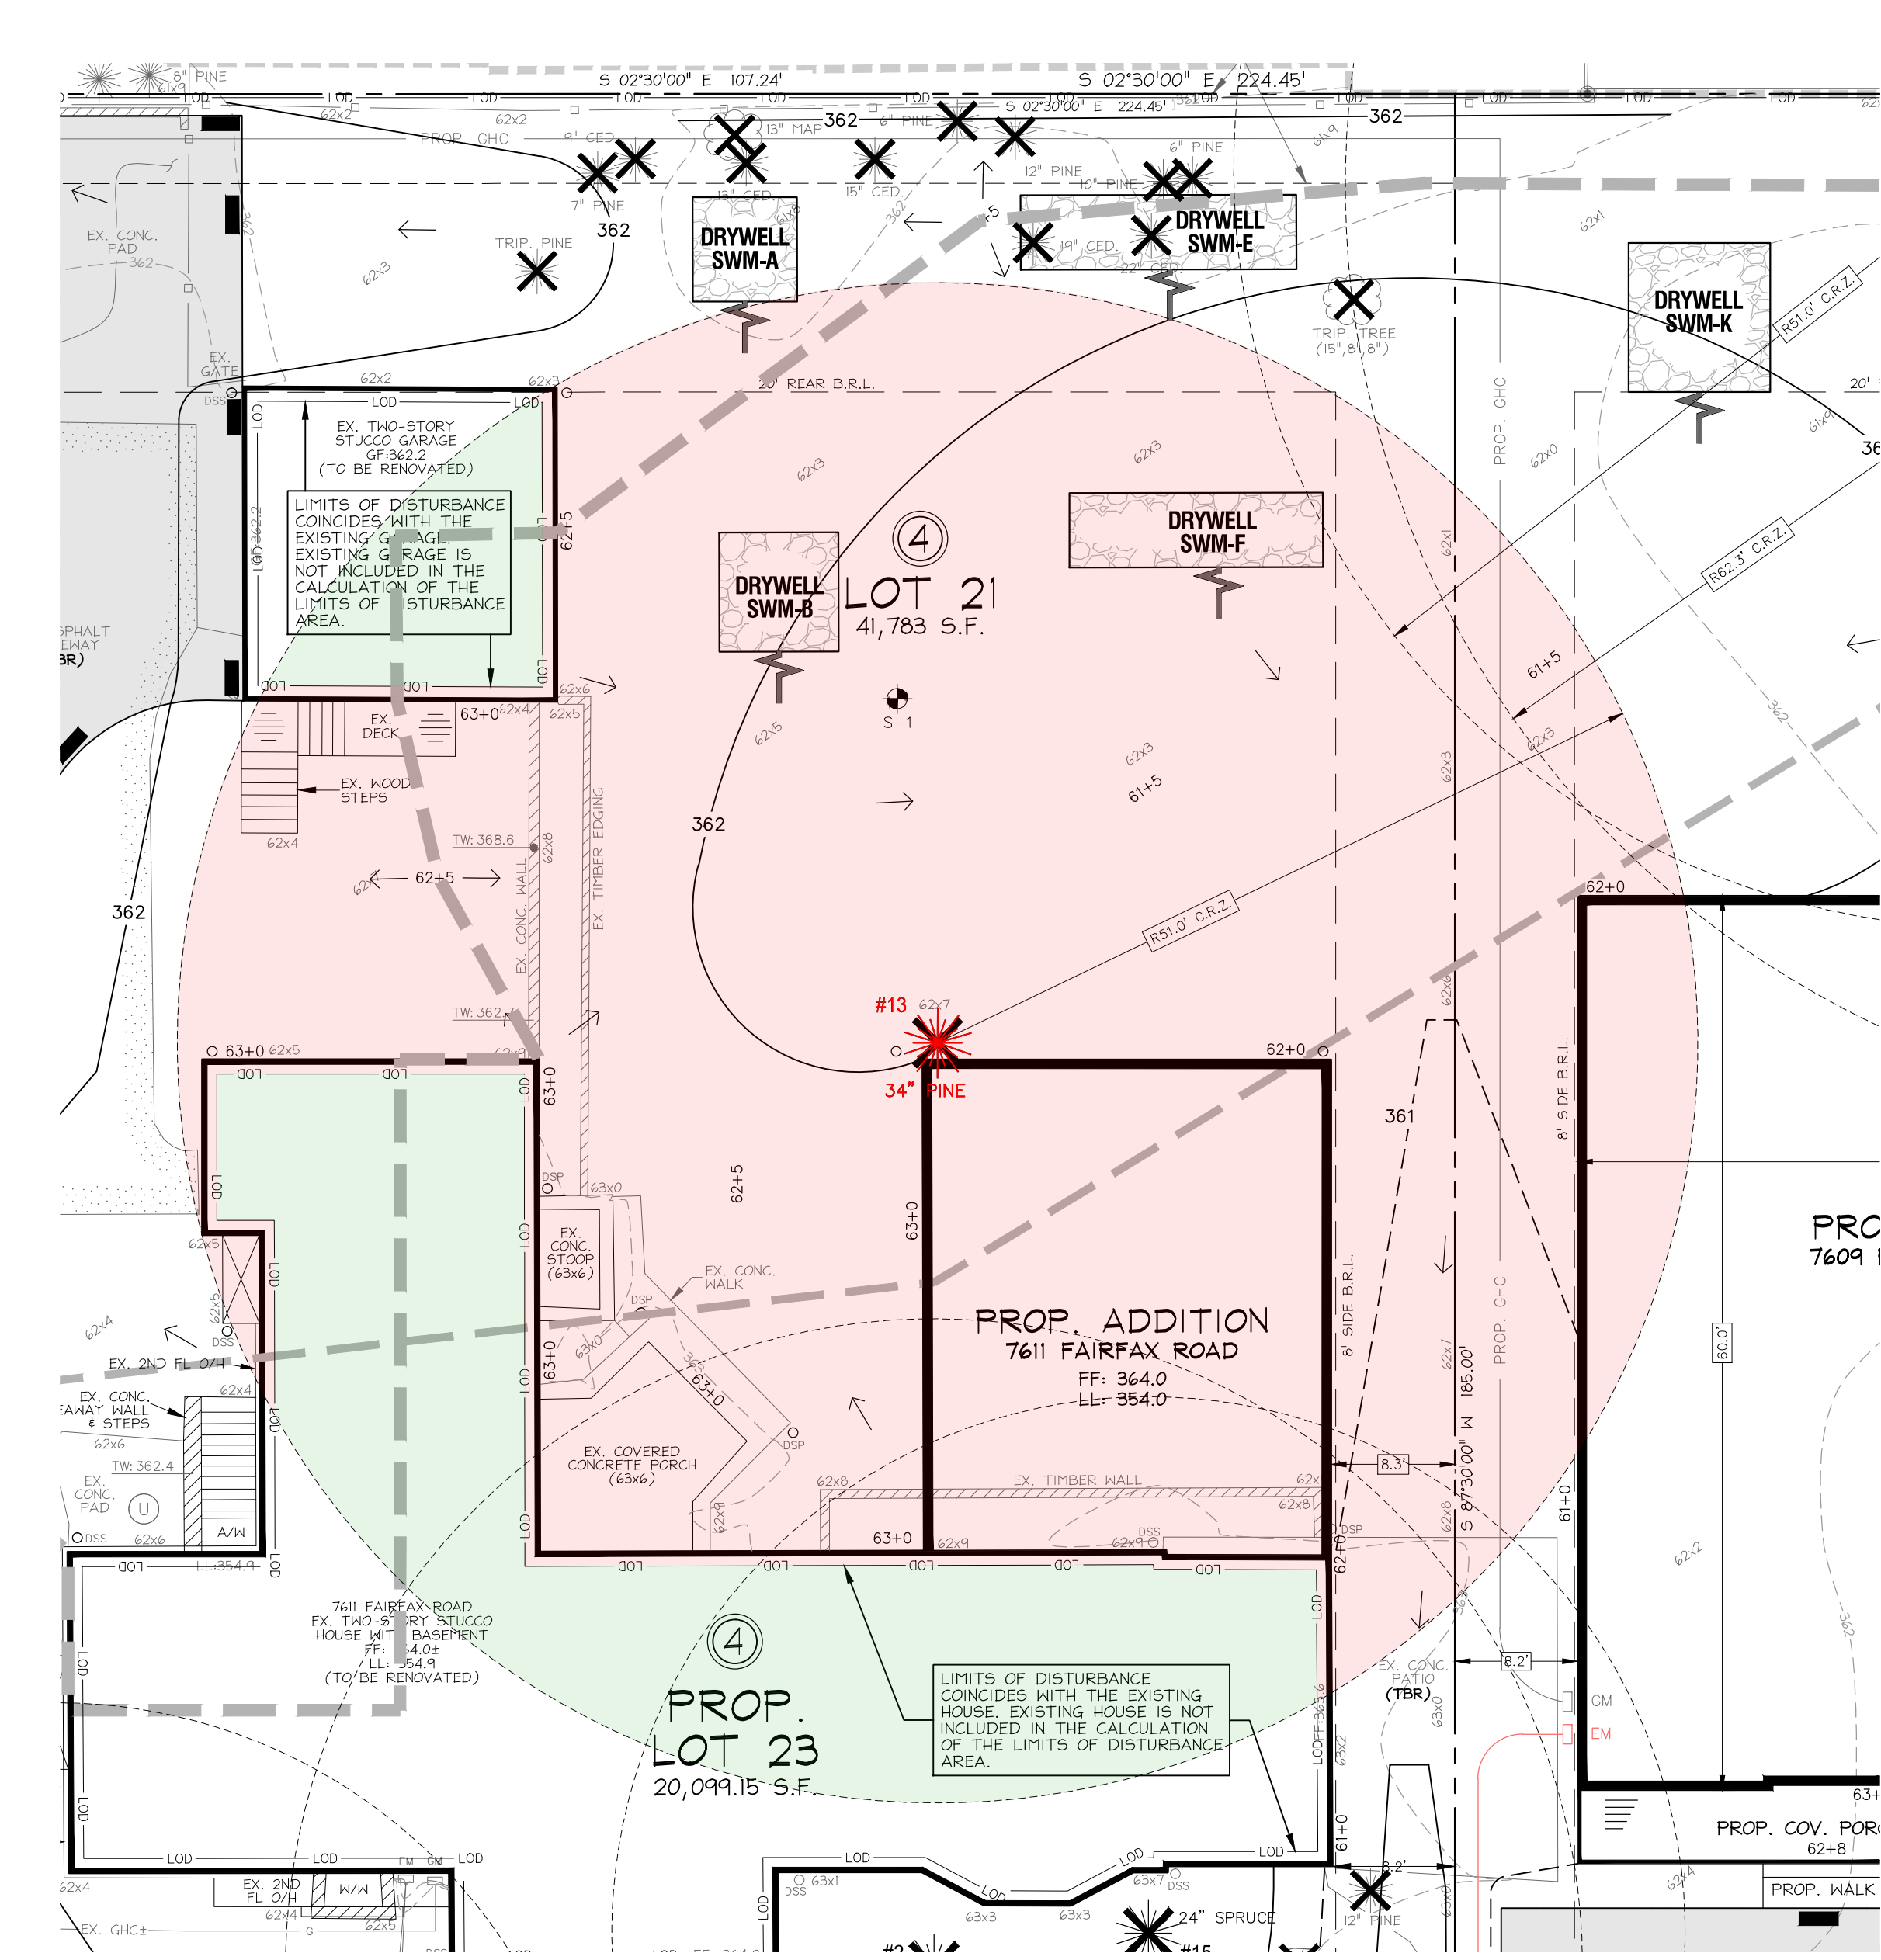
TREE NO. 13 CRZ DISTURBANCE EXHIBIT

CRZ DISTURBANCE
6,818 SF / 8,171 SF = 81.0%

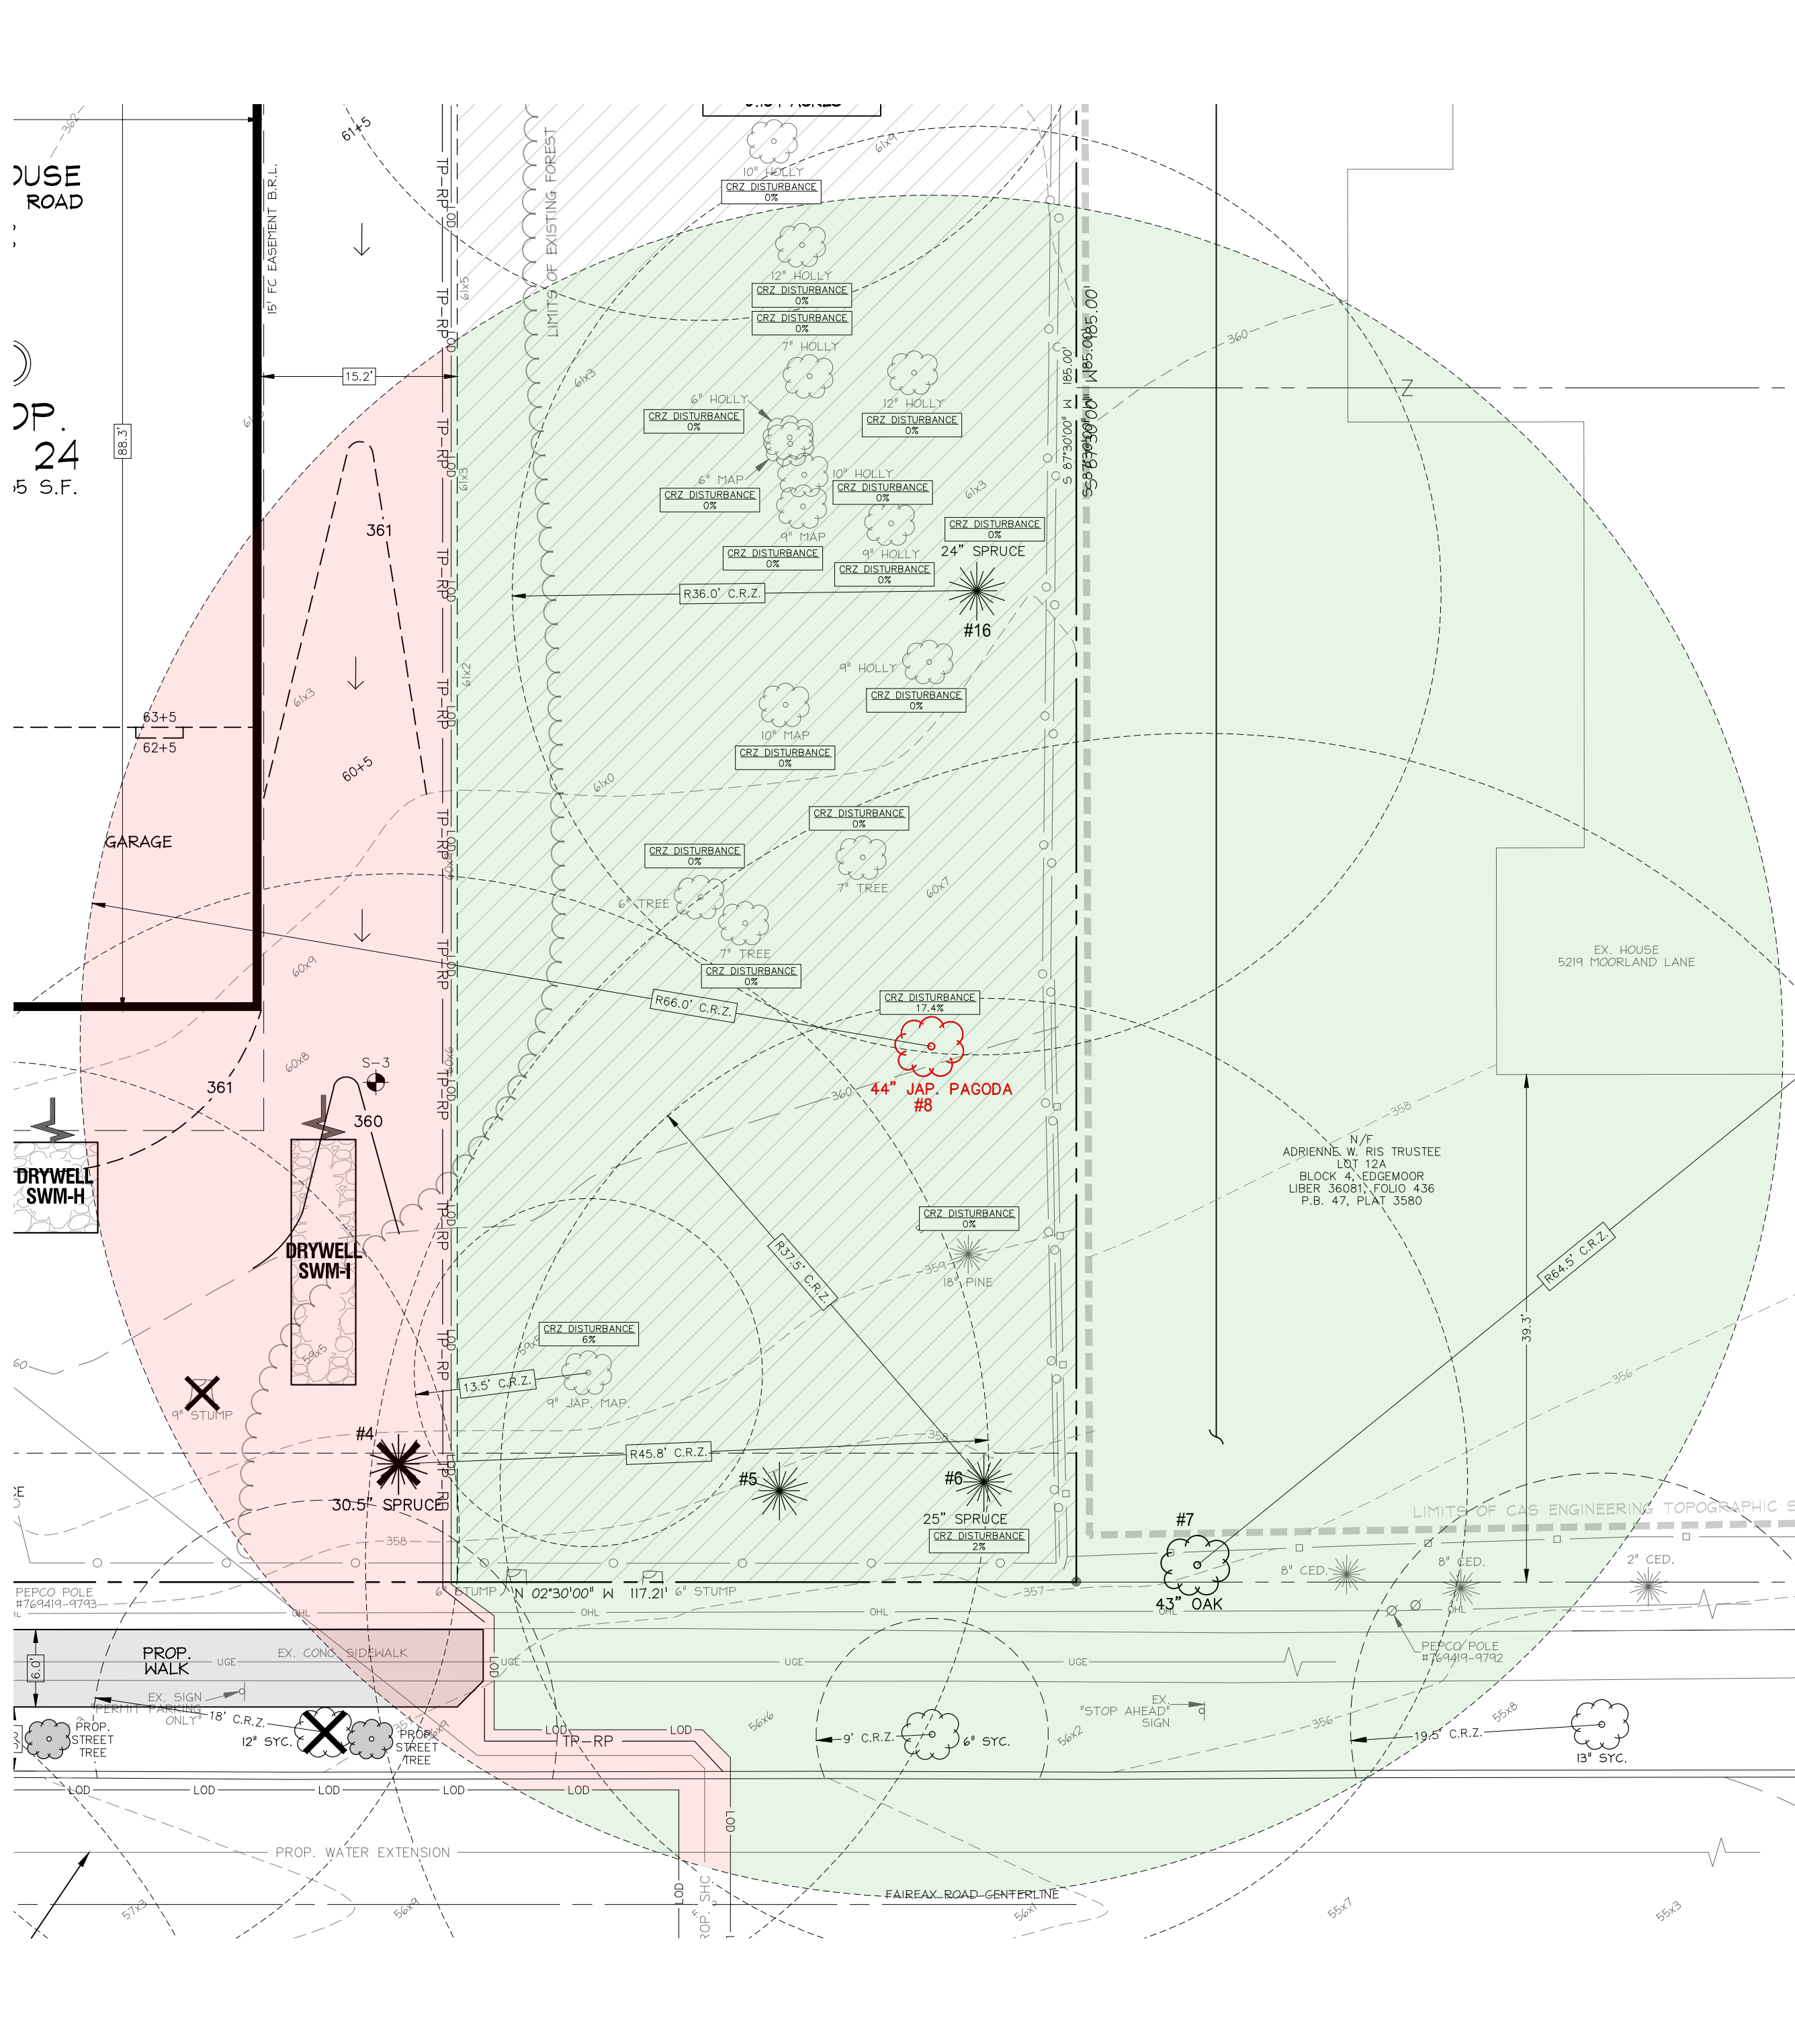
TREE NO. 8 CRZ DISTURBANCE EXHIBIT

CRZ DISTURBANCE
2,381 SF / 13,665 SF = 17.4%

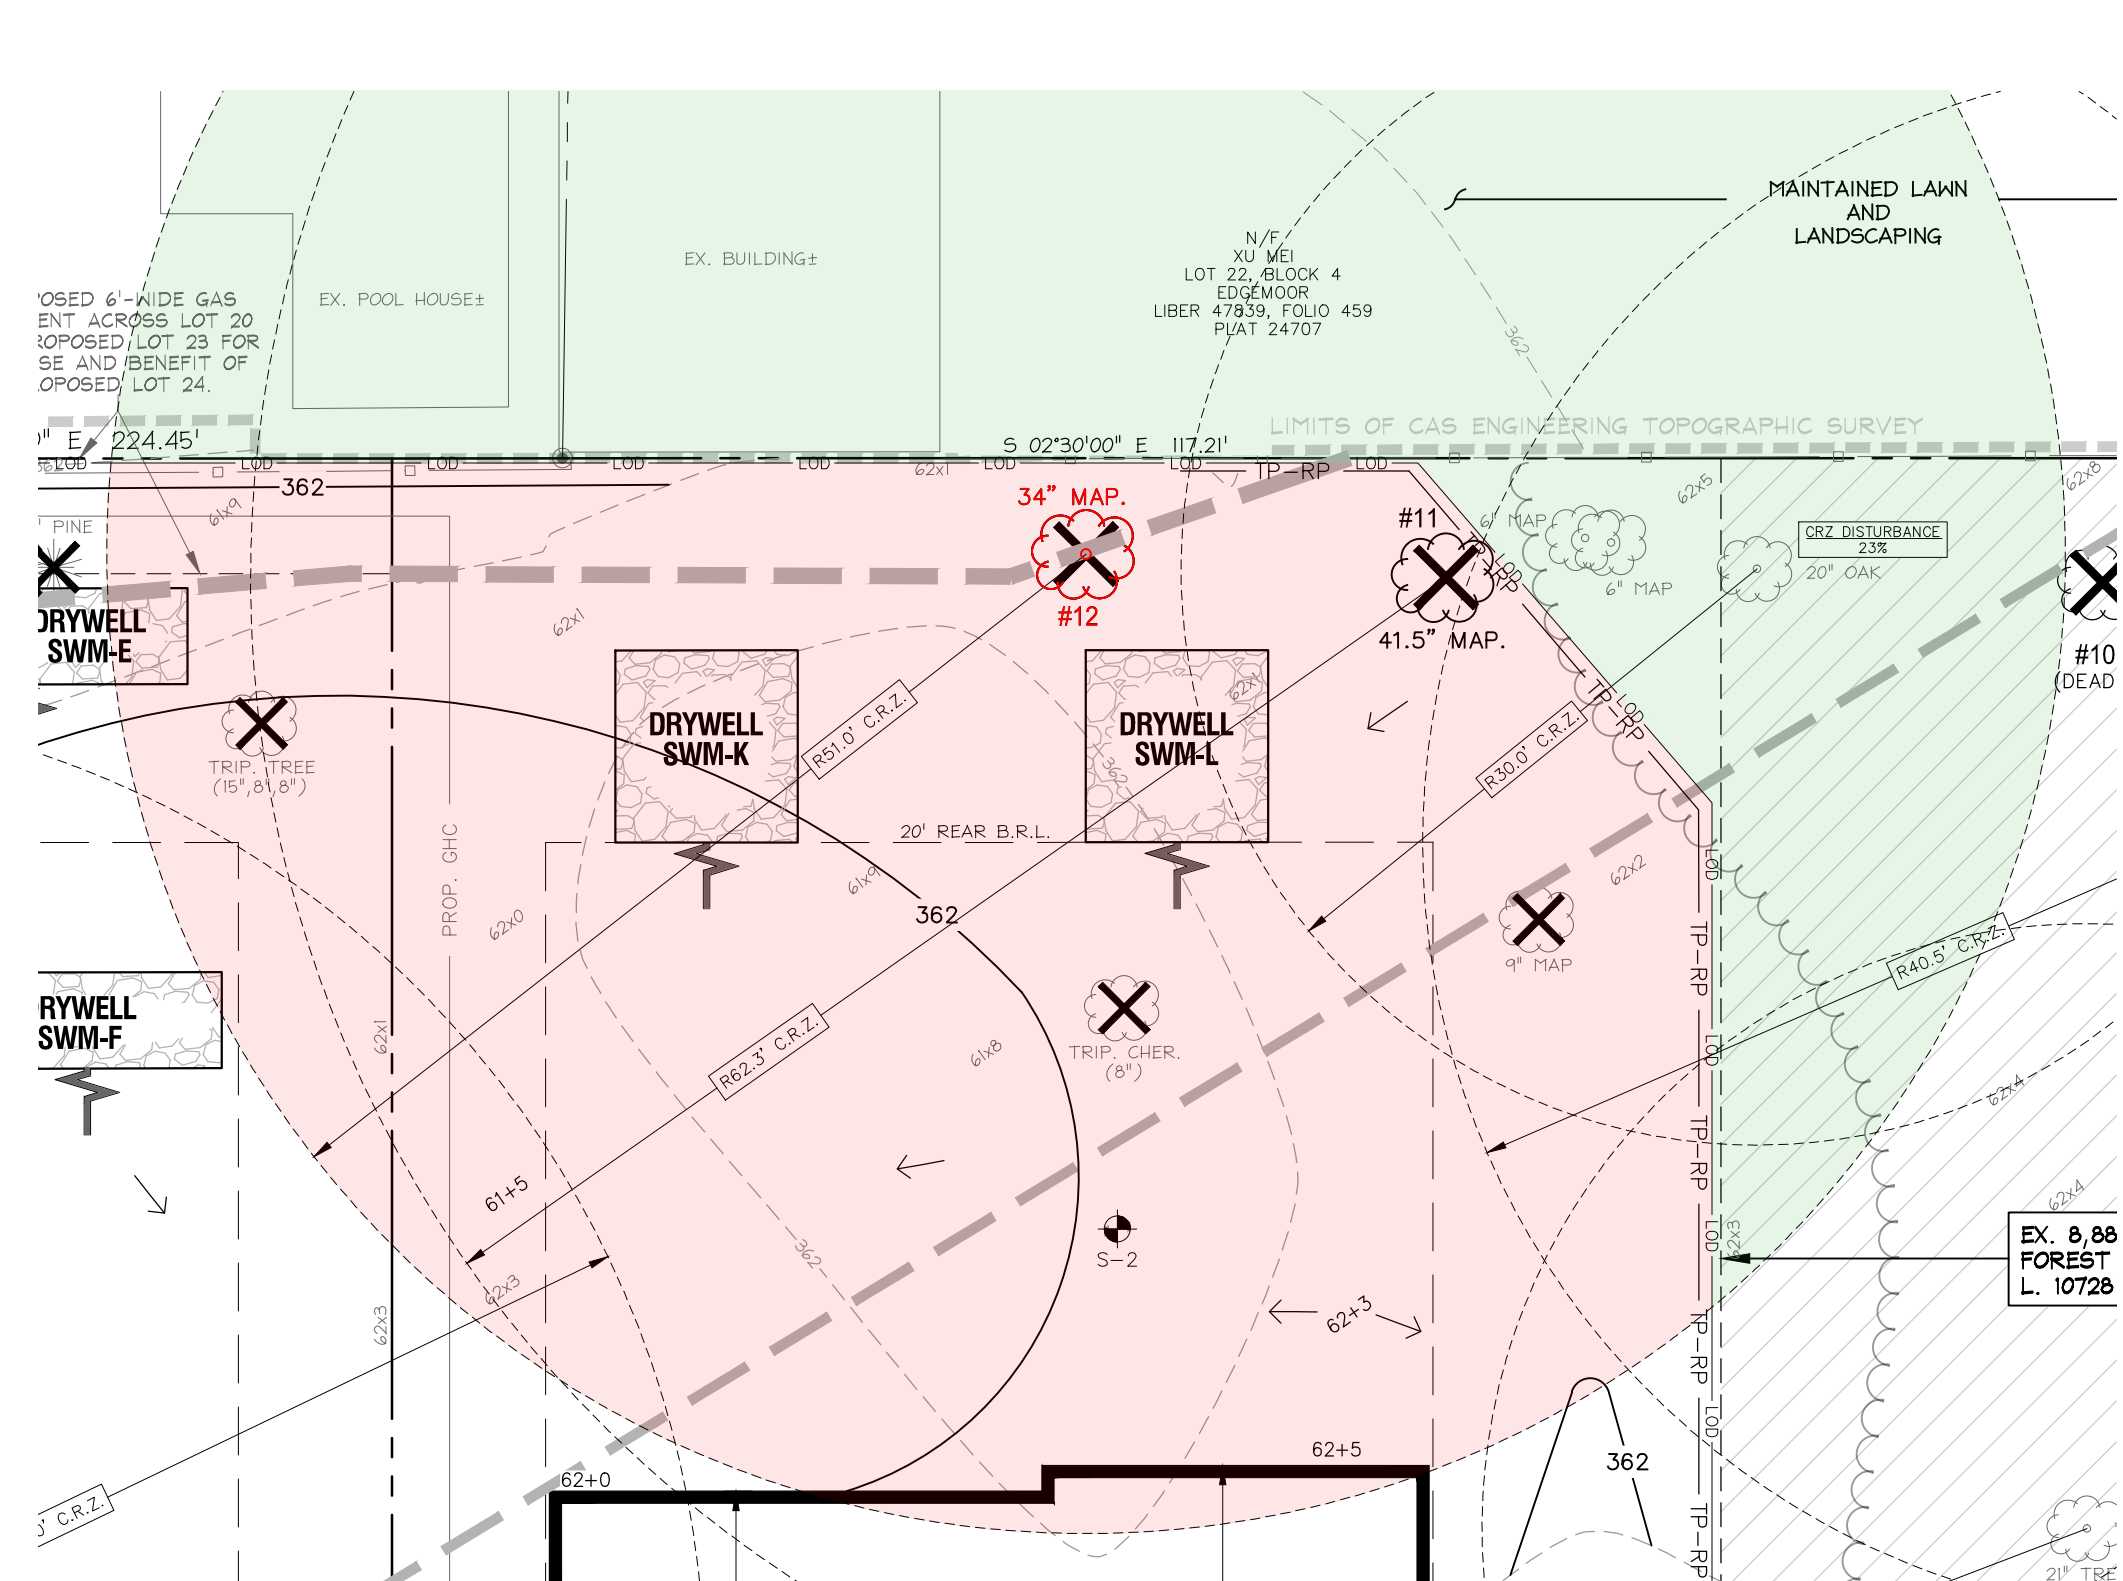
TREE NO. 12 CRZ DISTURBANCE EXHIBIT

CRZ DISTURBANCE
3,840 SF / 8,171 SF = 47.0%
