MONTGOMERY COUNTY PLANNING DEPARTMENT
THE MARYLAND-NATIONAL CAPITAL PARK AND PLANNING COMMISSION

MEMORANDUM

Final Report of the Reconvened Upper Paint Branch Technical Work Group

Upper Paint Branch Special Protection Area

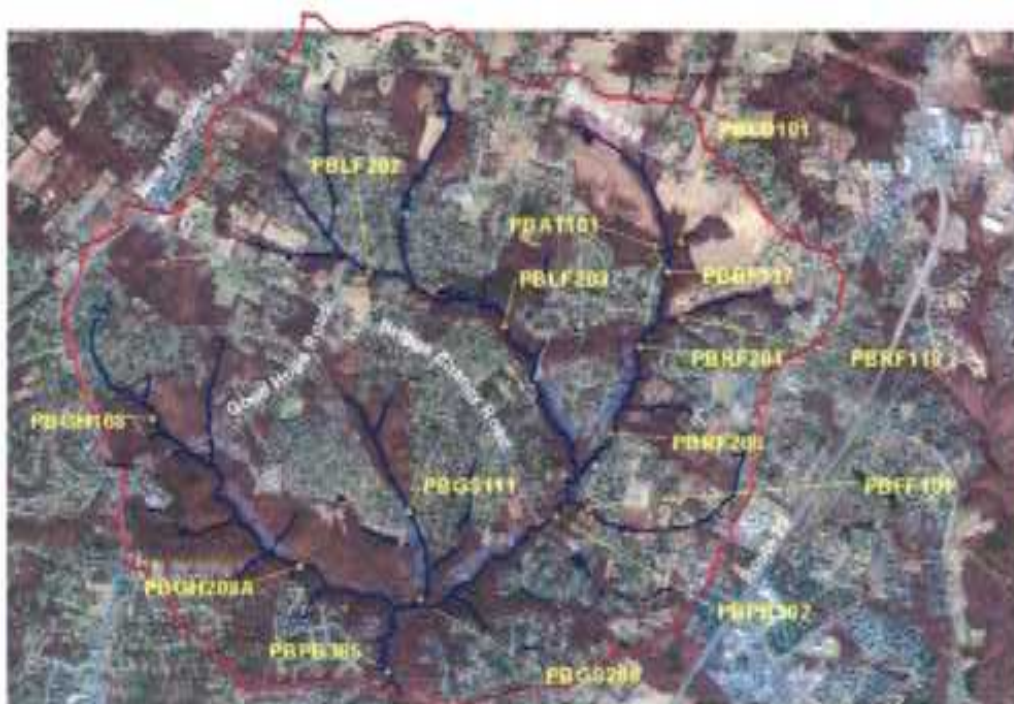
Figure 1. The Upper Paint Branch Special Protection Area, including stream monitoring stations, and major roads.

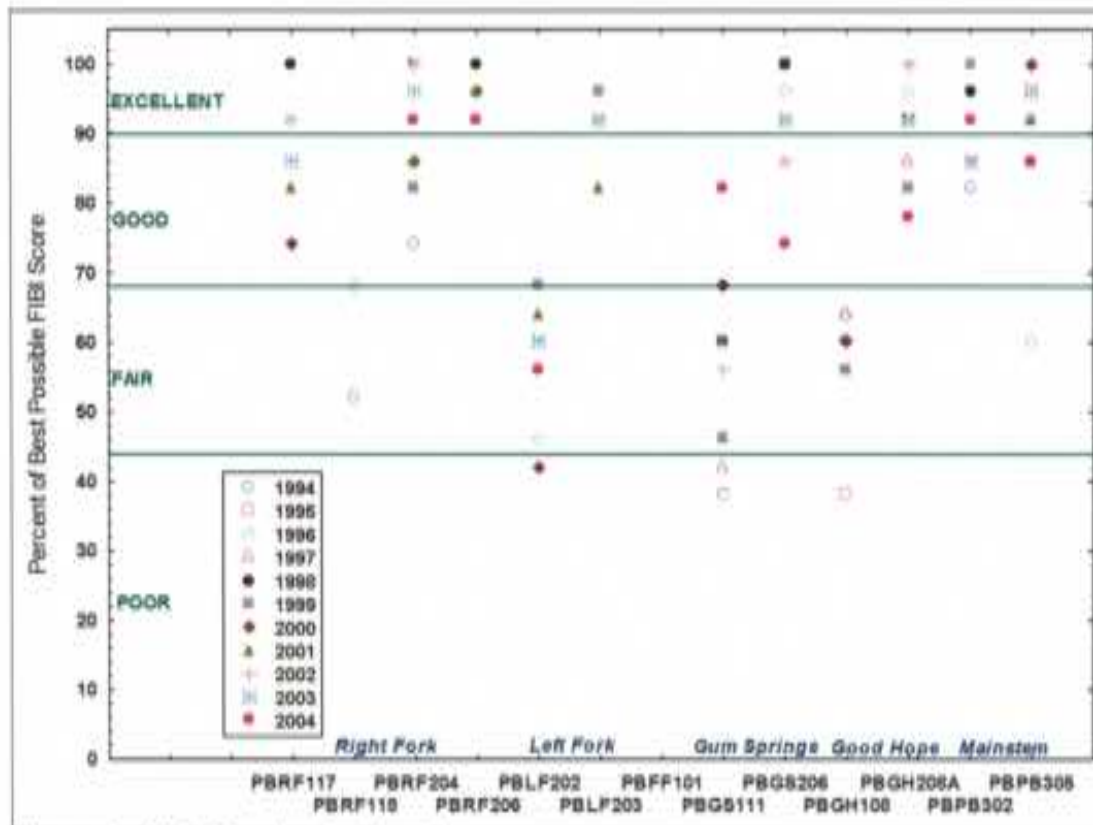
Figure 2. Fish Monitoring Results

The rest of the fish community also exhibited some response to drought conditions, mostly by reduced numbers of individuals. However, the diversity of the community (number of species) remained intact which is why IBI scores during 2003 and 2004, after the drought, are similar to previous years at most monitoring stations (Figure 2).

Results from monitoring station PBGS111, located in the Gum Springs tributary – near Bart Dr., show improved community health in 2004. The fish species Blue ridge sculpin, never before found at PBGS111, was present in relatively high number in 2004. This species is found throughout Paint Branch but was never before observed in the upper reaches of Gum Springs tributary. Because Blue ridge sculpins are pollution intolerant their presence bolstered the IBI score considerably from previous years. The changes in Gum Springs allowing this species access to upper reaches of the tributary are not known. One possibility is that higher than normal stream flows during 2003 and 2004 allowed this species to expand its range farther up Gum Springs tributary.

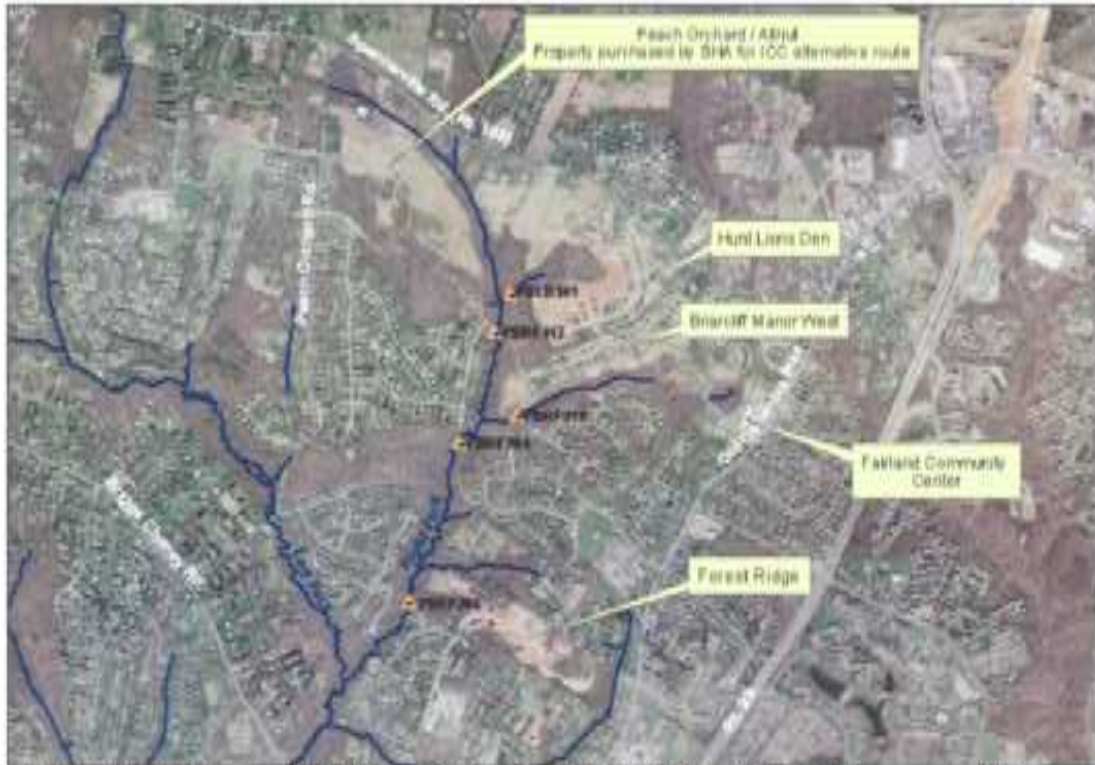
Figure 4. Aerial Photo of Right Fork - New Development Projects Are Labeled. (2004)

Most new development projects in the Paint Branch SPA have been within the Right Fork sub-watershed. To date there are five development projects, two have been completed, two are still under construction and one was halted. All five of these development projects cover 36% of the total drainage area in the Right Fork sub-watershed (Figure 4). Sediment washed off these construction projects may be the cause of degraded biological health in the Right Fork. The stream is often very turbid after rain events and a light coating of fine sediment is present on the stream substrate (Figure 5). This may be enough to impact the benthic macroinvertebrate community in the Right Fork and the mainstem of Paint Branch.

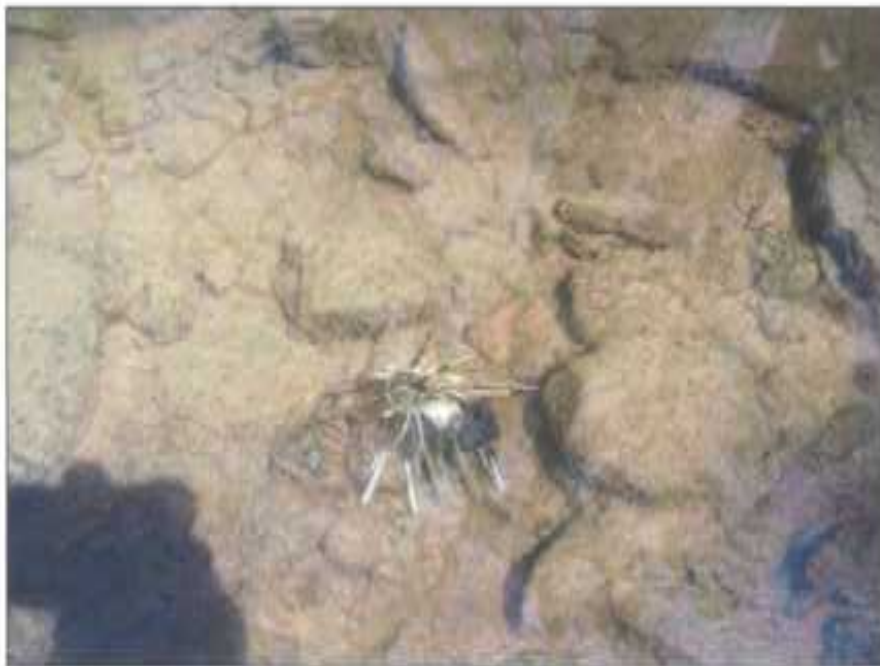
Figure 5. Stream Bottom at PBRF117 in the Right Fork.

Monitoring results from three stations (PBRF117, PBRF118 and PBRF204), which go back to 1995, show biological health has degraded from good/excellent during the years 1995 – 2000 to fair in 2004 (Figure 6). It is hoped that after construction projects are complete and the land stabilized impacts to the Right Fork will diminish and the biological health of the stream will

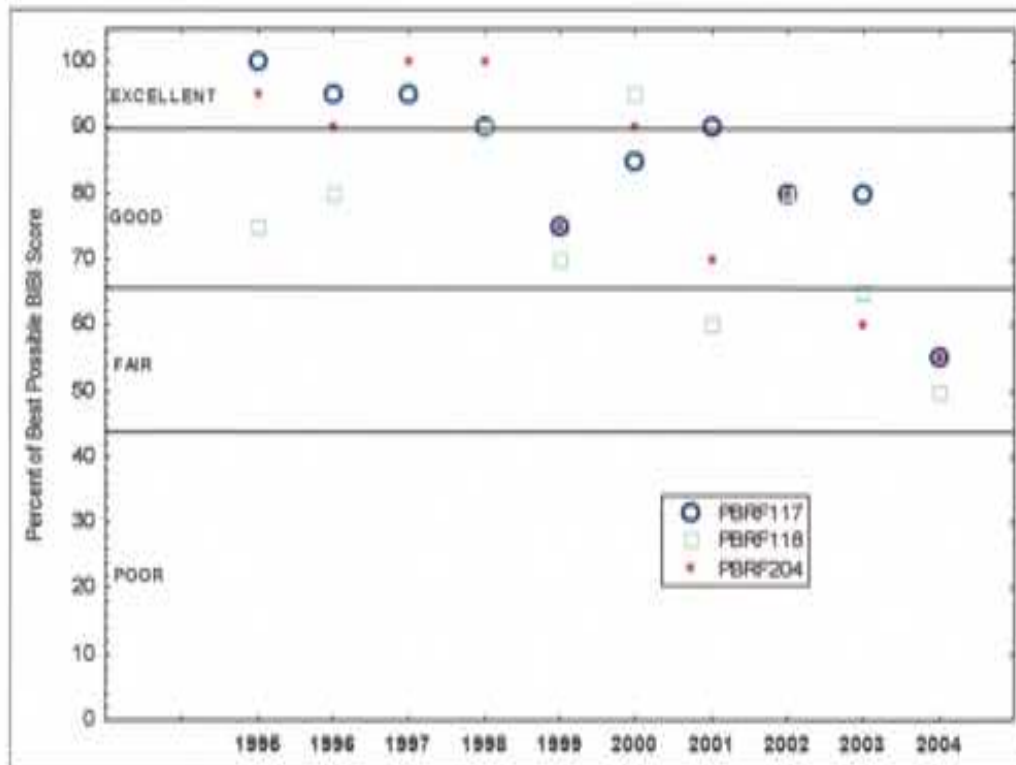
Figure 6 Time series plot of benthic macroinvertebrate monitoring results from the Right Fork

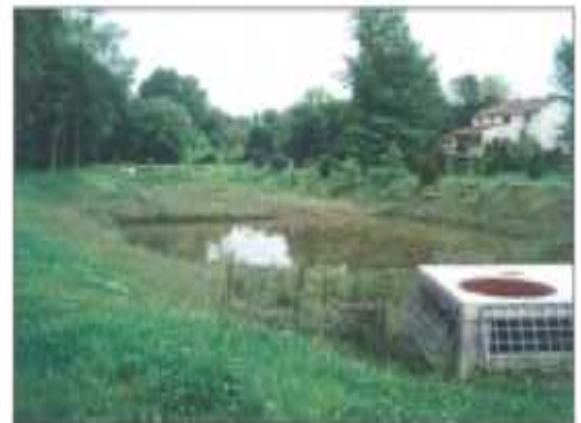
Figure 8. Piping Rock SWM Pond

This facility is located in the upper Good Hope subwatershed and provides stormwater management for 166 acres where none had previously existed. The pond has two small permanent pools located near the inlet and outlet (Figure 8). The area in between is

vegetated with various wetland plants. Because of the small permanent wet pools there were concerns of thermal impact in the Good Hope as warm water from these pools is flushed out during storm events.

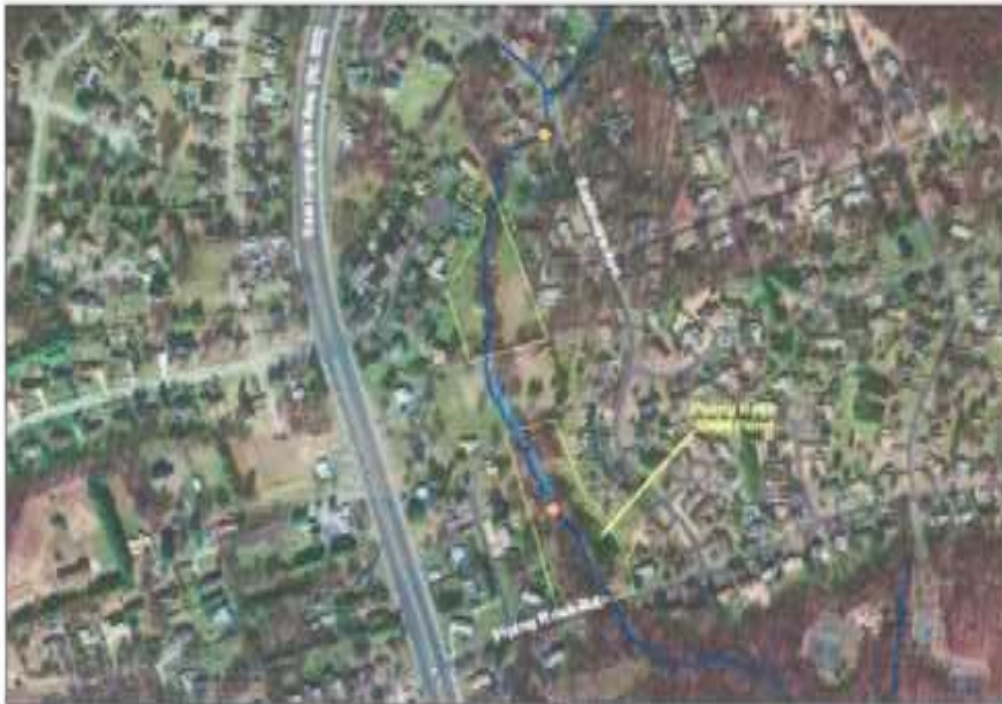
Figure 9. Upper Good Hope Tributary - Locations of Temperature Logger Deployment During 2004 Are Shown As Orange Dots. M-NCPPC Property is Delineated With Yellow Lines.

During the summer of 2004 temperature loggers were placed at two locations in the Good Hope tributary upstream of the Piping Rock SWM pond (Figure 9). One logger was placed just downstream of Southview Avenue, the other just upstream of Piping Rock SWM pond. Results show no thermal spikes downstream of Southview Avenue and many spikes at Piping Rock SWM pond, all correlating with rain events (Figure 10).

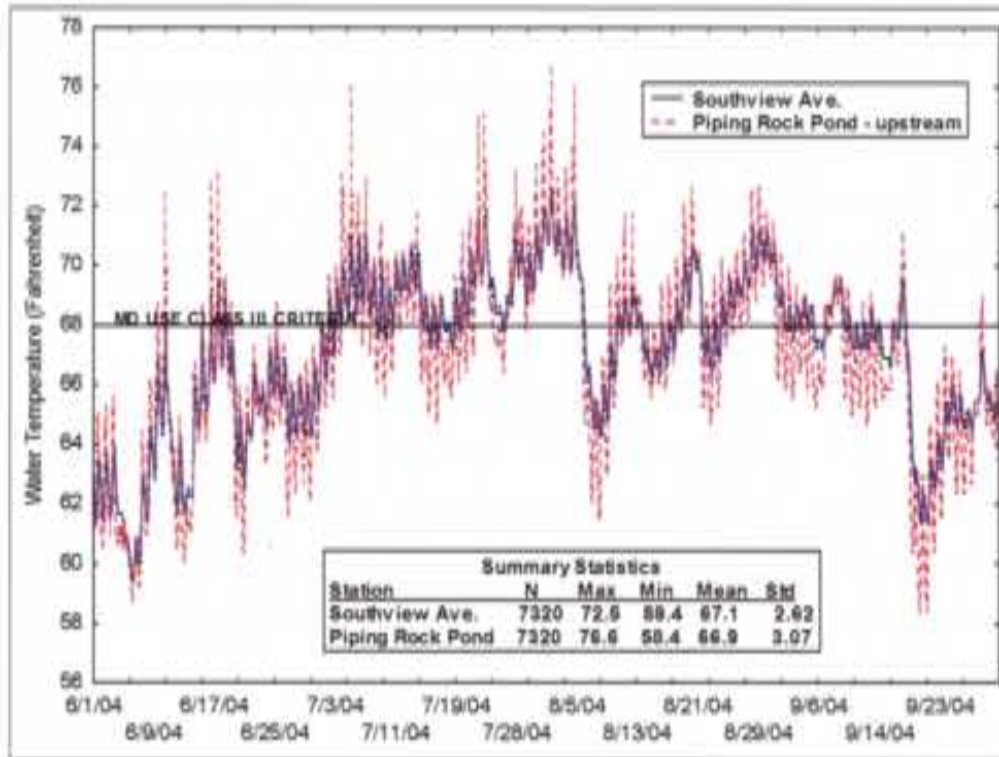
Figure 10. Stream temperature data from upper Good Hope at Southview Avenue and Piping Rock SWM pond.

These results indicate the source warm water runoff is not Southview Avenue but rather an unknown source downstream. The stream buffer between Southview Ave. and Piping Rock Rd. is poor, which may allow some warming due to a lack of shading but this would not cause the large temperature spikes. However, because much of this stream length is in public land this would be a good opportunity for stream buffer improvement. DEP plans to walk this stretch of stream during 2005 and look for stormwater outfalls that may be causing the thermal spikes.

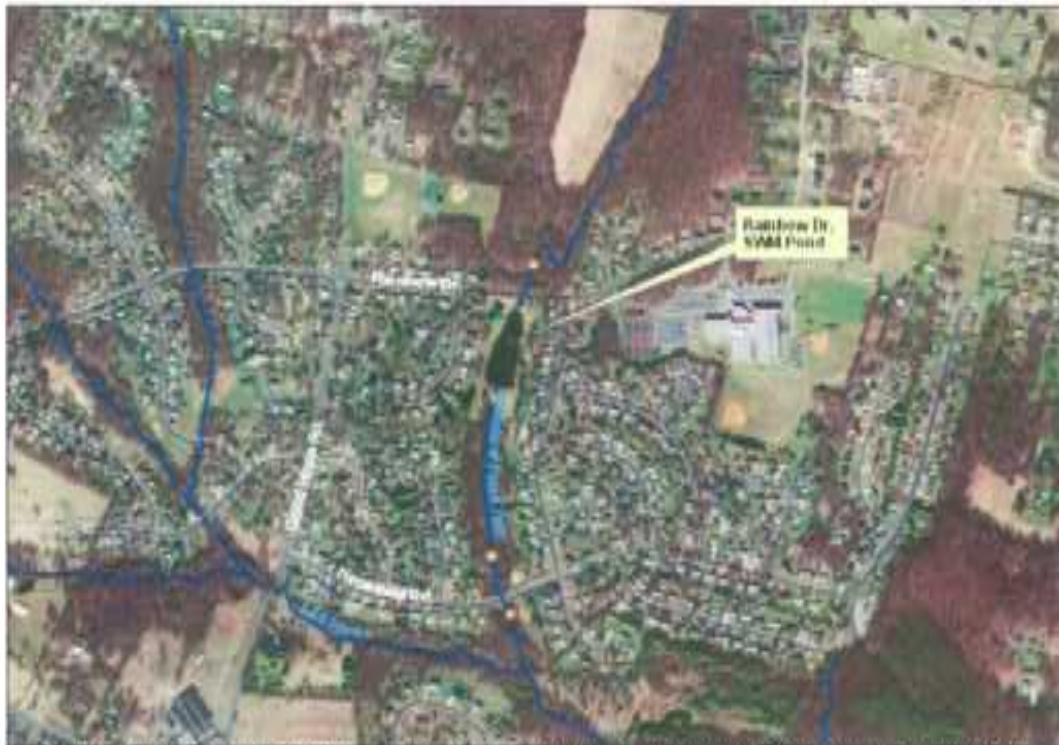
Figure 12. Rainbow Pond Tributary - Location Of Temperature Logger Deployment During 2004 Are Shown As Orange Dots.

From previous monitoring efforts DEP had identified the Rainbow Pond tributary as a source of thermal spikes during summer rain events. In 2004 temperature loggers were placed at three locations along the Rainbow Pond tributary to isolate the source of thermal spikes (Figure 12). The storm water management pond at Rainbow Drive was modified in 1997 with a base flow bypass to prevent downstream thermal impact during base flow periods. However it was thought that this large in-line wet pond could still be releasing warm water during summer rain events.

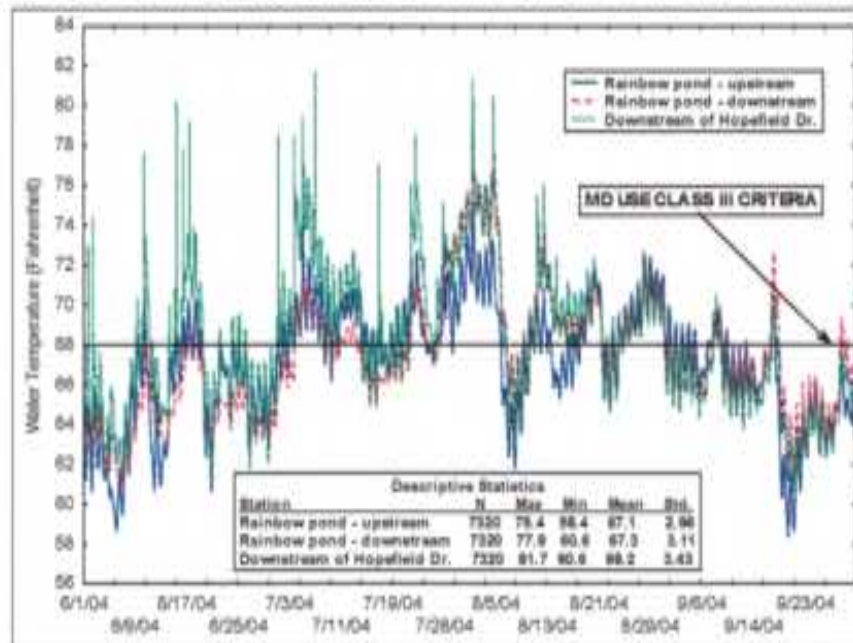
Figure 13 Stream Temperature Data From Rainbow Pond Tributary

Results show that, on average, stream water temperature is only slightly warmer downstream of Rainbow pond (Figure 13) indicating that the base flow by-pass is working to mitigate thermal

impact from the pond. Additionally, there are relatively few thermal spikes downstream of the pond. However, the logger placed downstream of Hopfield Rd. recorded many thermal spikes

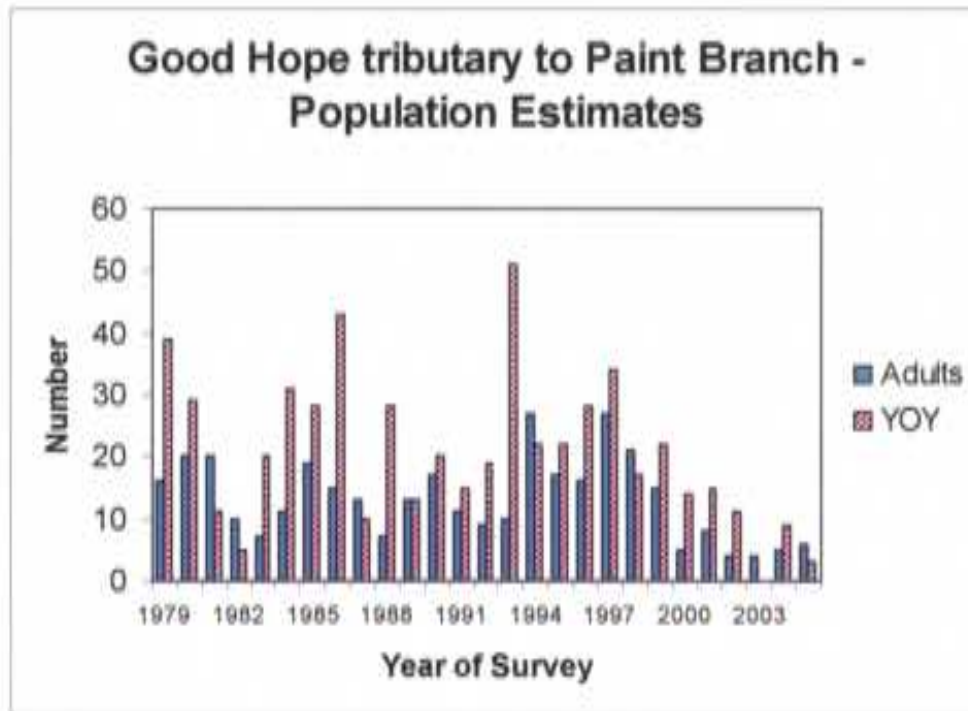
Figure 1. Population estimates for adult and young-of-the-year brown trout in the Good Hope tributary of Paint Branch at Hobbs Drive station, 1979-2005.

Brown trout population estimates and analysis conducted on the Good Hope tributary at Hobbs Drive by MD DNR Fisheries biologists since 1979, show the adult brown trout population declined sharply in 2000 and has remained low each of the following years through 2005. Figure 1 shows the twenty-seven year historical record of estimated numbers of adult and yoy brown trout from the Hobbs Drive station. The Hobbs Drive survey site is 295 feet long as measured along the centerline of the stream, referred to as the thalweg. Historical comparisons of adult trout numbers (Table 1) collected at the Hobbs Drive survey site through 1999 show double-digit performance that is consistent with all prior years, the exceptions being 1983 (7), 1988 (7) and 1992 (9). However, all of the last six years since 2000, have shown single-digit numbers of adult brown trout. Five of the last six years performed below the lowest numbers observed in all prior years, dating back to when the survey was begun in 1979. The one exception was 2001, when eight (8) adults were collected, which exceeded the historical lows observed prior to that date by one fish, as observed in 1983 (7 adults) and 1988 (7 adults). The twenty-seven year average number of brown trout adults collected from the Hobbs Drive survey site is thirteen (13). The numbers of adult brown trout for the twenty-seven year period of study have ranged from low of (4) adults in 2002 and 2003 to a high of (27) in 1997. The average number of adults collected

during the first seventeen-year period of study (1979 through 1995), averaged 14.1 adults. The ten-year period following 1995 to 2005 averaged 11.1 adult trout. The data show there has been a downward trend in the numbers of adult trout residing in the reach of Good Hope tributary at Hobbs Drive since 1995.

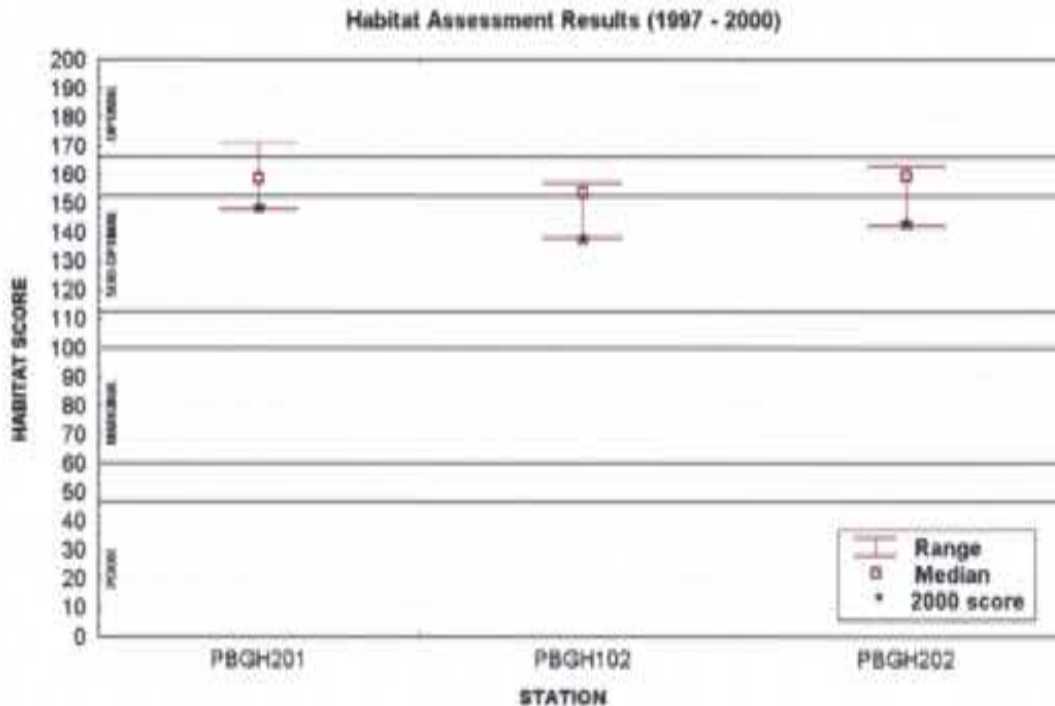
Figure 4. Habitat Scores for the Colesville Depot Tributary (PBGH102), Above (PBGH201), and Below (PBGH202) in the Good Hope Tributary.

Habitat scores remained in the sub-optimal range at all stations throughout the study period (Figure 4). This range covers over all habitat conditions that are adequate to support a diverse biological community and are therefore not considered to be limiting. However, the habitat scores from the year 2000 are the lowest of the three years, due to apparently increased sediment deposition at all three stations. Since the station above and below the Colesville Depot tributary showed the same increased sedimentation, activities in the Colesville Depot Tributary (including the Depot itself) were not affecting the Good Hope Tributary. The most likely source is stream bank erosion from heavy storms in the area during the summer and fall of 1999, including Hurricane Floyd.

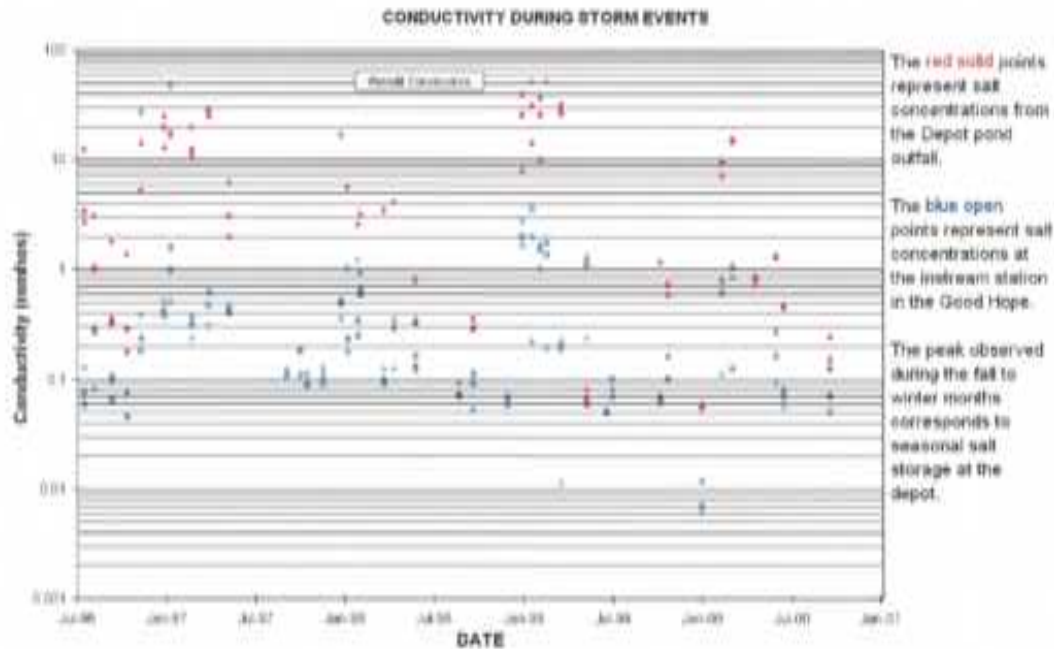
Figure 5. Conductivity Values for the Colesville Depot Tributary

The only parameter which showed a clear connection between outfall discharges and instream water quality was conductivity, Figure 5. The seasonal increases in conductivity reflected road salt storage and mixing at the Depot and did not seem to be controlled by the retrofit. The pattern of high winter concentrations continued after retrofit, although there was a significant reduction during baseflow at both stations and during storm events at the outfall station which may reflect more diligent management practices or milder winters with fewer opportunities for mixing and spilling of road salt at the Depot.

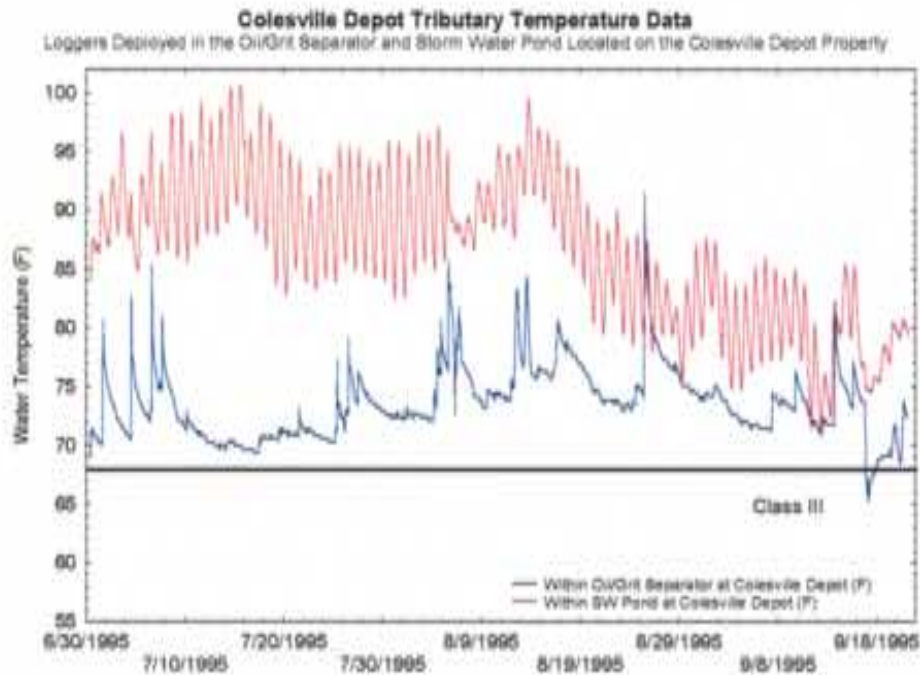
Figure A. 1995 Temperature Data (°F) from MCDEP depicting water temperatures within the Oil/Grit Separator and the Stormwater Pond on the Colesville Depot's Property.

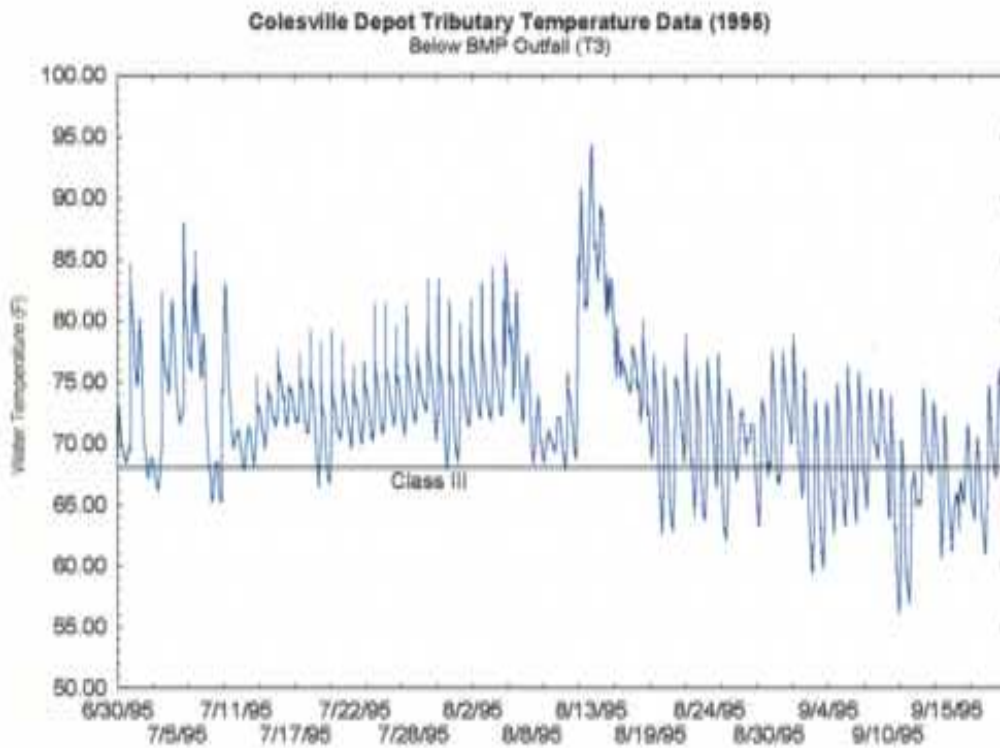
Figure B. 1996 Temperature Data from MCDEP depicting water temperatures (°F) directly below the Colesville Depot Outfall (T3).

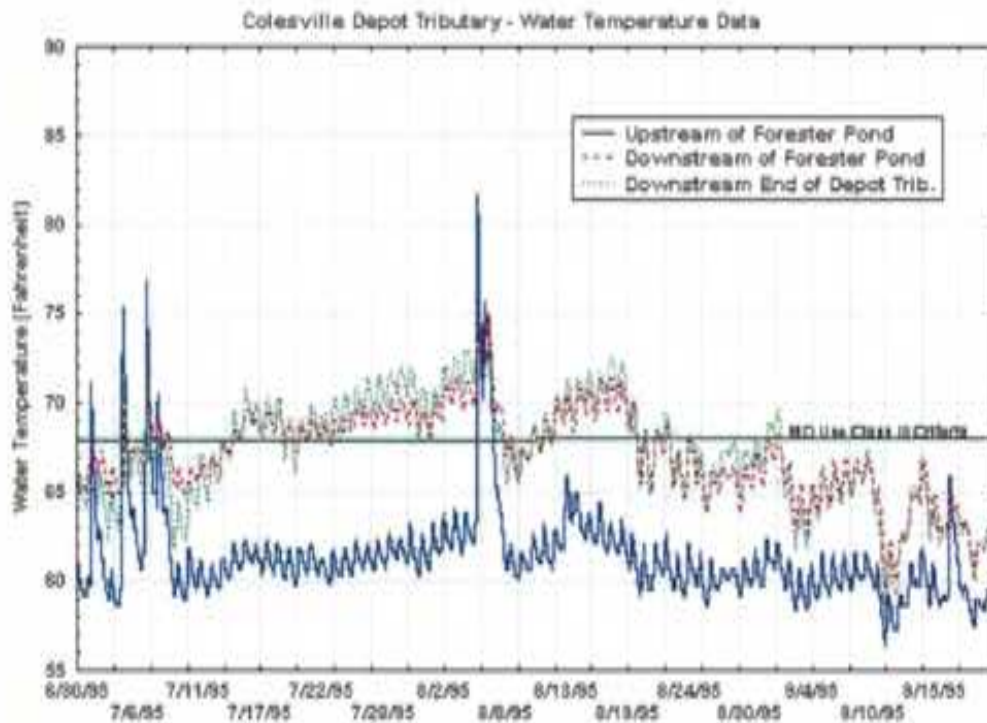
Figure C. 1995 Temperature Data (°F) from MCDEP depicting water temperatures above (T4) and below (T5) the Forester Pond and on the Colesville Depot Tributary above the Confluence with the Good Hope (T6).

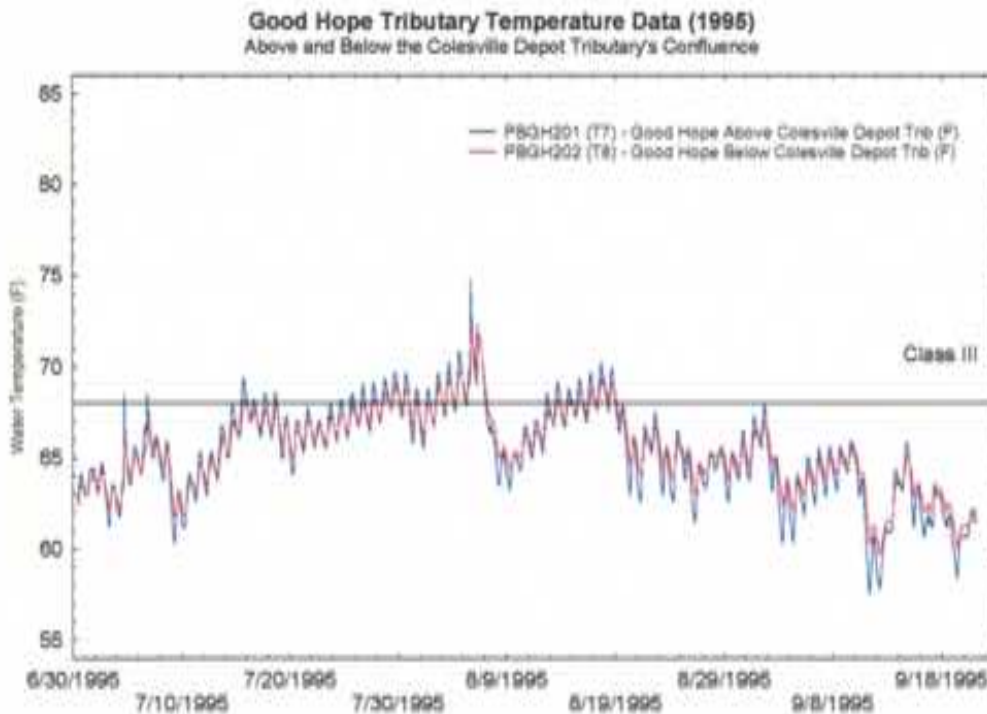
Figure D. 1995 Temperature Data (°F) from MCDEP depicting water temperatures on the Good Hope Tributary above (PBGH201 – T7) and below (PBGH202 – T8) the Confluence of the Colesville Depot Tributary.

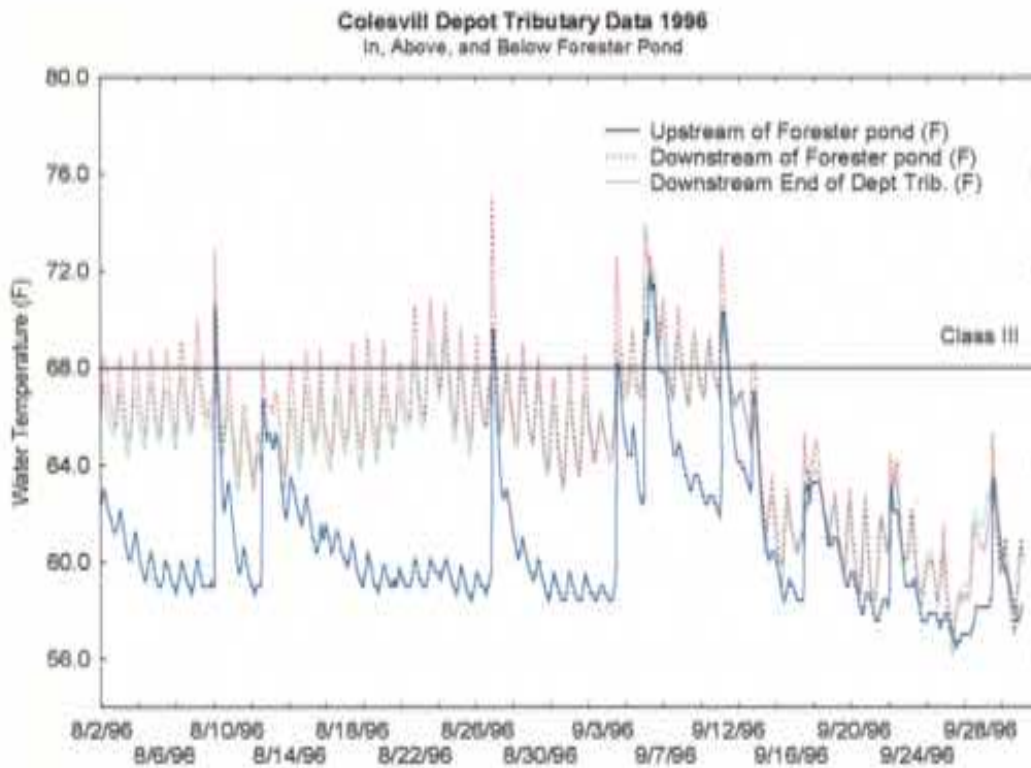
Figure F. 1996 Temperature Data from MCDEP depicting water temperatures (°F) above (T4) and below (T5) the Forester Pond, and on the Colesville Depot Tributary above the Confluence with the Good Hope (T6).

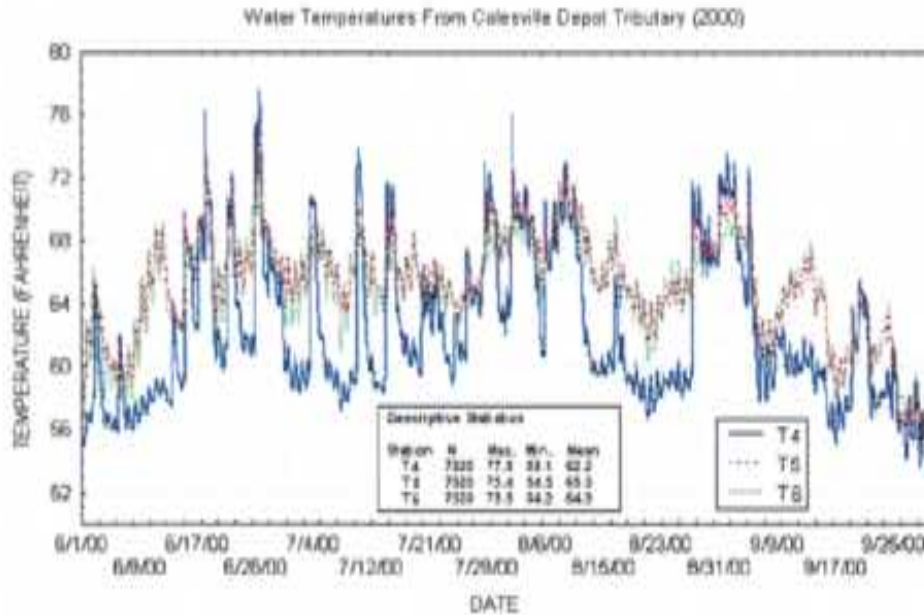
Figure I. 2000 Temperature Data from MCDEP depicting water temperatures (°F) above (T4) and below (T5) the Forester Pond, and on the Colesville Depot Tributary above the Confluence with the Good Hope (T6).

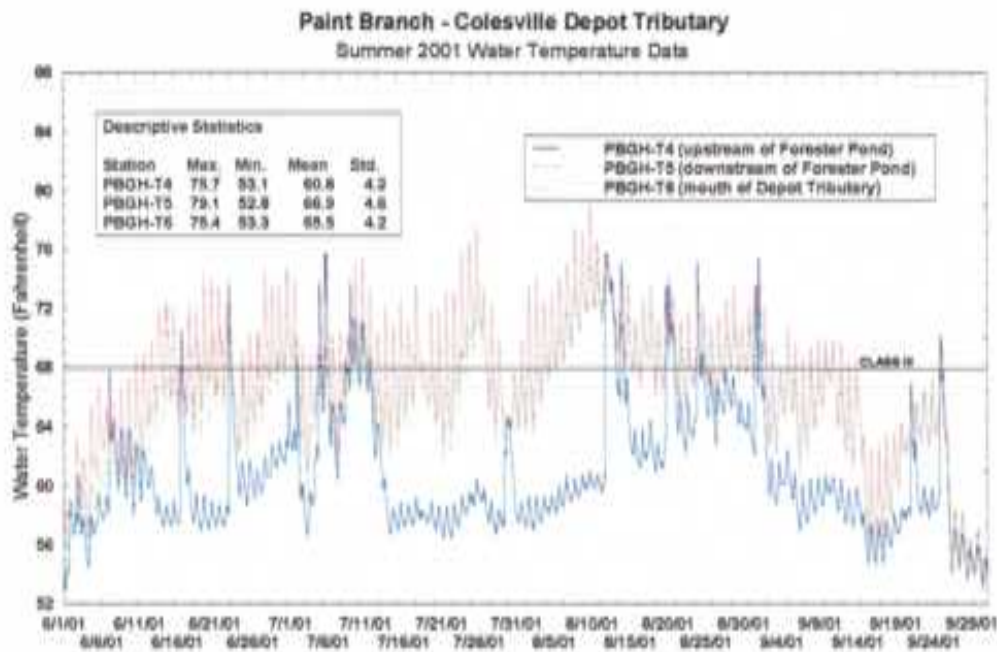
Figure J. 2001 Temperature Data from MCDEP depicting water temperatures (°F) above (T4) and below (T5) the Forester Pond, and on the Colesville Depot Tributary above the Confluence with the Good Hope (T6).

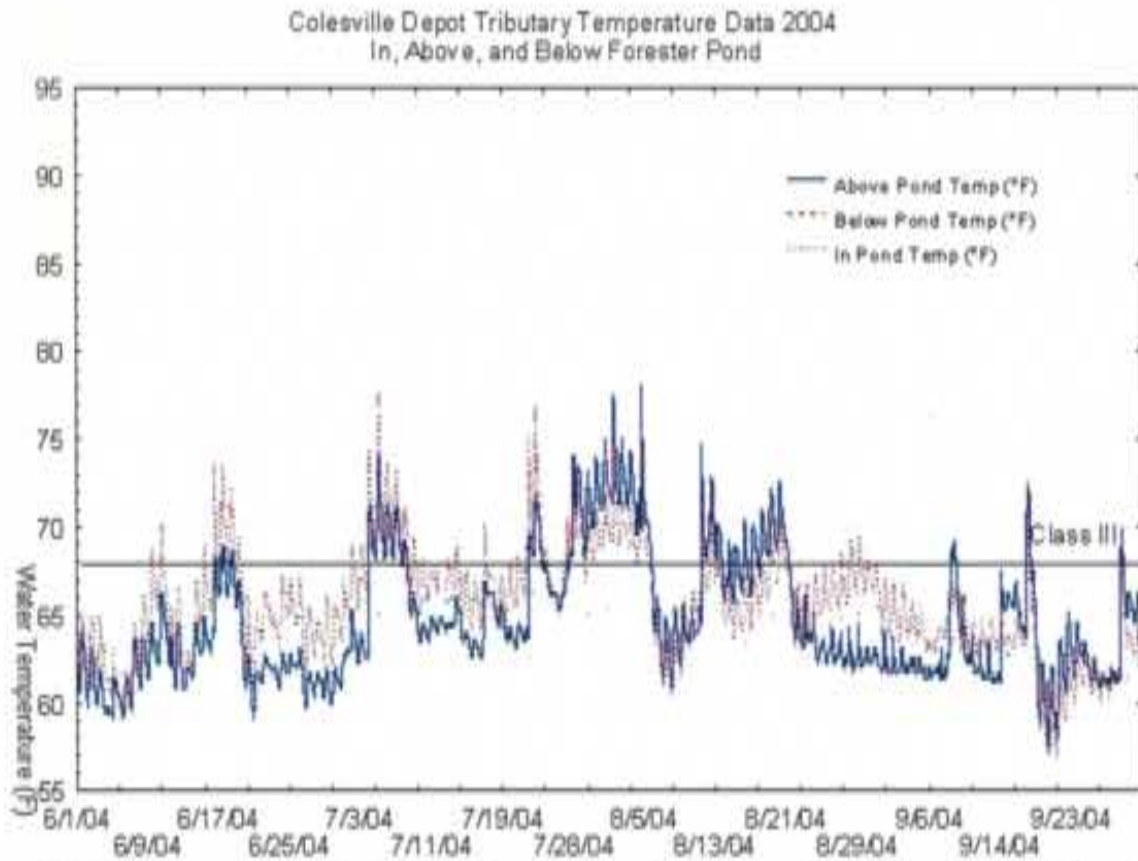
Figure K. 2004 Temperature Data from MCDEP and RK&K depicting water temperatures (°F) Inside, Above (T4), and Below the Forester Pond (T5).

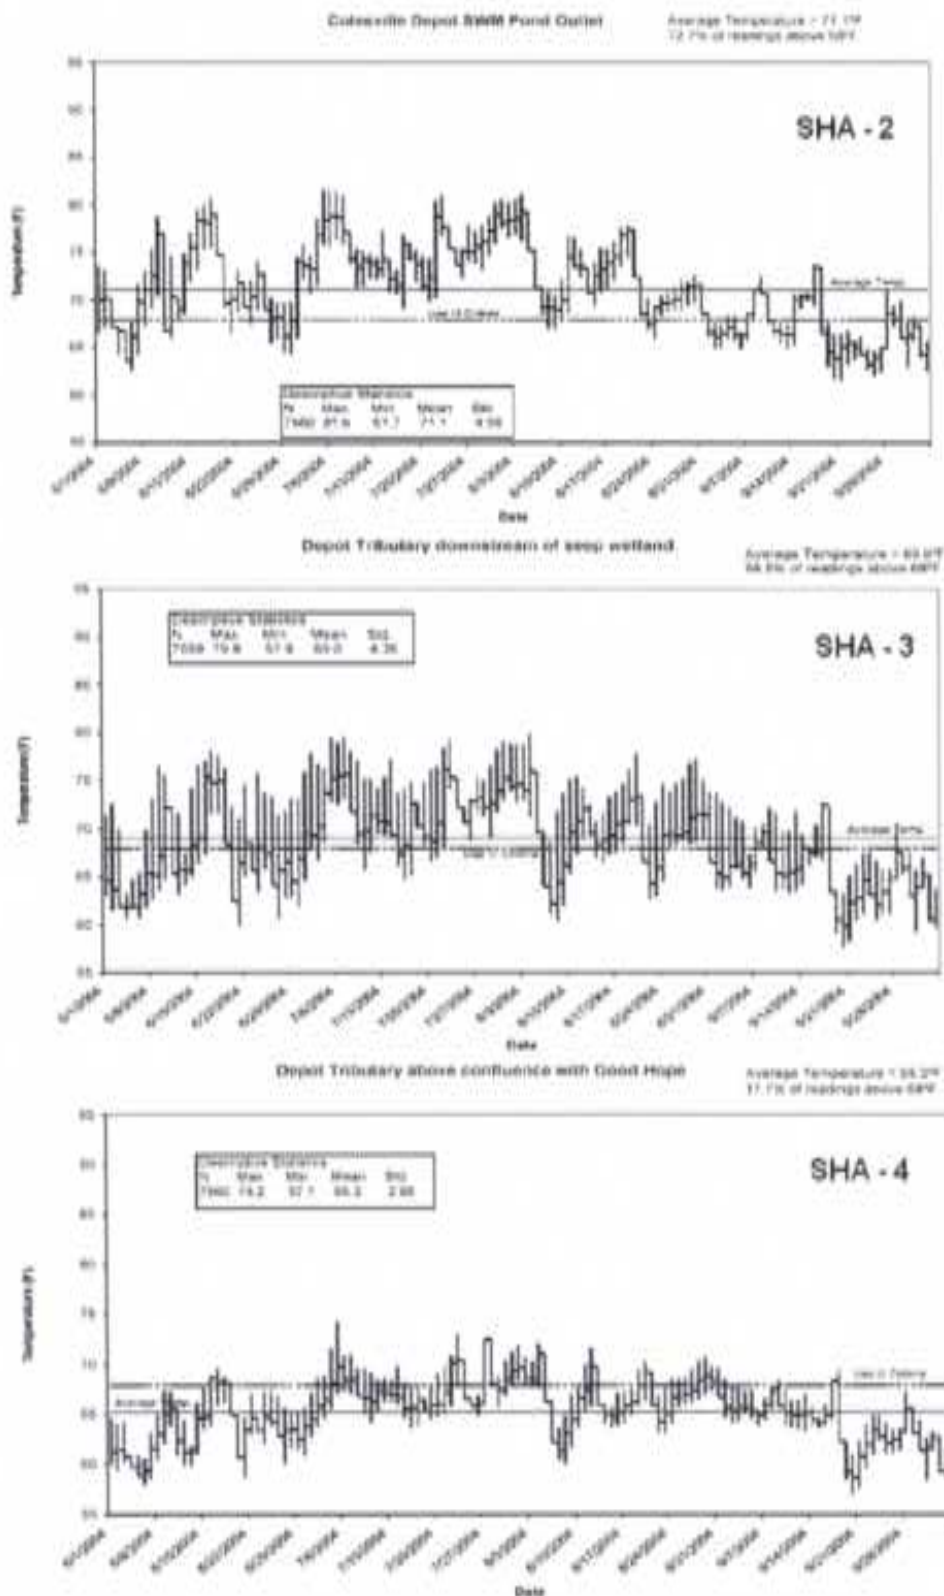
Figure L. 2004 Temperature Data (°F) from SHA and Coastal Resources "Study Summary (2004)
