# Maryland Historical Trust

## Maryland Inventory of Historic Properties Form

Inventory No. 31-3-2

historic Shorefield  
other Stubbs Barn (preferred)

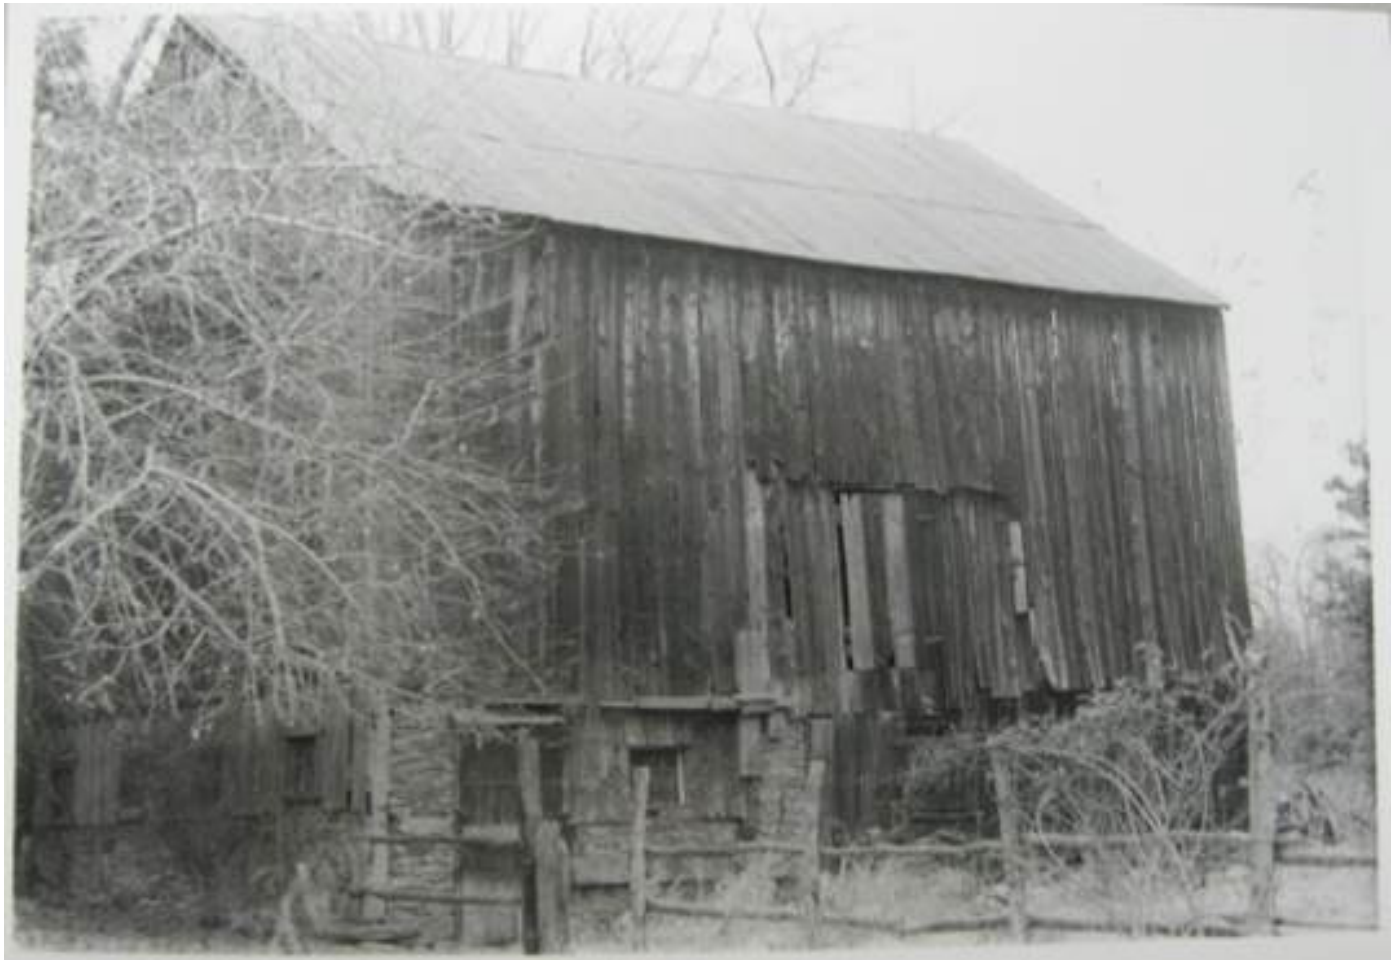
Figure 11. Stubbs Barn prior to renovations in the late 1980s. A note on the back of this photo, believed to have been written by John Armstrong, states: "Barn siding was always loose fitting. Tobacco barns were built that way. I was always told that the farm had originally been a tobacco [farm] long ago." Although tobacco was originally grown at "Shawfield," by 1850 the Stubbs family had switched to grain and corn cultivation, and this barn likely served those purposes. Courtesy: M-NCPPC

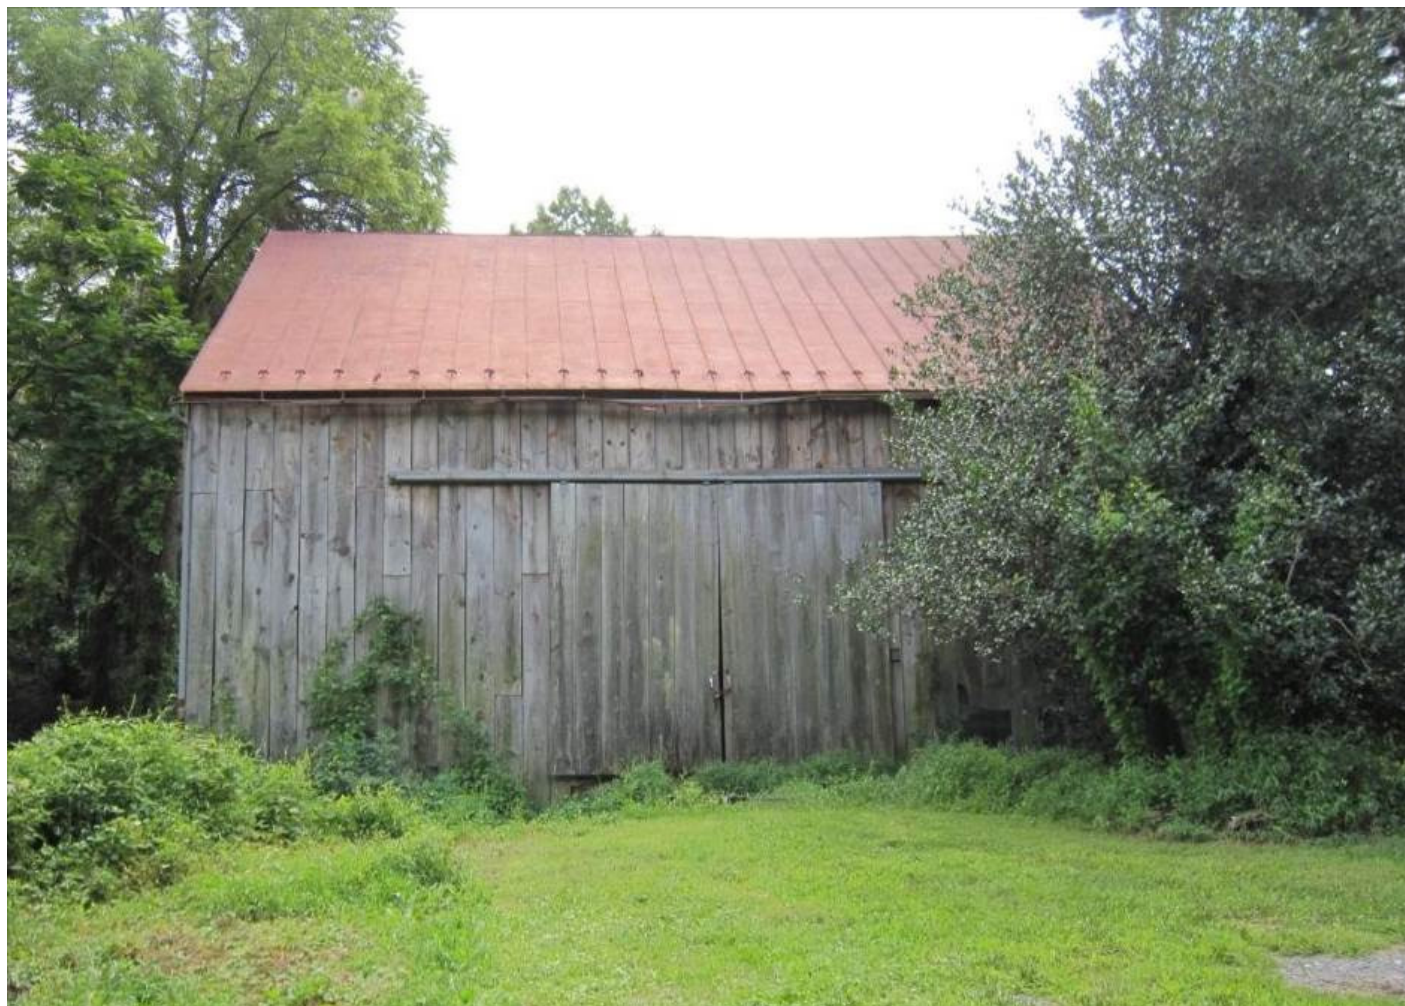
Figure 13. Current view of Northwest front façade.

The main northwest, uphill façade features a local fieldstone stone foundation and vertically planked walls, many sash-sawn, which means they may be contemporaneous with the barn's construction. Other planks are clearly appended to the frame with 20<sup>th</sup> century nails. All planks are now completely devoid of their former red paint and some of them have their wood worn away on the façade to the point that the building has been temporarily fixed with steel mesh to preclude nuisance animals and vandalism. A large-scale double, sliding door on the banked, threshing-floor level is the barn's sole feature, and the door is still operable. It opens into the tall, large interior.

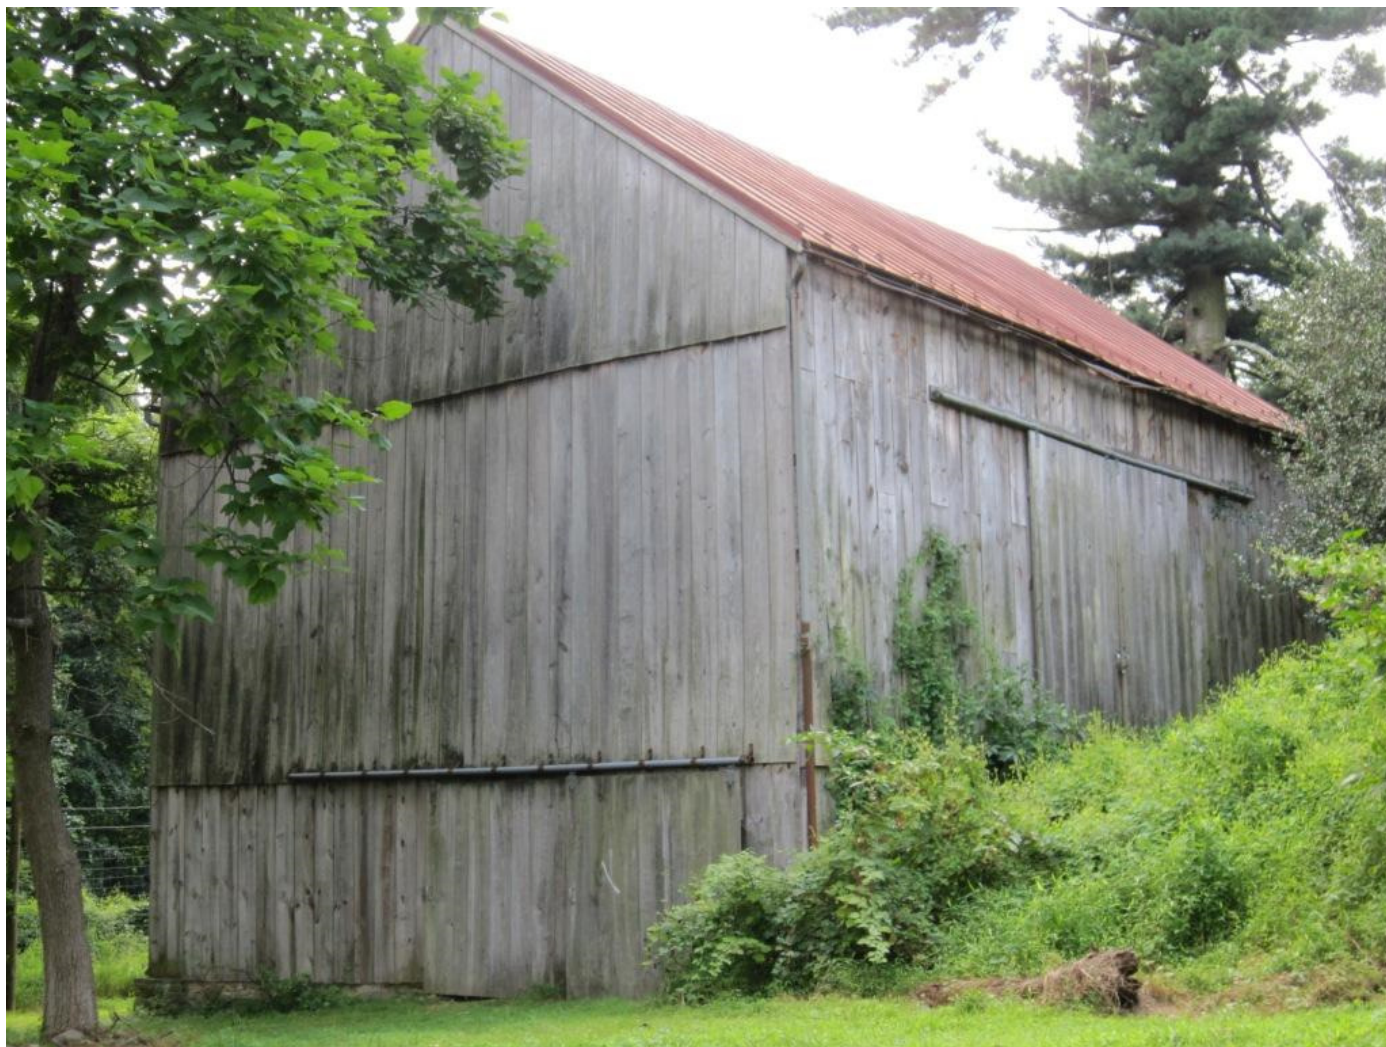
Figure 14. Northwest (front façade) at right, with Northeast gable end.

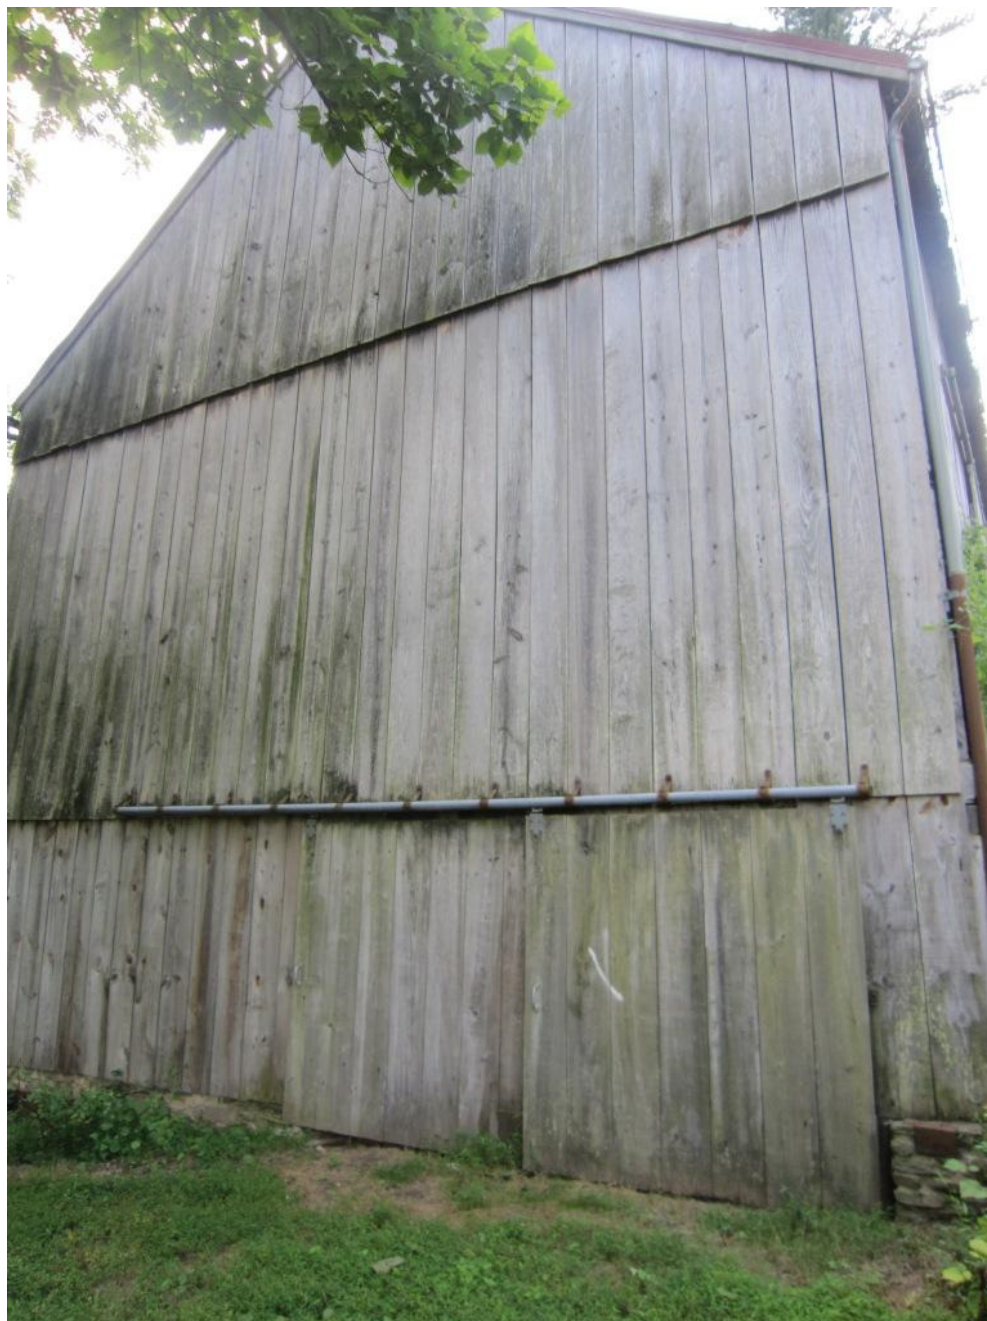
Figure 15. View of the Northeast face.

The northeast face features a sliding door on the lower level that gives way into the former livestock area. This door may have been added after original construction as sliding doors on the stable level of bank barns are not common.

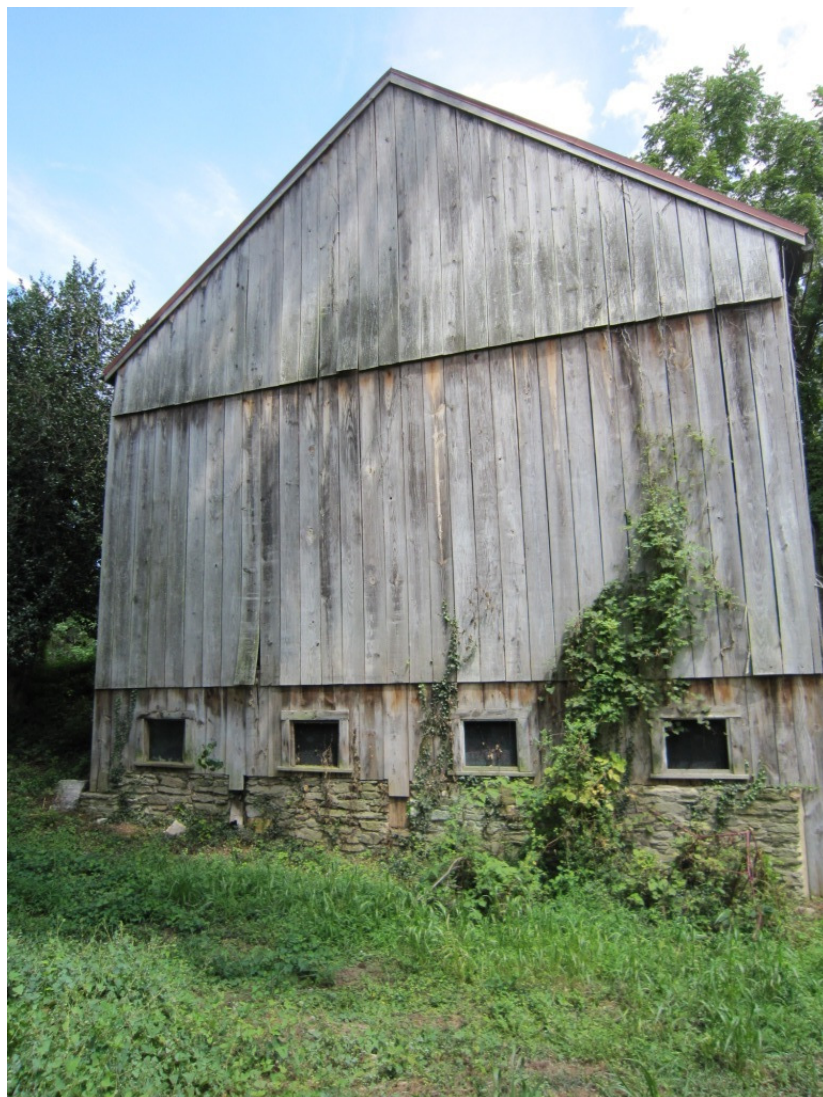
Figure 17. View of Southwest gable end.

The southwest face, again possibly altered from its original appearance, has a rubblestone and mortared wall that is approximately four feet high. Above it are four, square window openings that used to be filled with multi-pane glazing in a three-over-three pattern.

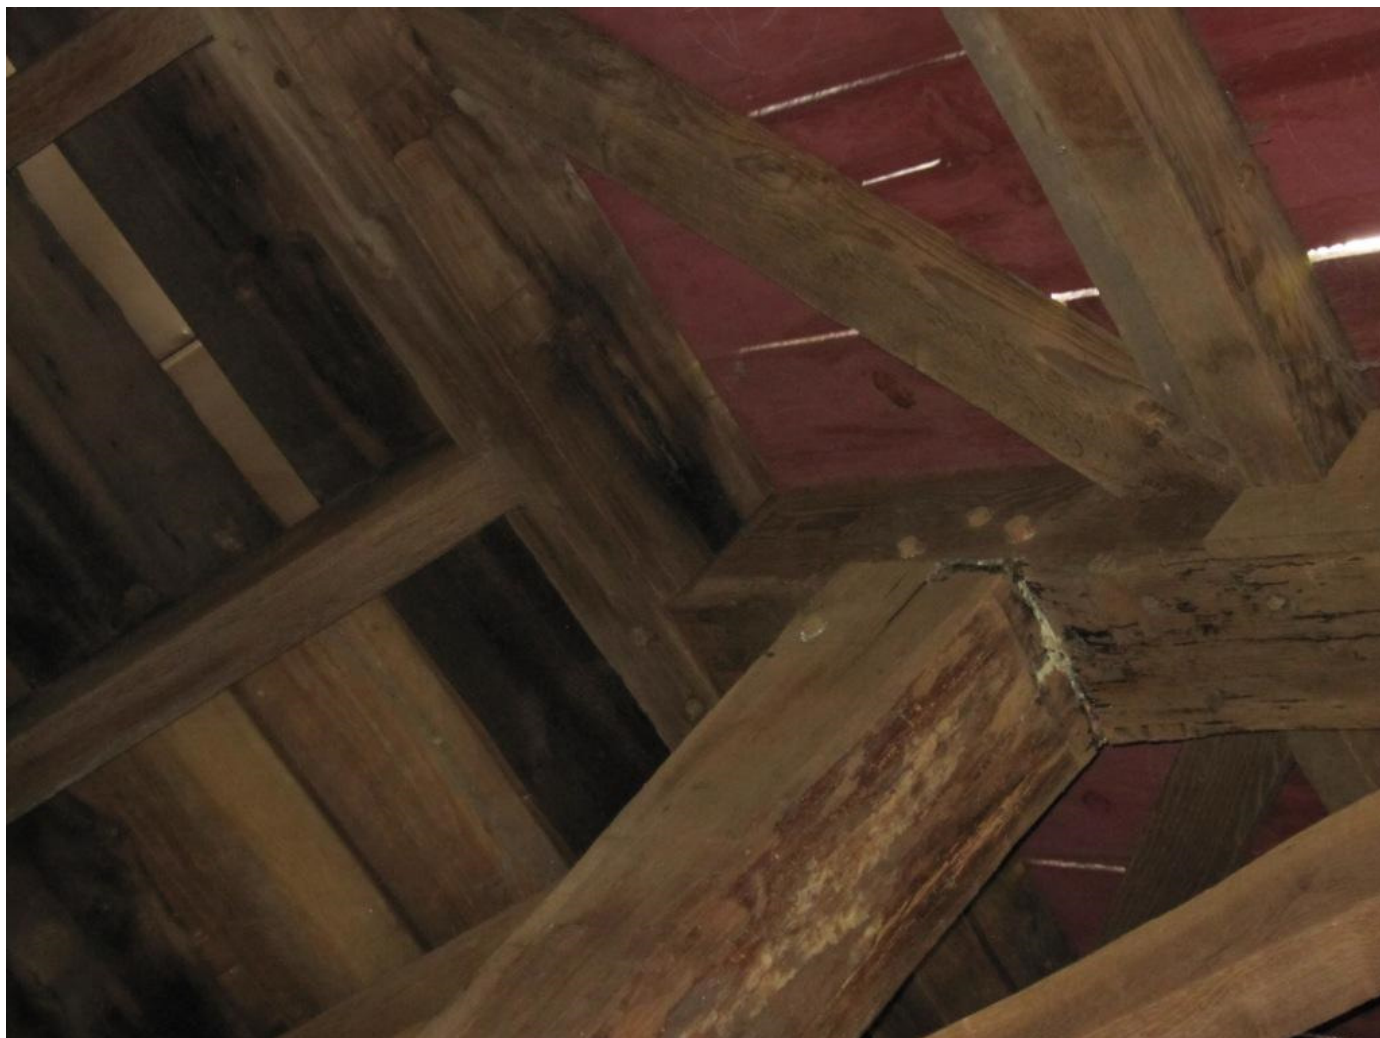
Figure 19. Framing system shows pegs and diagonal braces.

The tall interior space manifests the double-tie beam framing system with its upward posts and diagonal bracing that support the top plates. The common rafter and purlin roof has a 30 degree slope and features a center ridge board. The barn's walls are framed in a series of pegged posts and beams, including a mid-level girt, and pegged diagonal braces. The exterior planks are nailed to smaller dimension “nailers” and from the interior, an abundance of daylight shines through their slats.

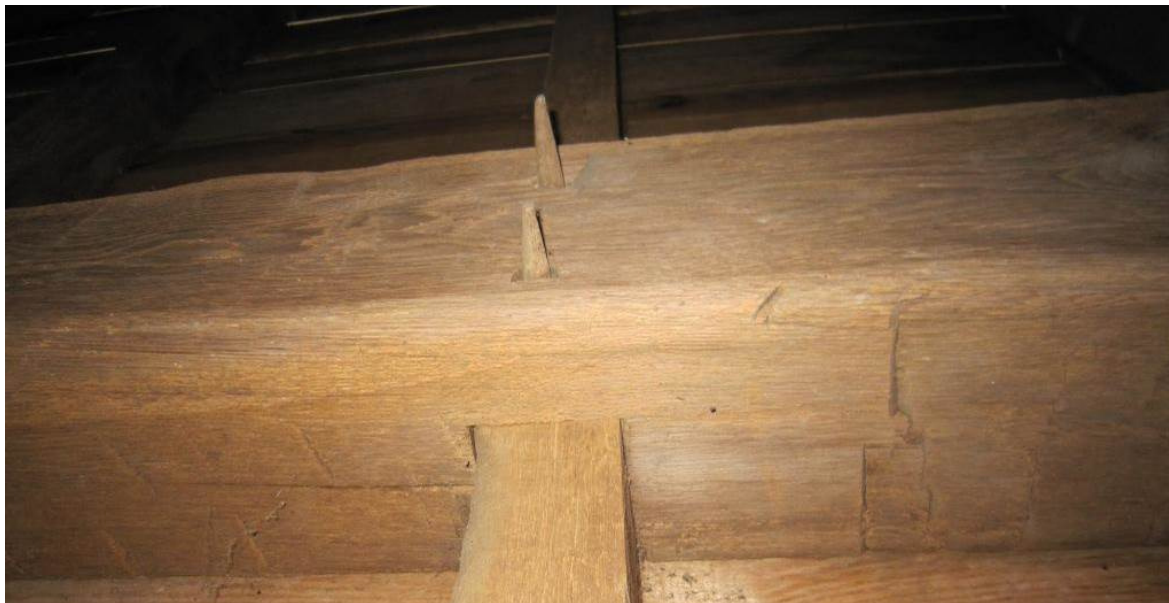
Figure 20. Pointed Pegs between Post and Tie Beam.

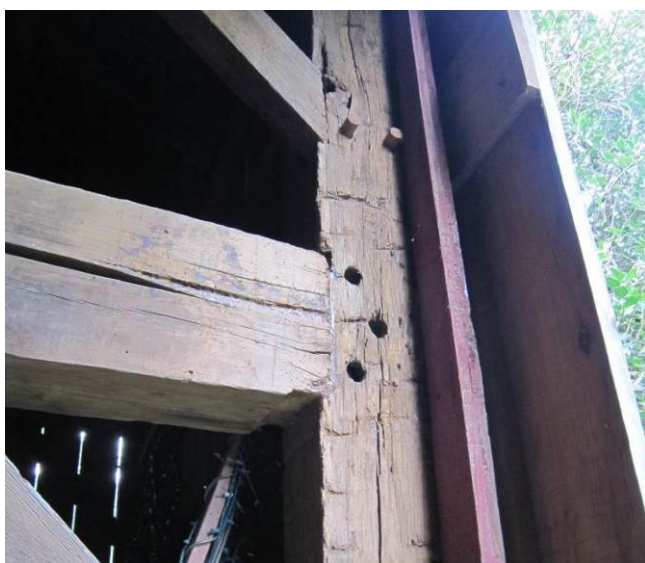
Figure 21. Hewn Interior Post showing missing pegs at Tie Beam.

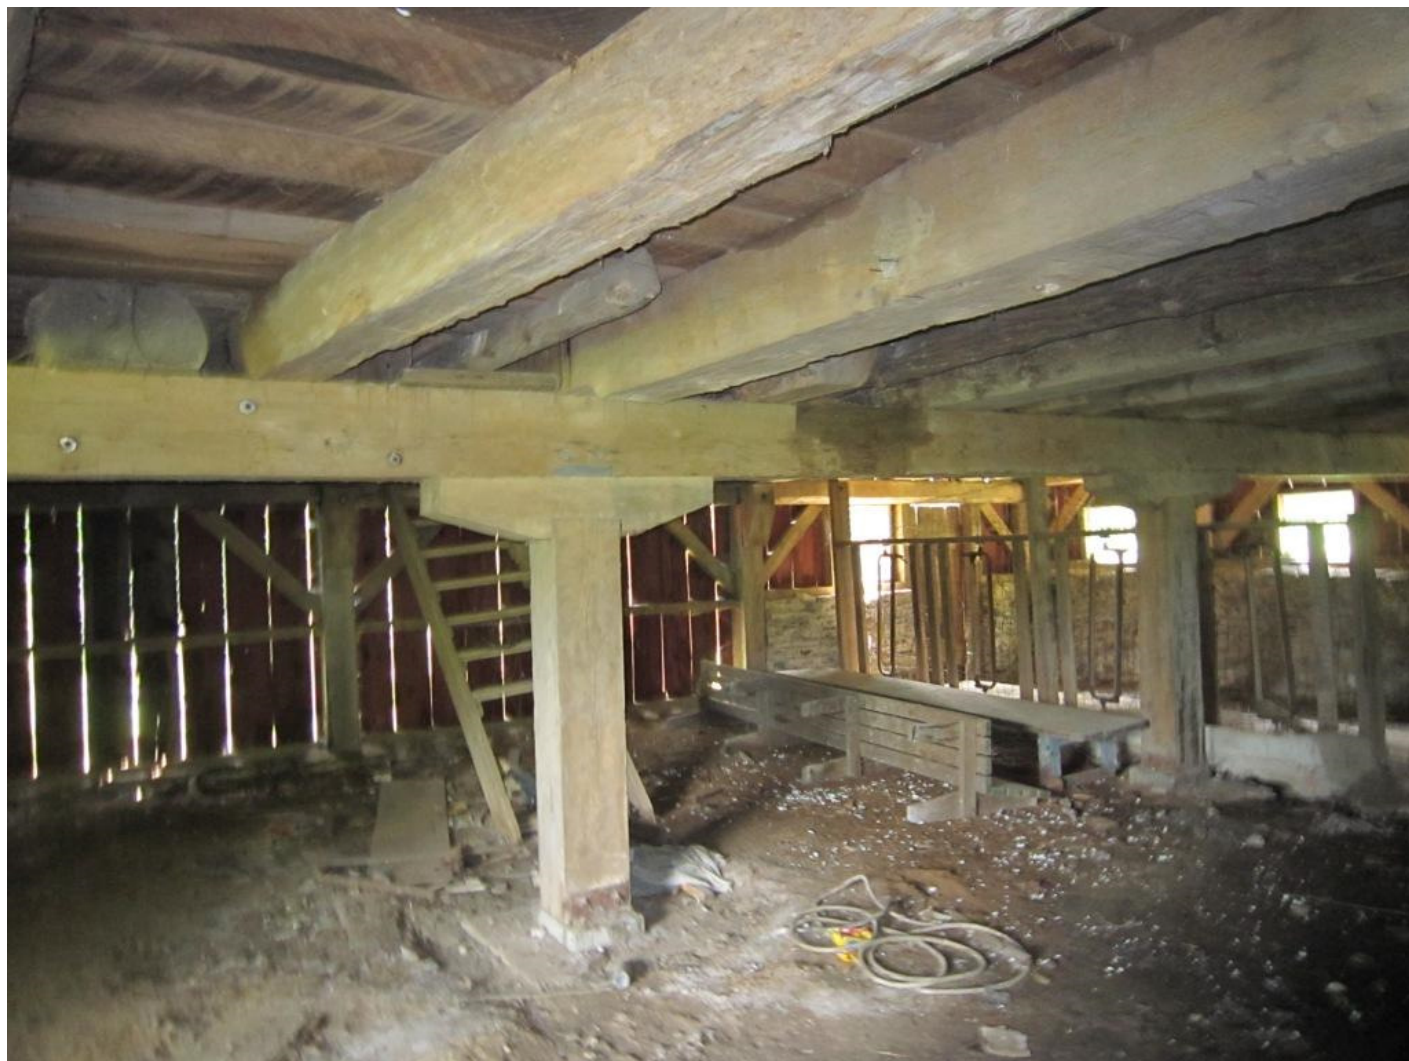
Figure 22. Interior of lower stable level, looking southeast. Ladder to upper level in center background, and 20<sup>th</sup> century milking stanchions in right background.

Originally, this interior space held wooden livestock stalls, feeding aisles, and mangers for cows and horses, and perhaps mules or sheep. The Armstrongs, owners from the Depression era, used the barn for horses and goats. Today, the livestock level features only some 20<sup>th</sup> century milking stanchions and an added concrete trough on the floor for the dairy operation, probably located where the former horse stalls stood.

A single wooden plank ladder provides a former connection up to the threshing level by means of a hatch in the floor that is no longer apparent.

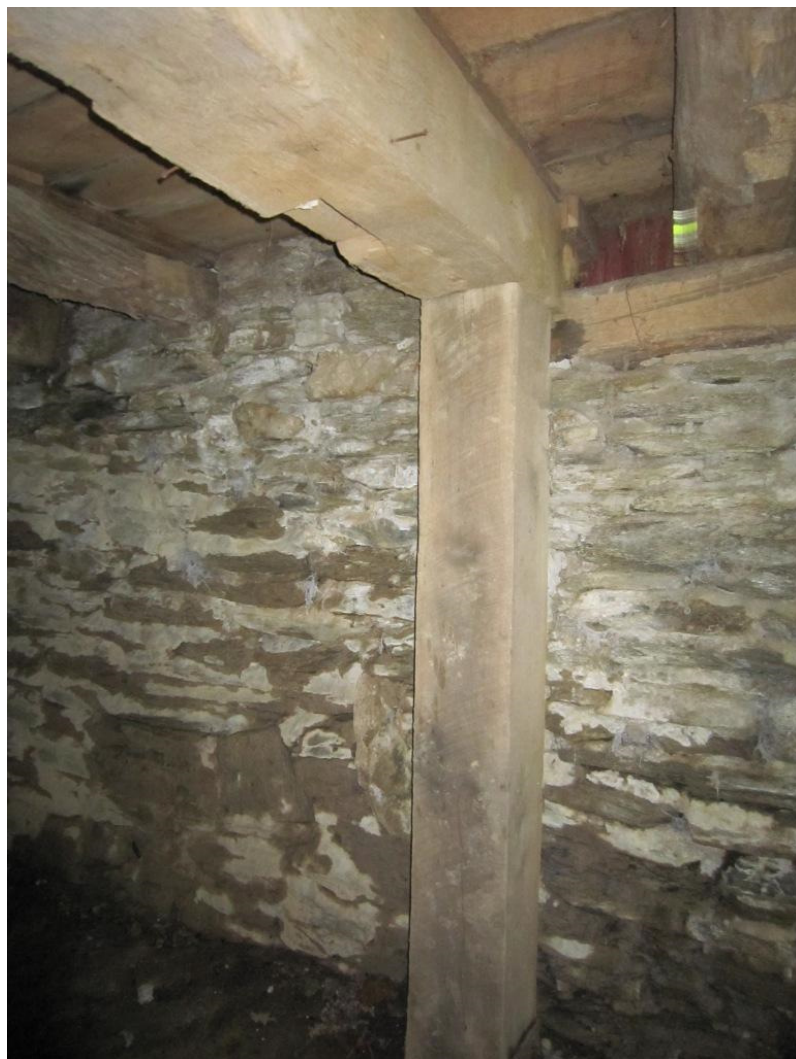
Figure 23. Interior detail, stable level: whitewashed walls and joist framing.

The lower, livestock stable interior reveals a dirt floor and (now) open floor plan within stone masonry walls of 8 ½ feet height showing remnant whitewash. Above the wall are wood plates and or pockets within the stone (at different wall heights distinguishing the main bay and side aisles) into which the joists are framed or set

respectively. One can look up to the rhythmic thirteen joists, their flattened undersides circular sawn or hewn, and their sides, still left with the bark on, and comprehend the framing of the 40-foot width. Some of the joist's bark is splintering off rather wildly due to age. The summer beam that provides most floor support is a replacement wood member, now supported on posts with concrete footings. Additional support members extend from this summer beam to the edge of the building's southeast wall.
