Maryland Department of the Environment (MDE) field reports

Facility Address: 17900 Trundle Road
Dickerson, MD 20842

Site Name: PAF 06-1090 17900 Trundle Road

**Site photographs, June 28, 2006, M-NCPPC Environmental Planning,
Countywide Planning Division**

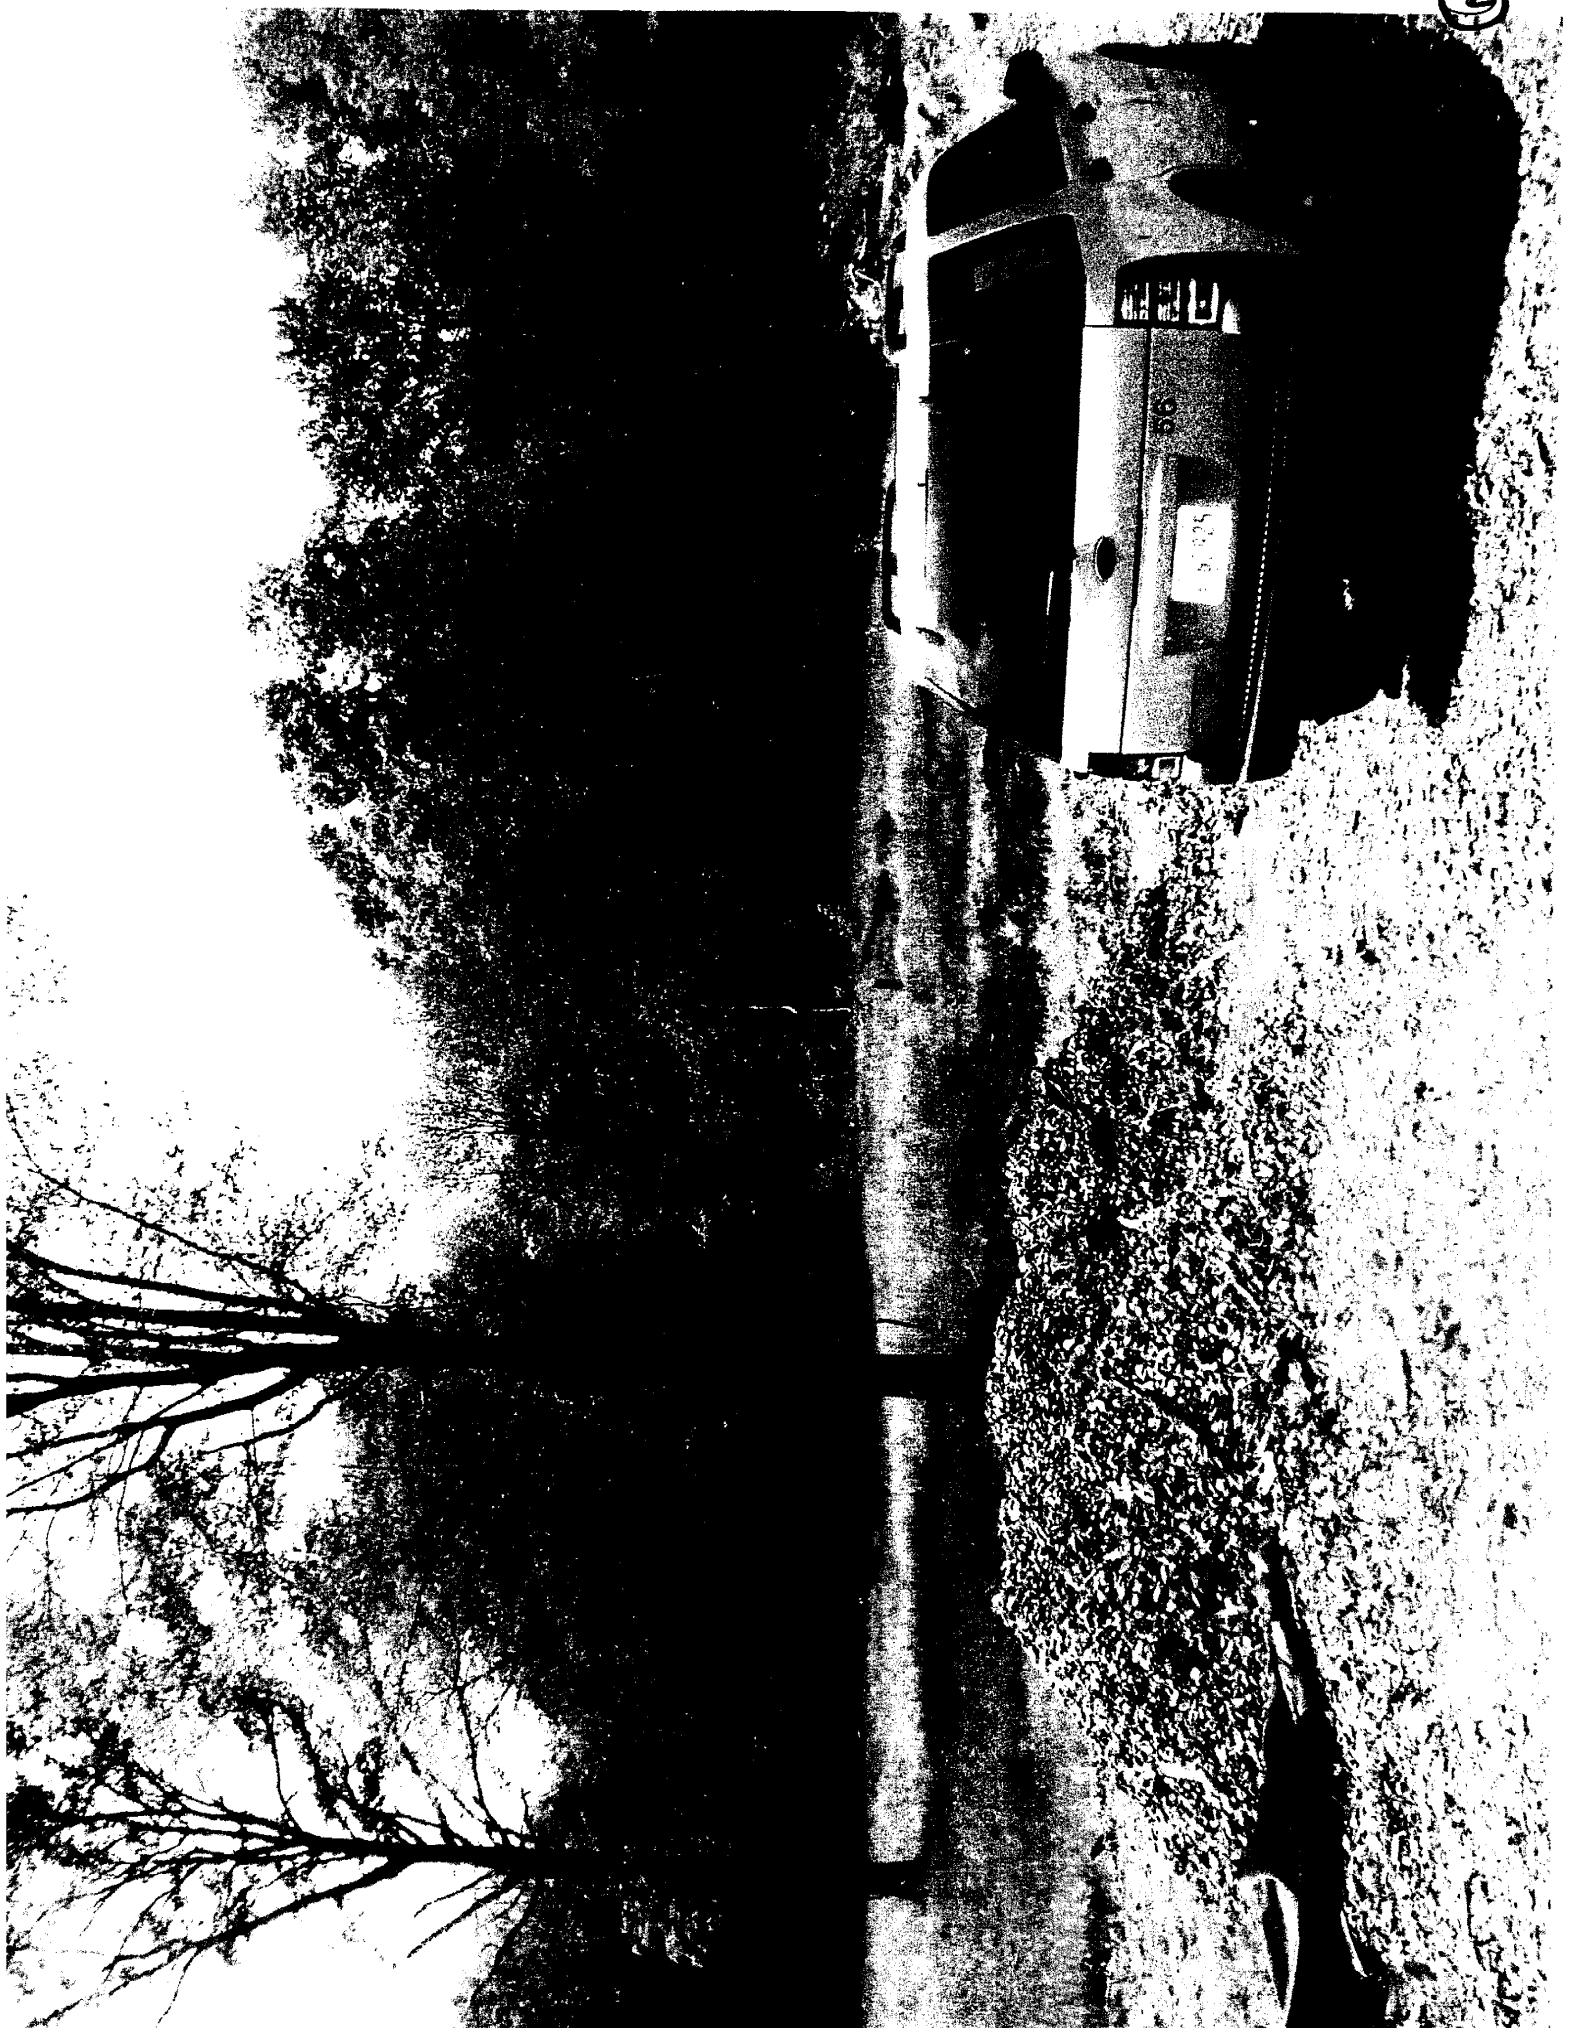
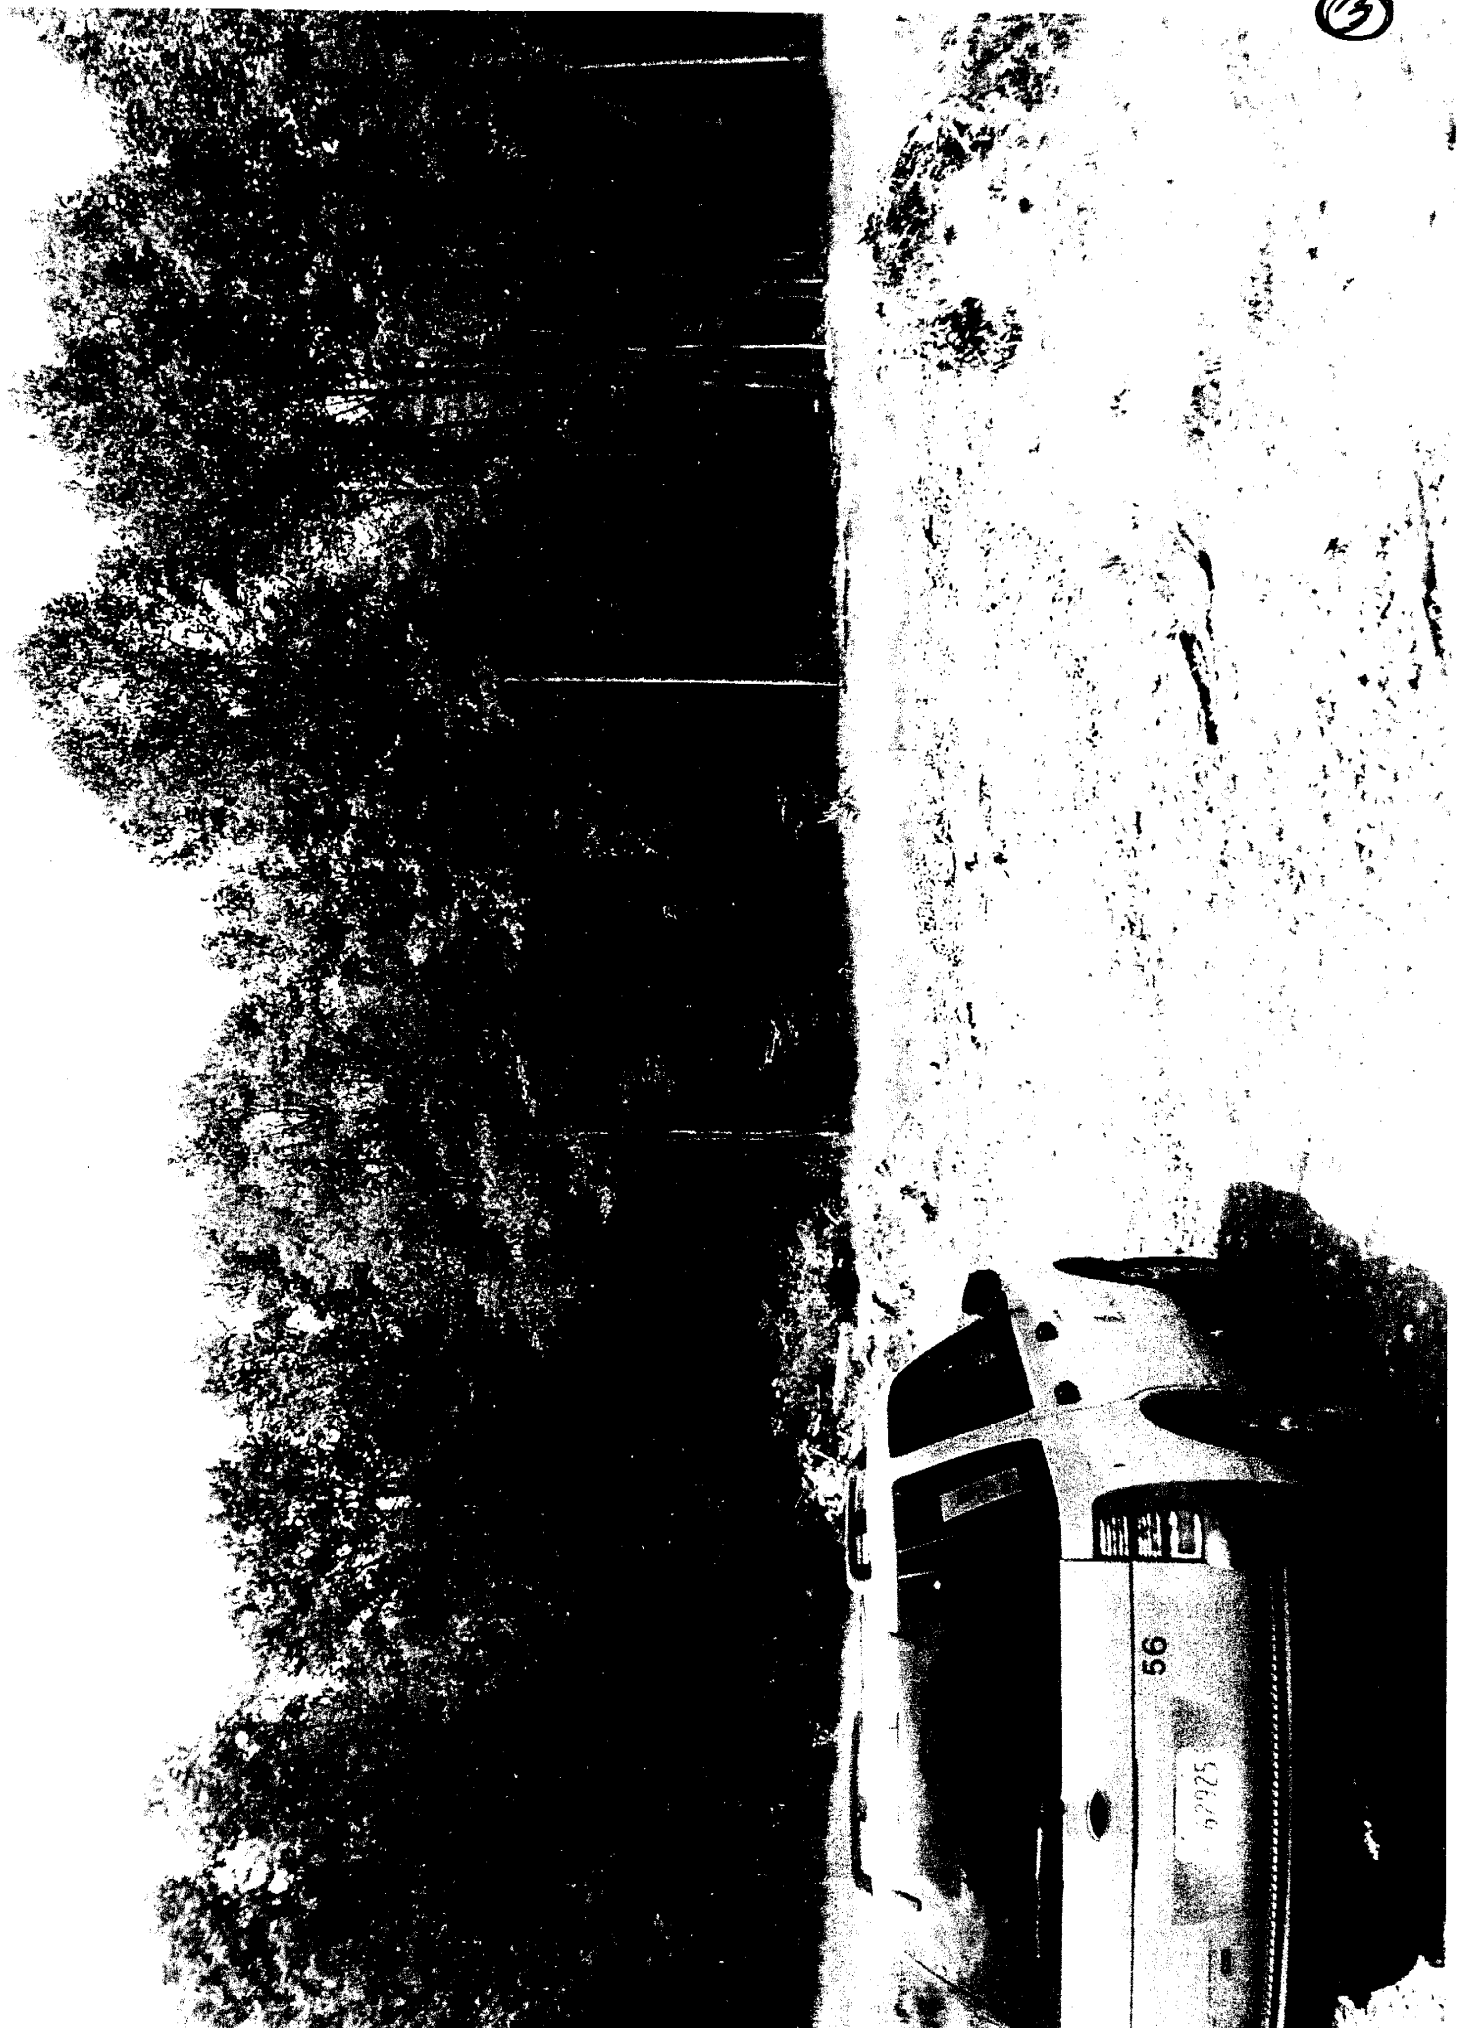
I visited 17900 Trundle Road at 2:30pm. Upon arriving at the site I proceeded to take 35 various pictures of the area. Photos #1-#6 are an overlapping panorama of the site. The Various pictures of forest with understory were taken just outside the clearing area perpendicular to the site access driveway.

Letter A indicates the point where photographs #1-11 were taken. The first six pictures show an overlapping panorama view from the site entrance off of Trundle Road.

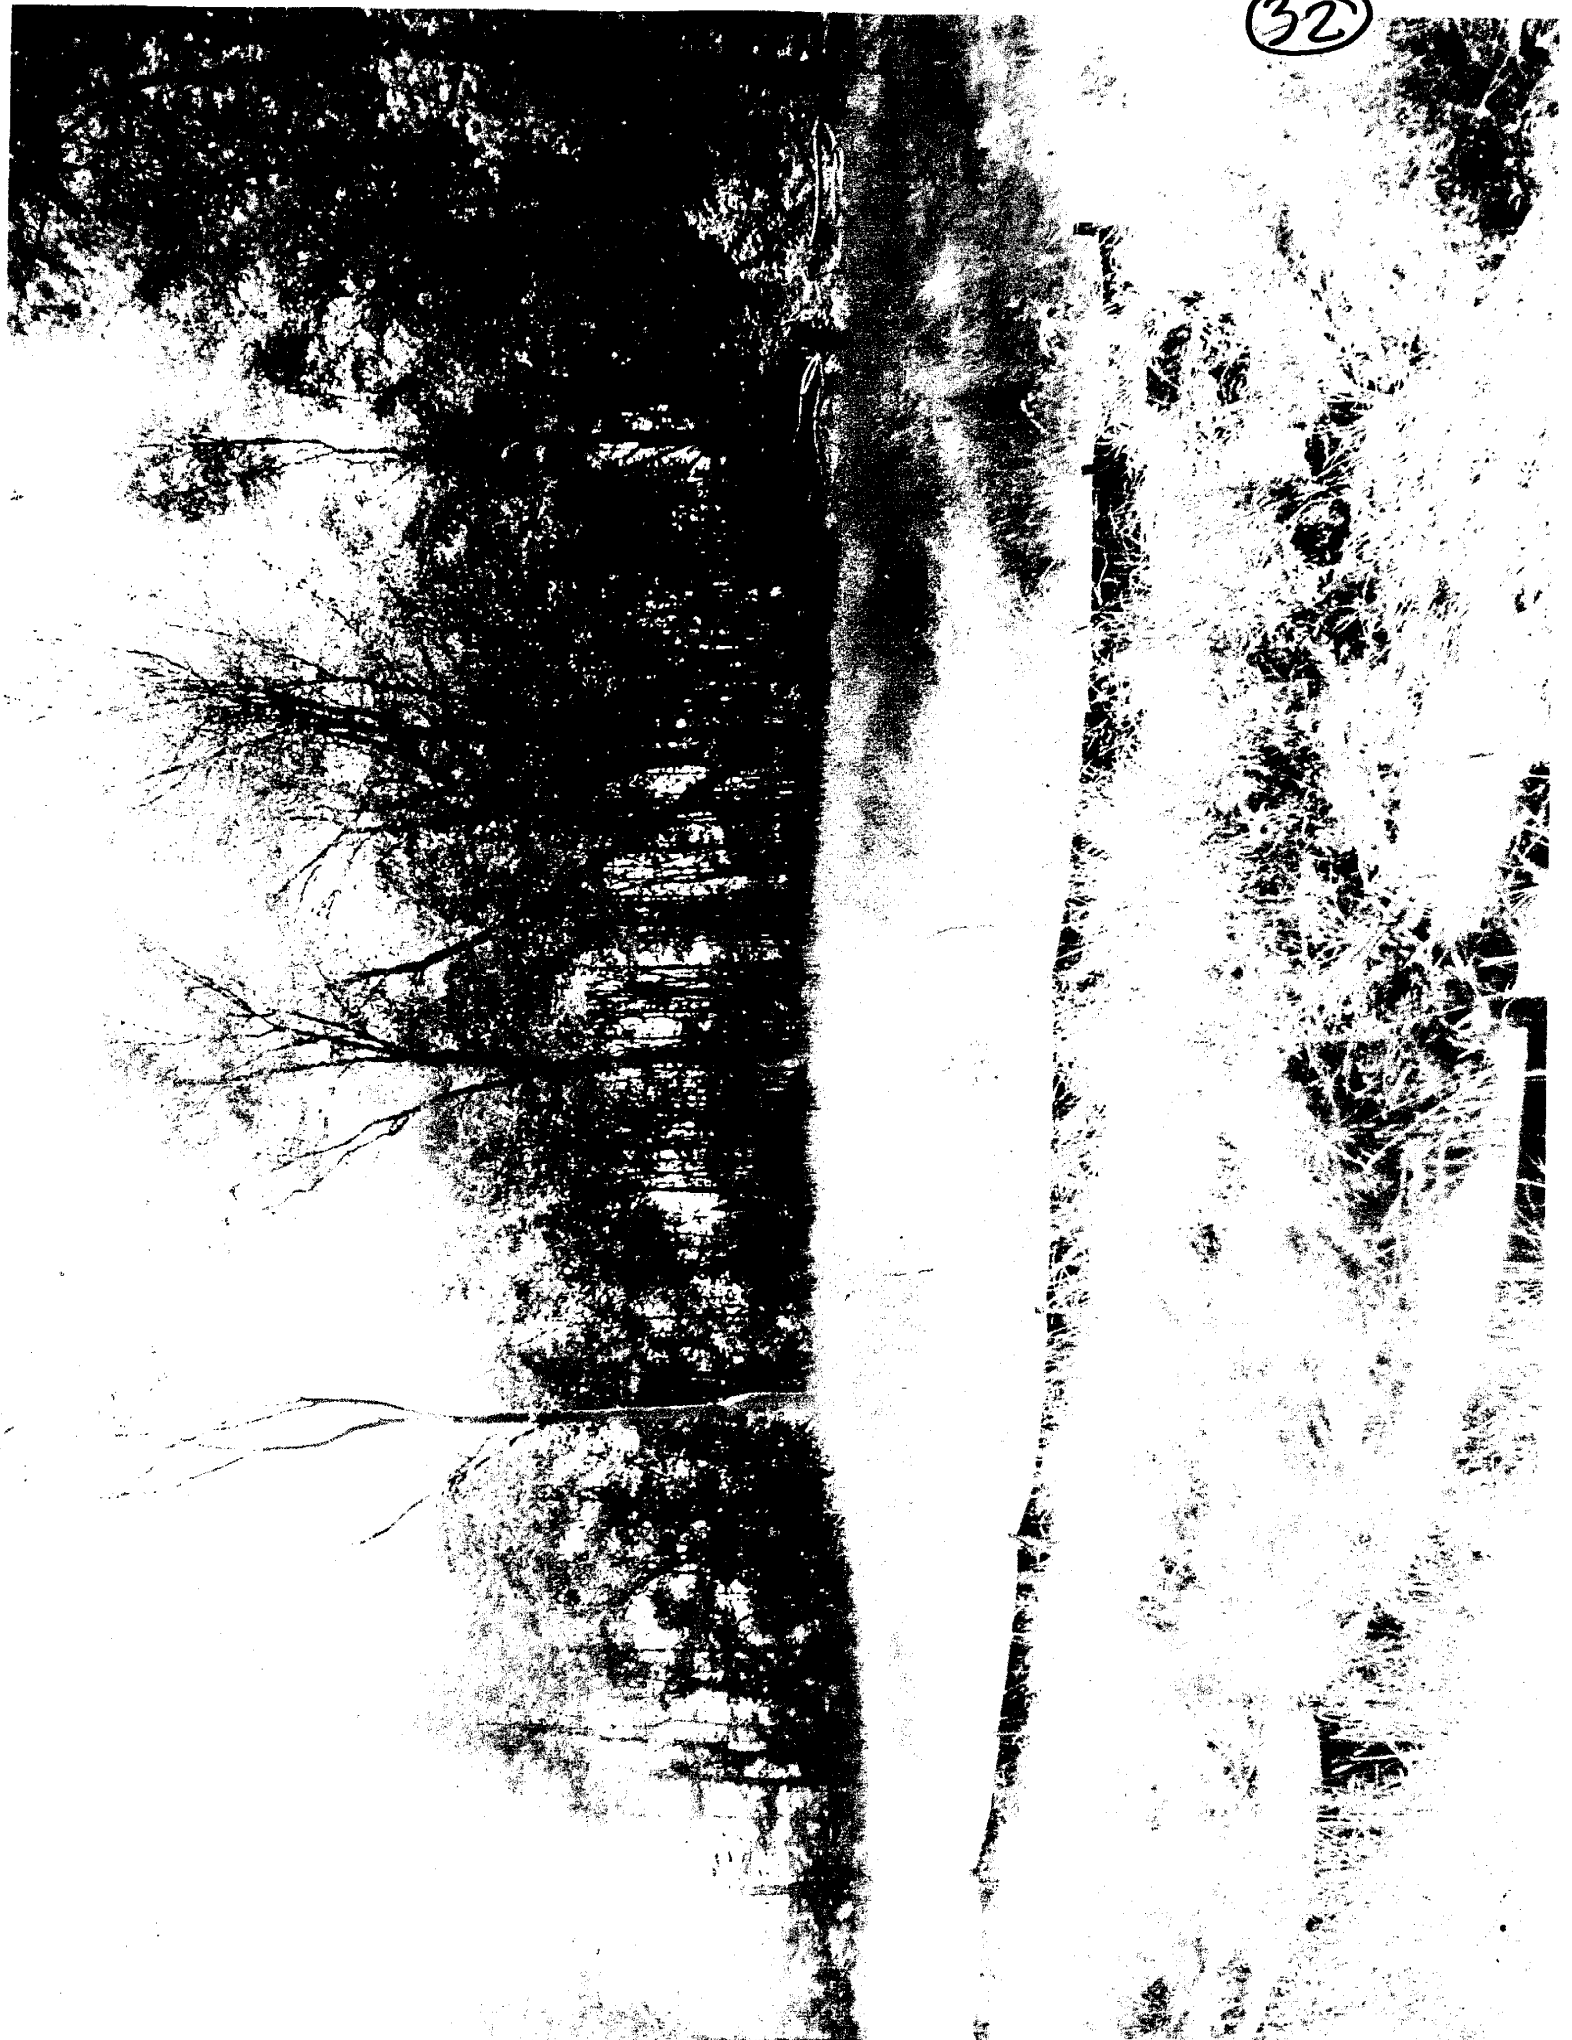
34

Letter F indicates the area where photographs #33-35 were taken. These pictures were taken from the interior of the site facing the access road to the property..
