NRI 420240850 and Concept Plan #520240040, 9312 Persimmon Tree Road

NRI 420240850, V4

Concept Plan #520240040

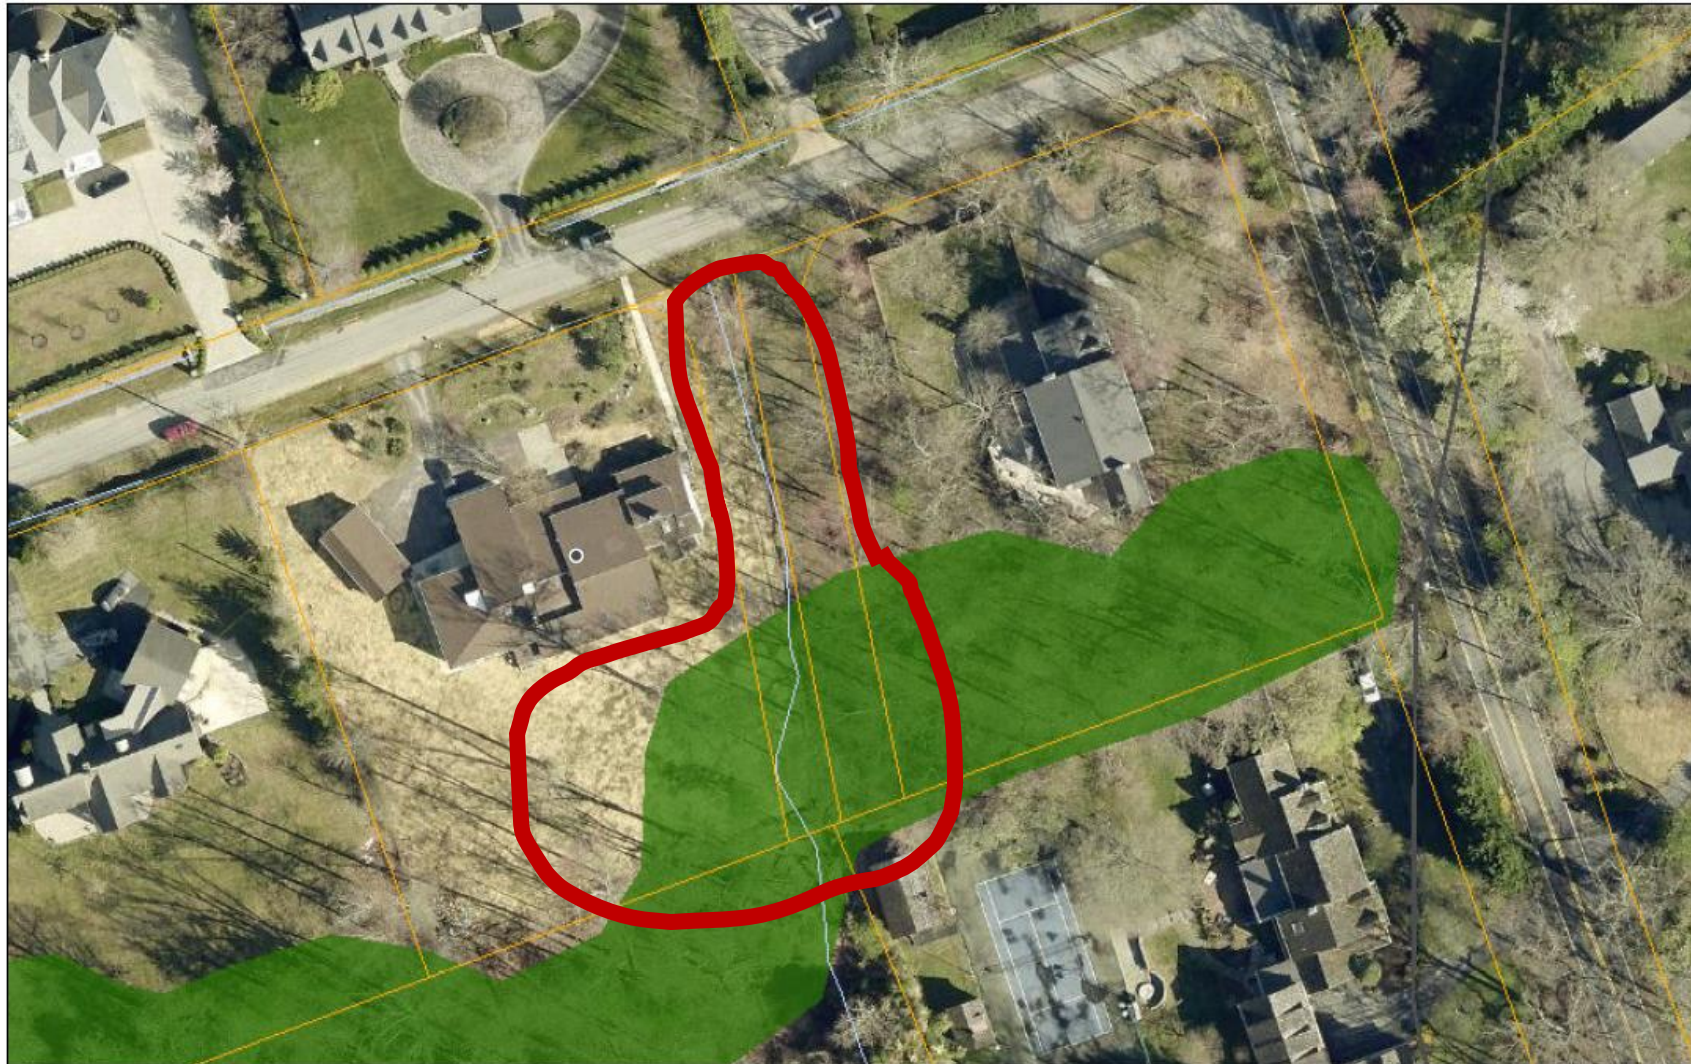
MCG, GIS, ESRI, Pictometry
Sources: Esri, HERE, Garmin, Intermap, increment P Corp., GEBCO, USGS,

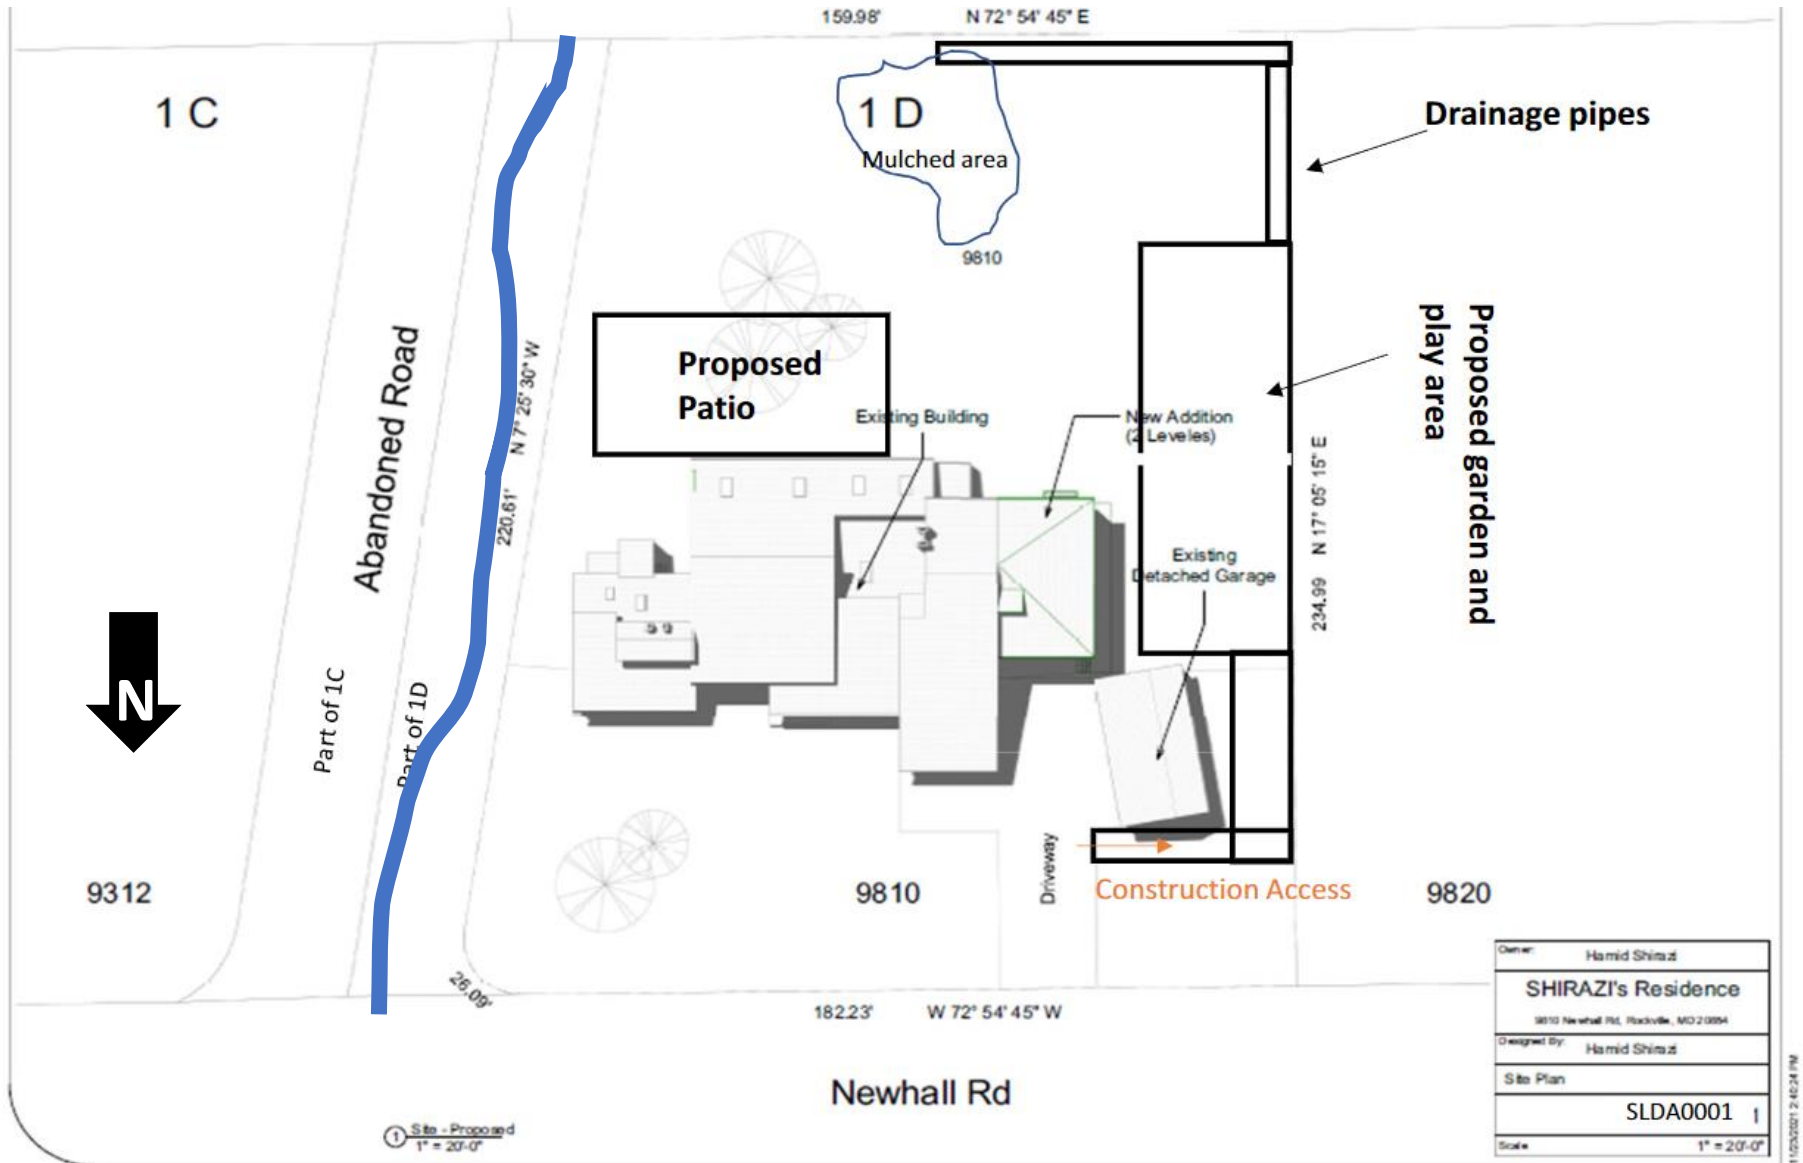
FC Exemption Plan (Withdrawn)

*Blue line
(Stream), just
for reference

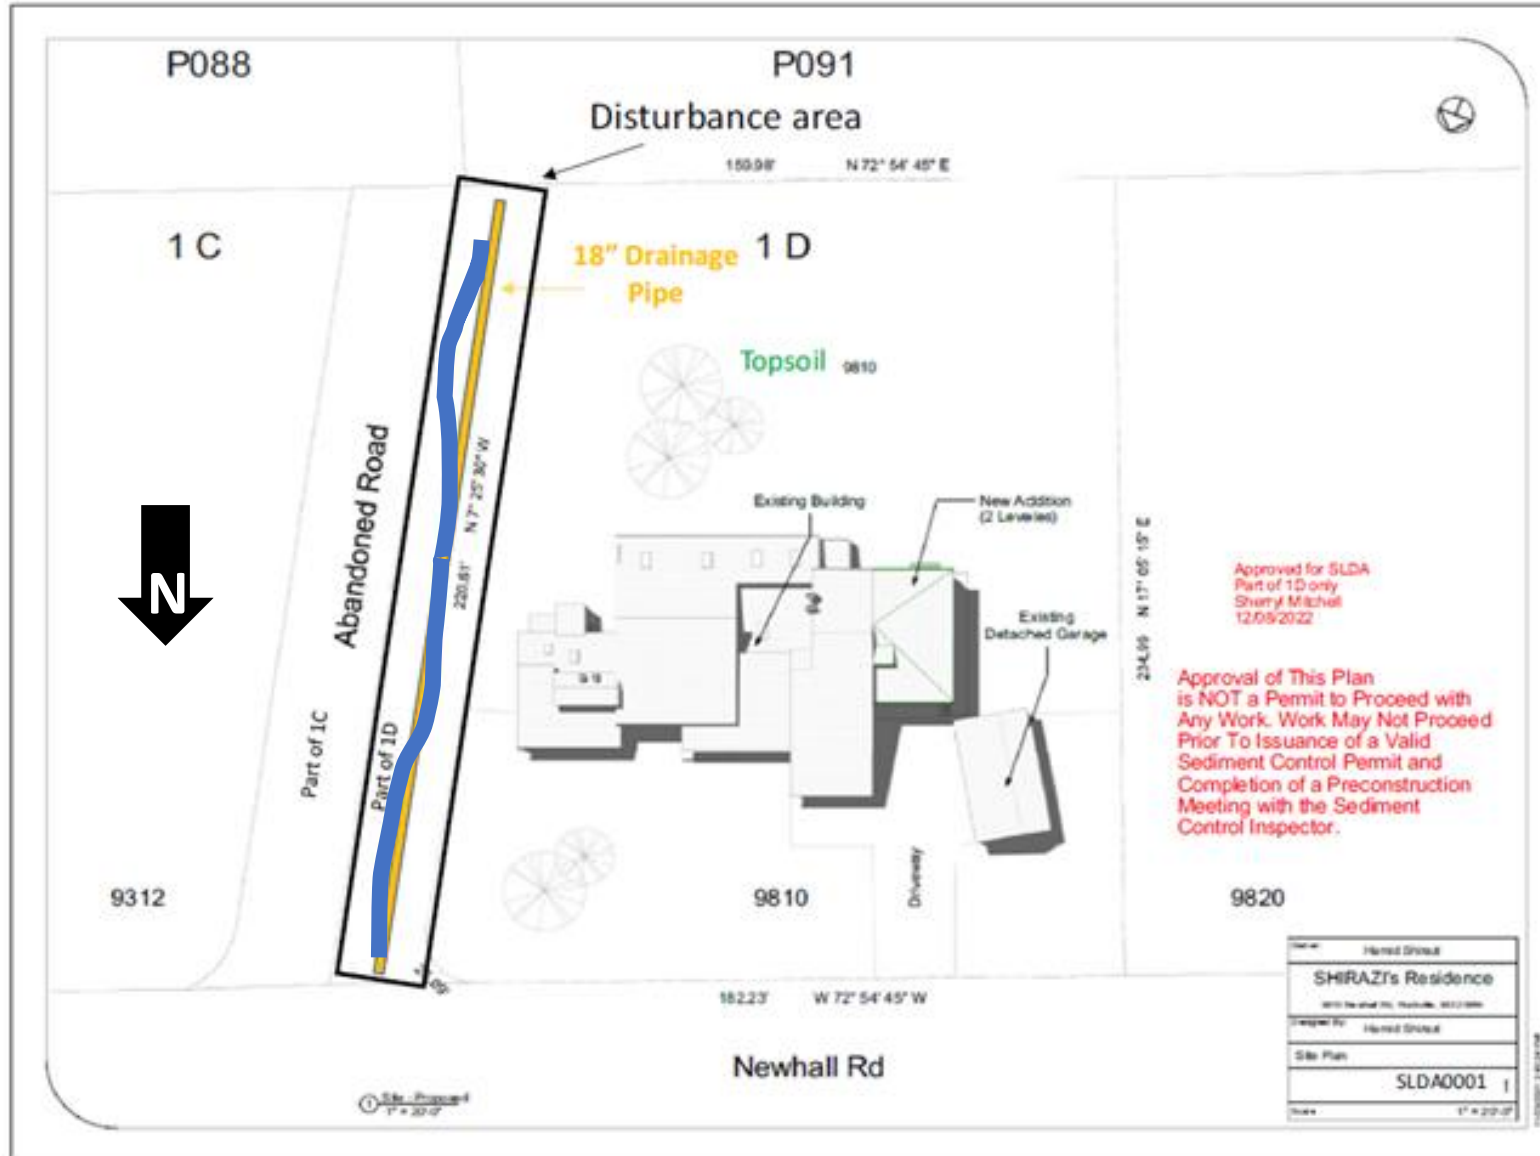
Sediment
Control Permit
approved by
DPS

APPROVED
Department of Permitting Services
Permit # SEDIMENT-288894
Date 12/08/22
Project # 18124949

*Blue line
(Stream), just
for reference

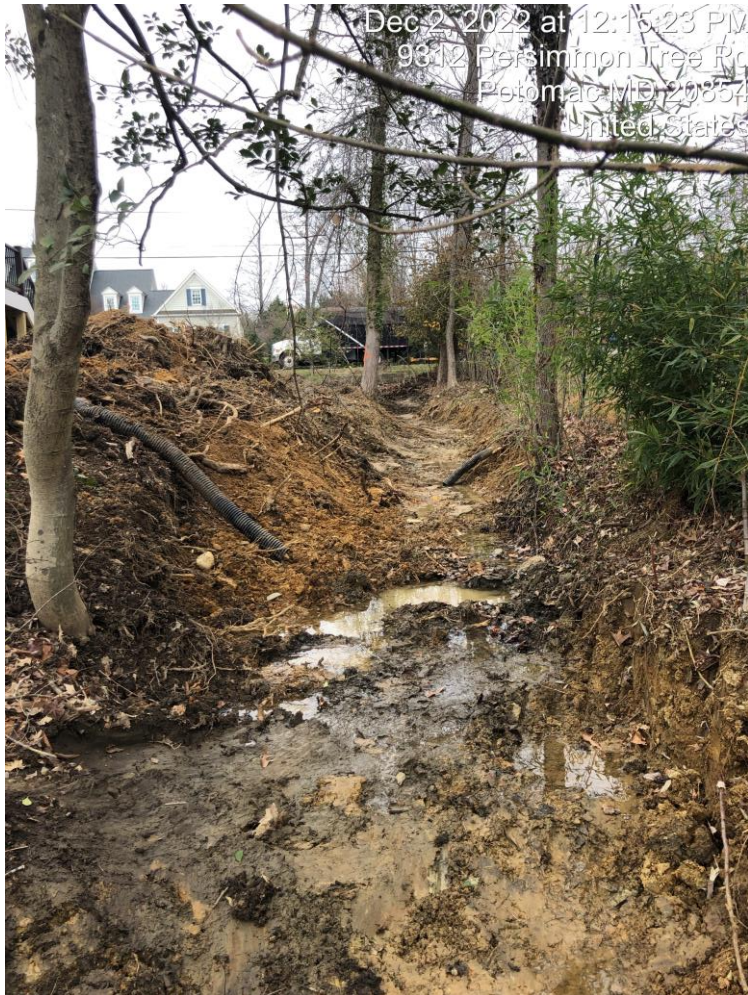
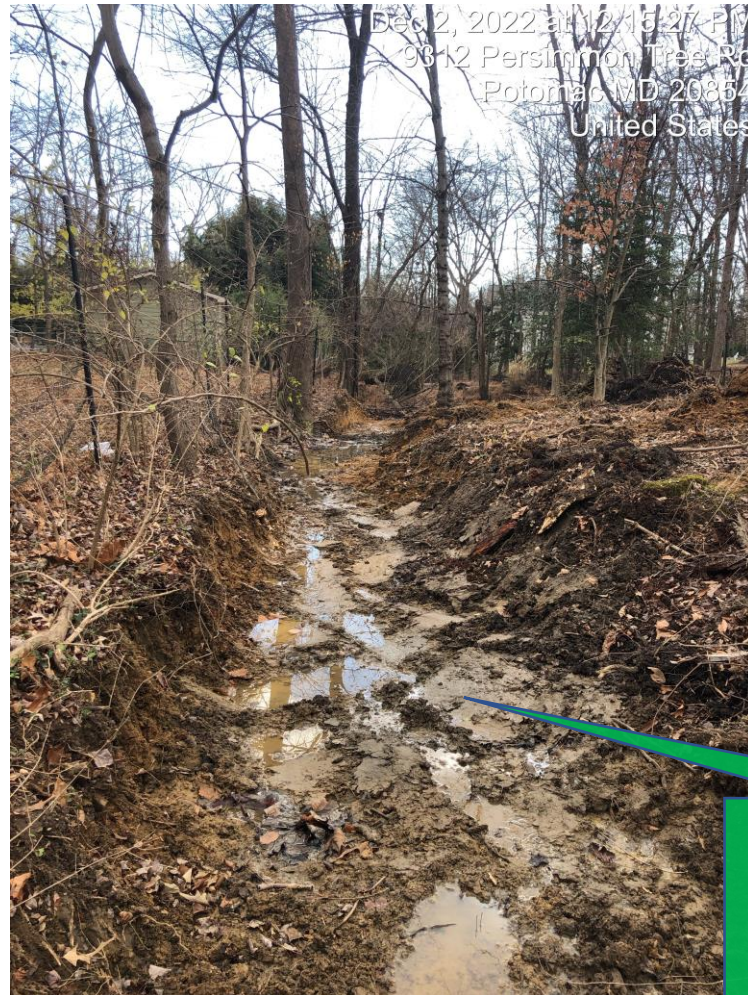
During the installation of the piping, there was some over-disturbance observed, which led to a violation of the Department of Permitting Services (DPS) regulations.

"The soil from the excavation was thrown onto the main property and ***some trees were observed to be removed.*** Work was ***beyond our requirements***, so I issued an NOV and directed to obtain a permit".
Inspector III CESSWI (DPS)

"SLDA application (SC 288894) was modified to include only the work on the smaller parcel, and we issued that ***approval without forest conservation***". Manager (DPS)

Potentially, they found water table within 3 ft deep

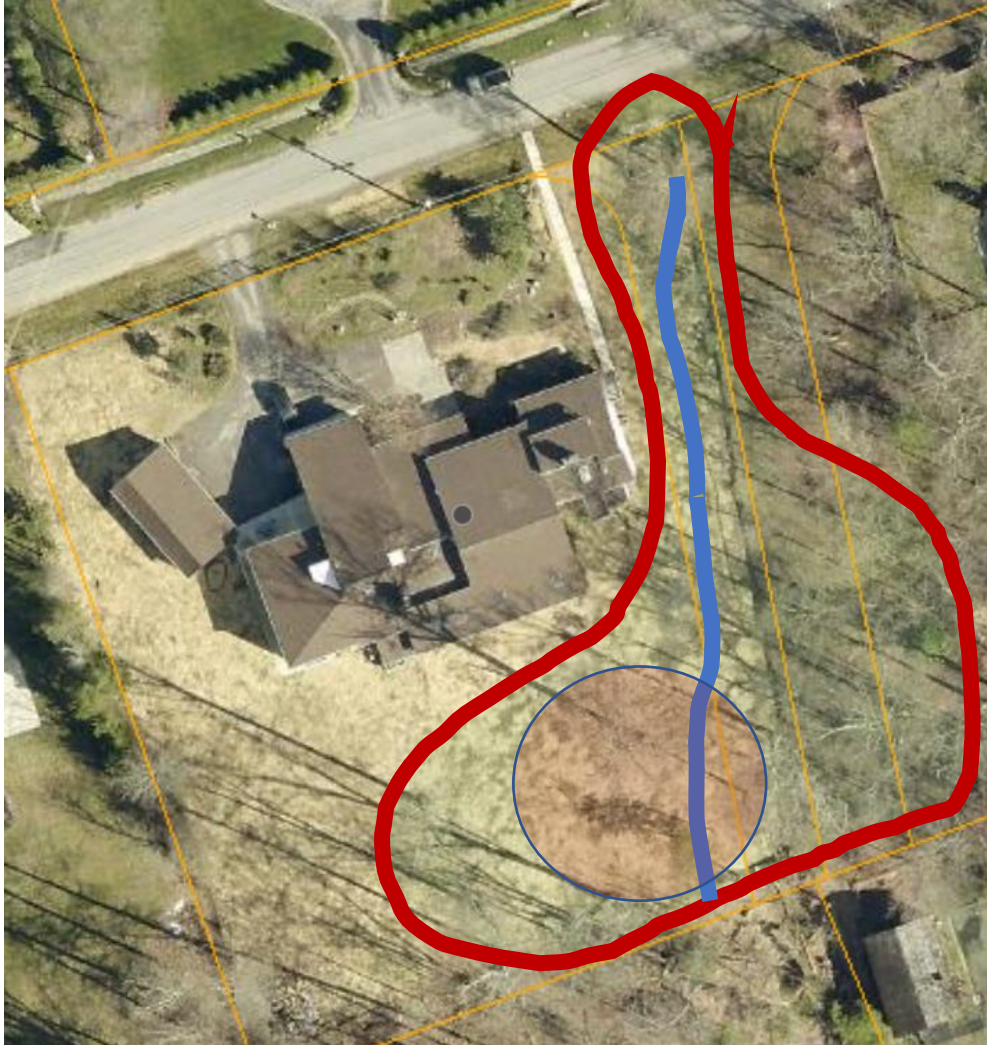
Aerial Photograph 2023

Synopsis of the activities provided by the owner

There were 2 dead trees in my backyard. I found criteria for removing dead trees on the county website: <https://www.montgomerycountymd.gov/green/trees/permits-and-concerns.html>. None of the criteria listed were applicable to us. I had a contractor remove both on May 17.

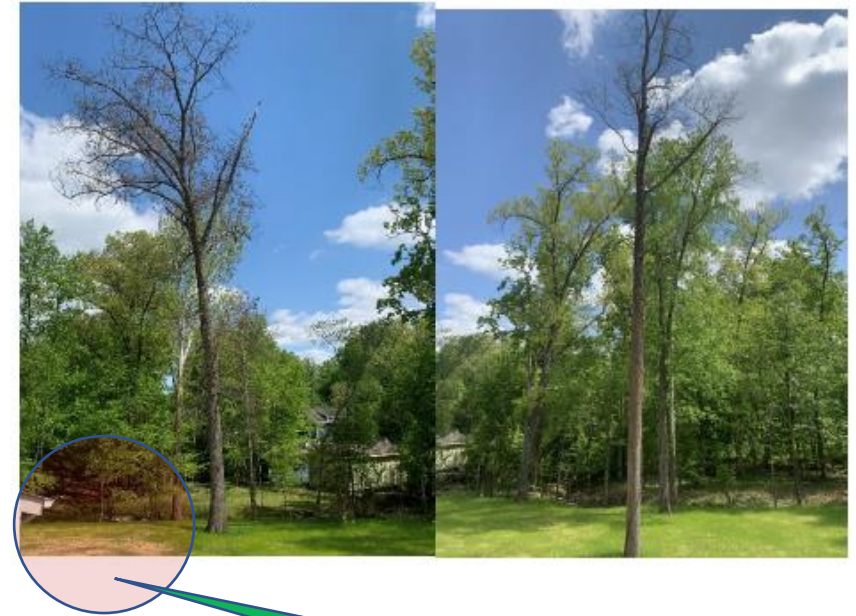
Trees were killed due to their proximity to the piping installation and grading.

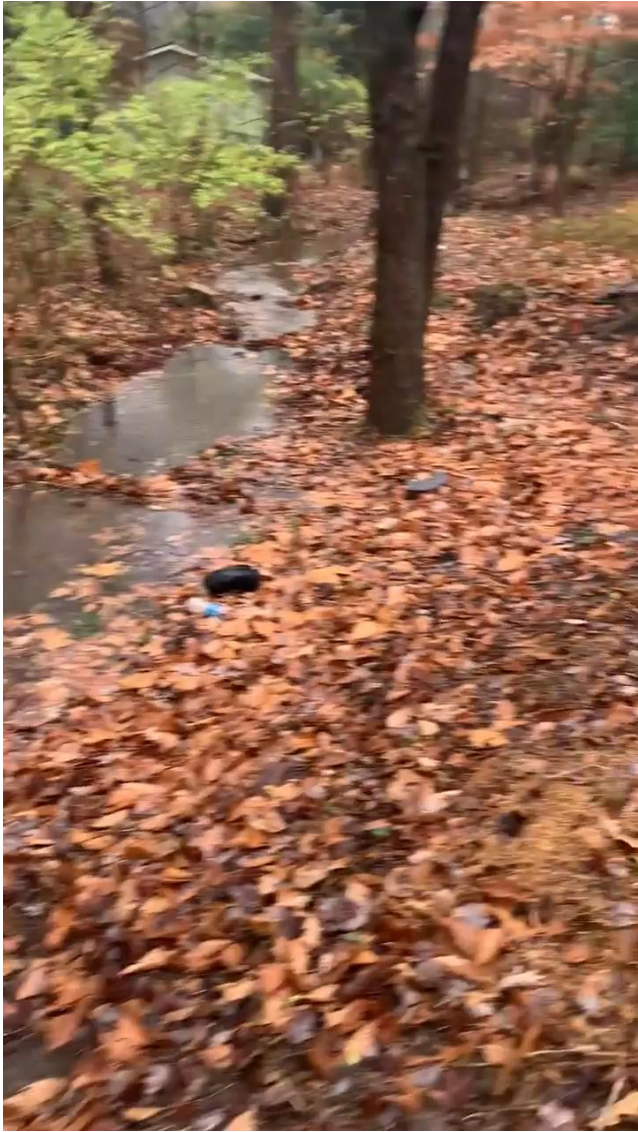
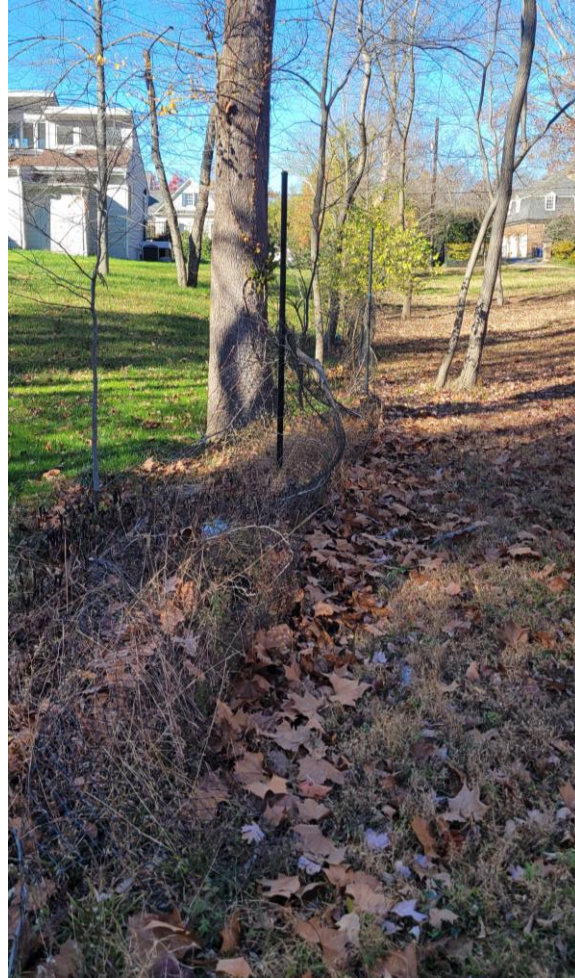
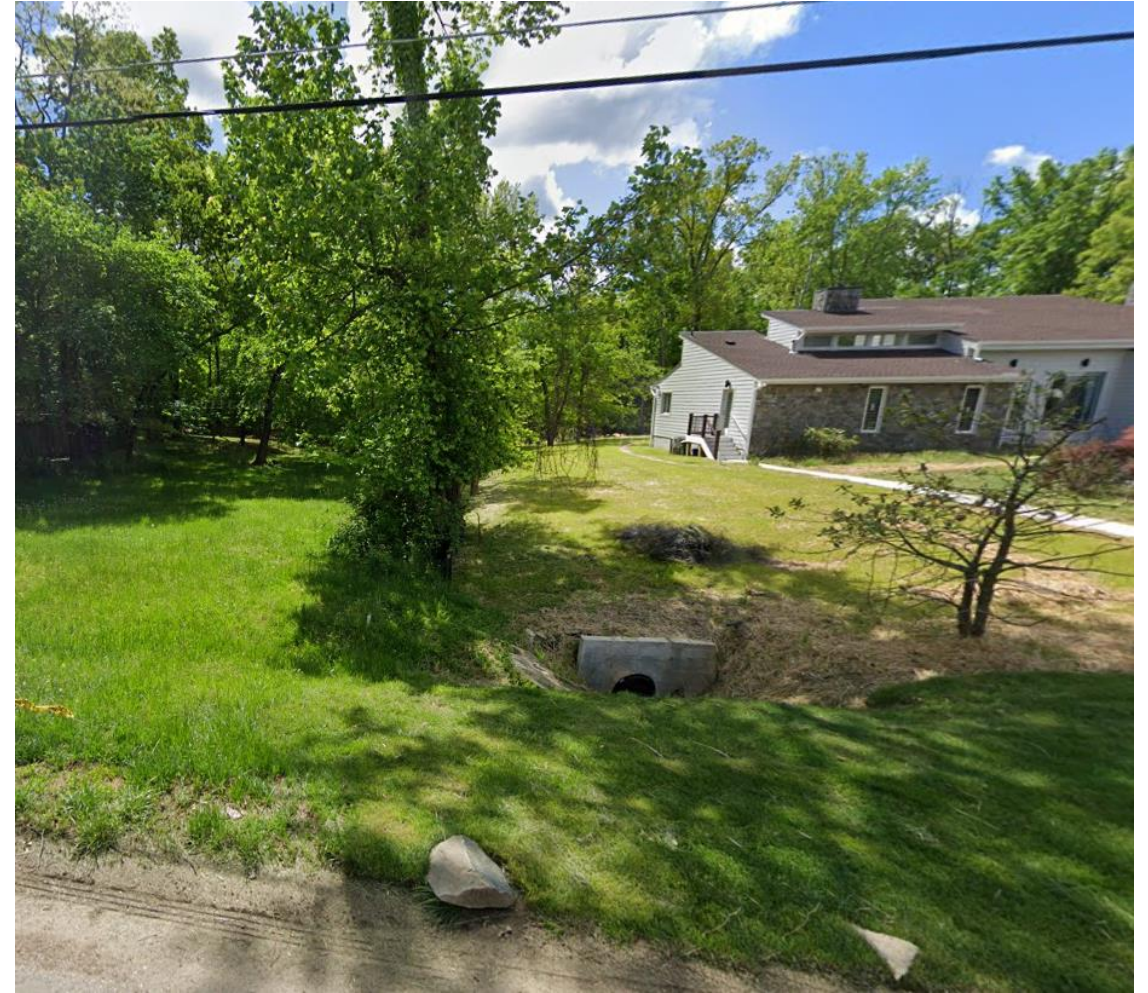
Current field conditions (2023)

Field Indicators and Descriptions (Observed in the field)

- Continuity of Channel Bed and Bank
- Sinuosity of Channel
- In-channel structure: Riffle-Pool, Step-Pool, Ripple-Pool sequence
- Particle Size of Stream Substrate
- Depositional Bars or Benches (Bankfull elevation)
- Recent Alluvial Deposits

- Presence of Baseflow
- Leaf litter
- Sediment on Plants or Debris
- Organic Drift Lines

- Wetland Plants in Streambed

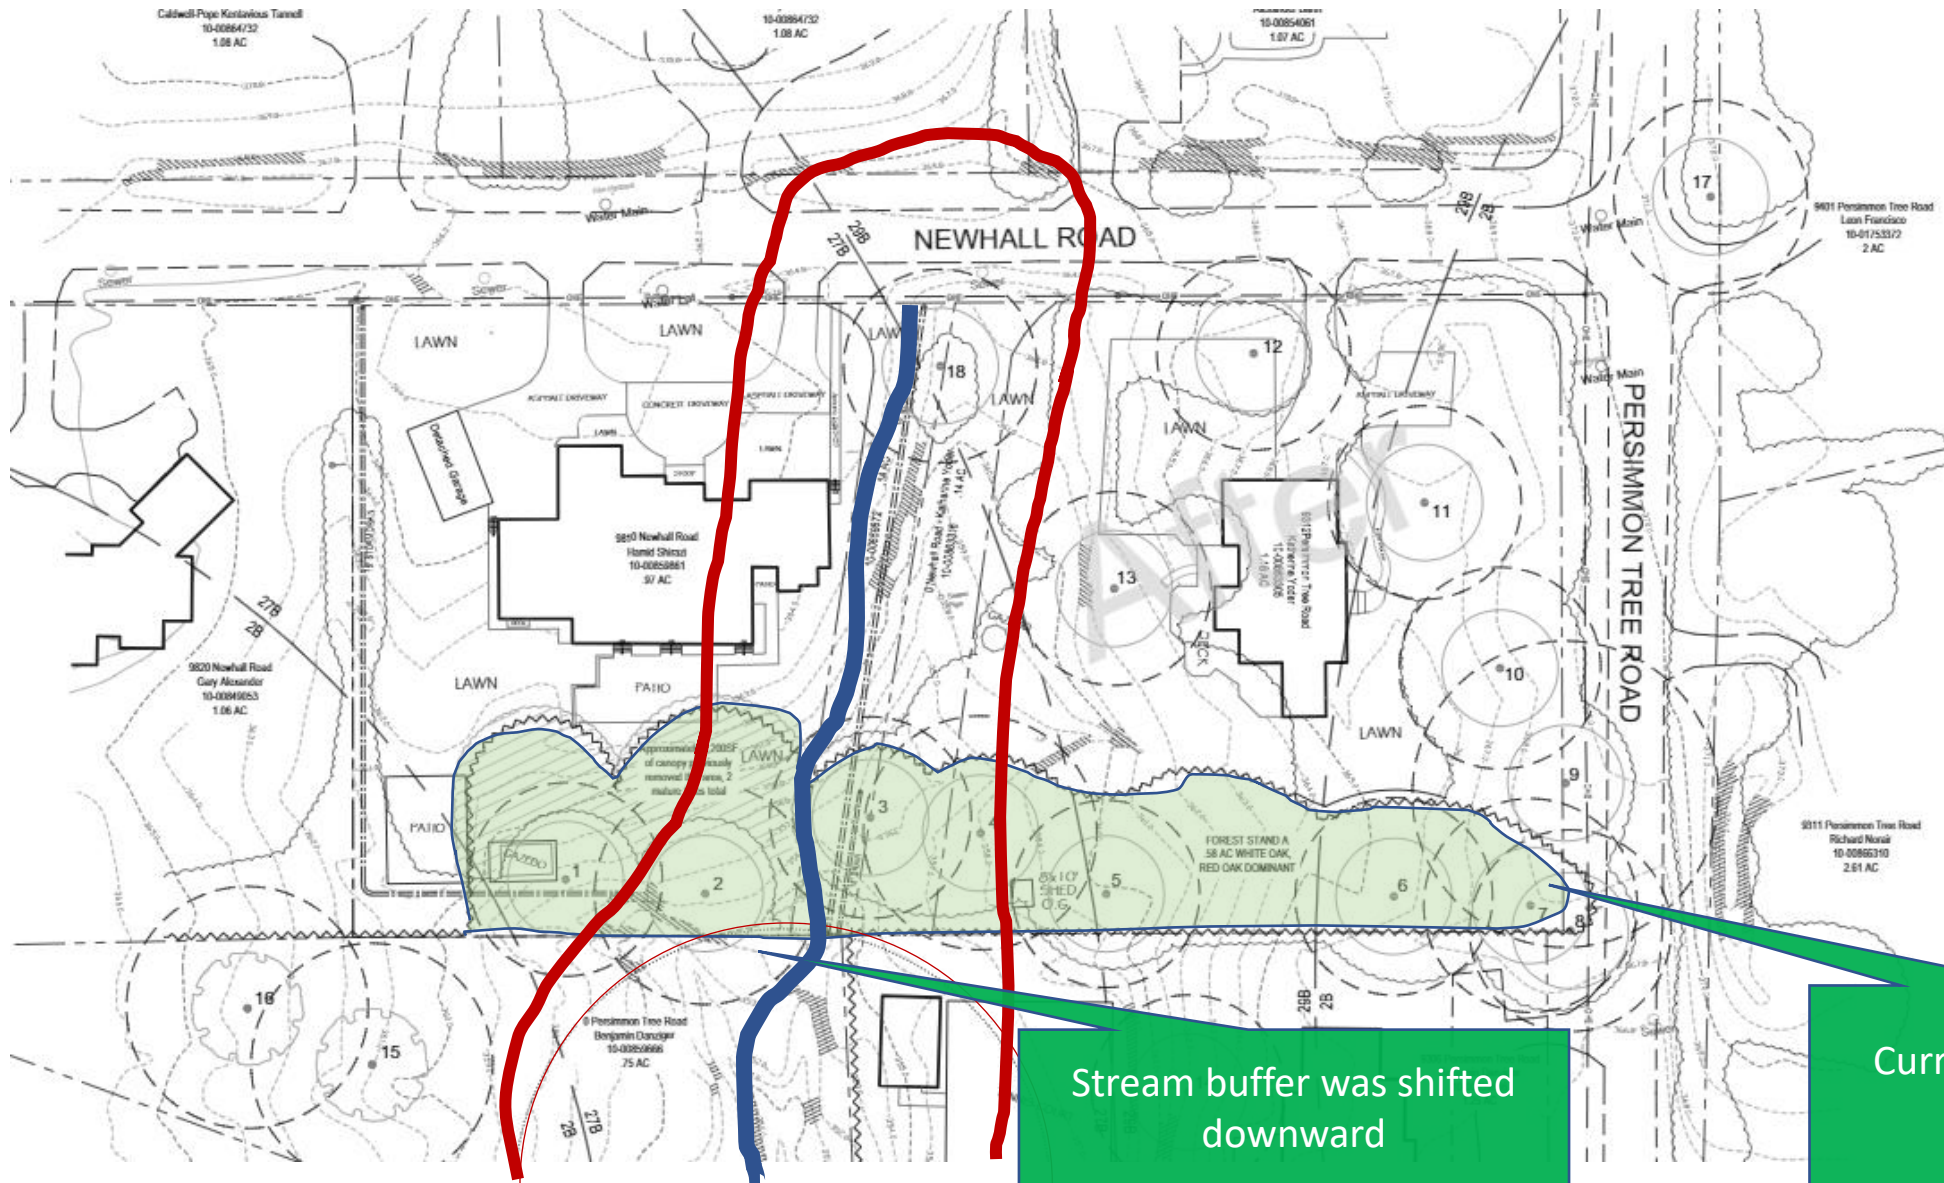
*Red line (Stream buffer) is currently not being shown by the applicant.

*Blue line (Stream), just for reference) is currently not being shown by the applicant.

Stream buffer was shifted downward

Field data, documentation (video and pictures), and Forest Conservation Plan Exemptions have confirmed the presence of previous critical environmental features such as a stream and the associated buffer that were recently disturbed on the subject property. Topographic, hydrologic, and soil maps, Geographic Information Systems (GIS), and fine-resolution Light Detection and Ranging (LIDAR) have also been used to verify the extent of the stream and forest that have been disrupted. The provided Letter from the MDE will not be considered for this plan. Therefore, remove the letter from the plan.

In order to comply with the Forest Conservation Law Chapter 22A, Trees Approved Technical Manual 1992, and the Environmental Guidelines for Management of Development in Montgomery County 2021, the applicant must address the previous comment to fully represent previous and current field conditions (the applicant must show the stream and its associated buffer) and other relevant environmental features for the Natural Resource Inventory/Forest Stand Delineation (NRI/FSD). By failing to address the standard requirement for the Natural Resource Inventory/Forest Stand Delineation (NRI/FSD), the plans cannot be approved.
