Re: Appeal of Denial of Natural Resources Inventory/ Forest Stand Delineation No.  
420240850 for Persimmon Tree Subdivision ("NRI/FSD")

**Site Photos for the 9810 Newhall Road Property  
Montgomery County, MD**

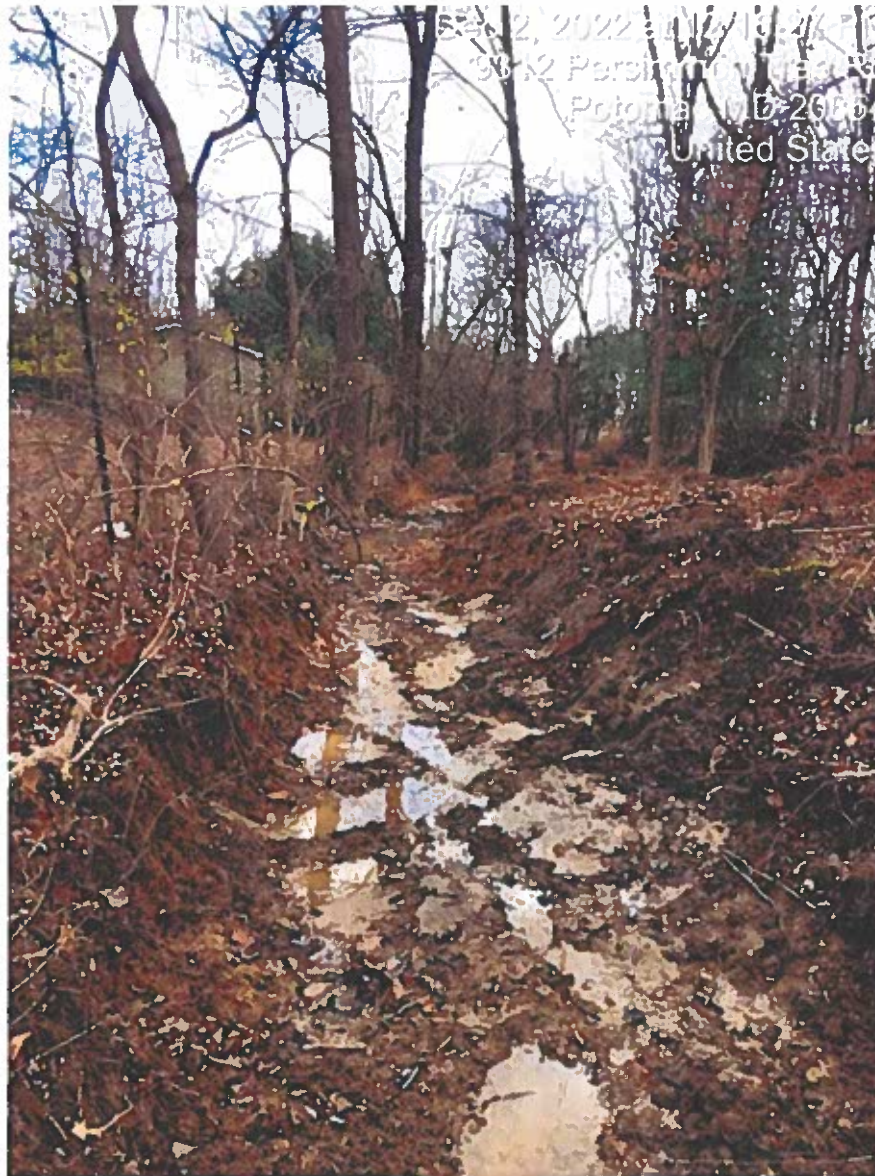
Figure 1. DPS Photo During Pipe Installation

Additionally, pictures from the DPS staff site visit on December 2, 2022, showed water ponding/accumulation in the channel being trenched (Figure 1). The National Weather Service records (Table 2) for the area show zero precipitation in the two days before the DPS site visit (and no more than 0.25 inches of precipitation in the 24 hours starting 4 hours before the site visit). This suggests that the work being executed found seeps, springs, or wetland areas that

were disturbed within the stream bed channel during the construction, causing the water to emerge from the ground. These features are currently observed on the adjacent property at 9306 Persimmon Tree Road. This evidence supports the determination that before the pipes were installed on the Property, there was a stream meeting the definition of “intermittent stream,” as provided in the Environmental Guidelines.

We've also reviewed the photos that were taken by the DPS inspector on December 2, 2022 shortly after a channel was excavated within the drainage to prepare it for pipe installation. We understand that it rained within 48 hours prior the inspectors site visit. Standing water is seen in the excavated channel and we understand that the County had found a water table within 3ft. There is however no strong evidence in these photos of stream characteristics typically found in intermittent or perennial streams. The photos and any measured depth to water table should also not be considered in the stream determination as the site was in the process of construction and excavated below the original ground elevation.

- 6) **The Director's letter references a photo taken by a DPS inspector on Dec 2, 2022, and states "water ponding/accumulation in the channel being trenched" suggests that "the work being executed found seeps, springs, or wetland areas that were disturbed within the stream bed channel during the construction, causing the water to emerge from the ground" since "the National Weather Service records for the area show zero precipitation in the two days before the DPS site visit". The letter also states that there was "no more than 0.25 inches of precipitation in the 24 hours starting 4 hours before the site visit". A presentation made by the Staff on Feb 8, 2024, had also referenced the picture and commented "potentially, they found water table within 3 ft deep".**

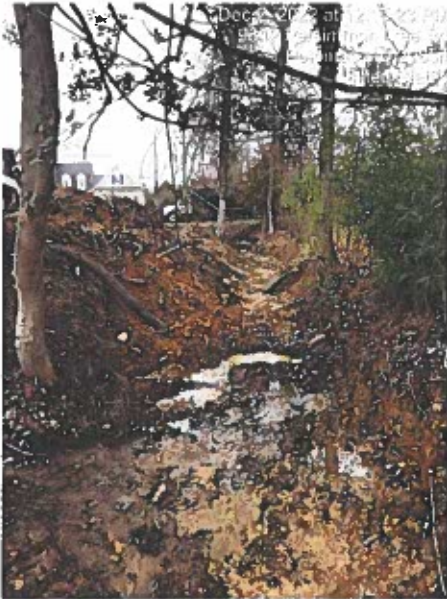
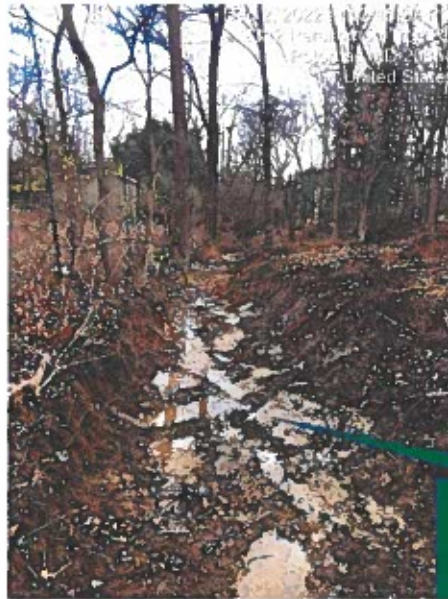
During the installation of the piping, there was some over-disturbance observed, which led to a violation of the Department of Permitting Services (DPS) regulations.

"The soil from the excavation was thrown onto the main property and **some trees were observed to be removed**. Work was **beyond our requirements**, so I issued an NOV and directed to obtain a permit". Inspector III CESSWI (DPS)

"SLDA application (SC 288894) was modified to include only the work on the smaller parcel, and we issued that **approval without forest conservation**". Manager (DPS)

Potentially, they found water table within 3 ft deep

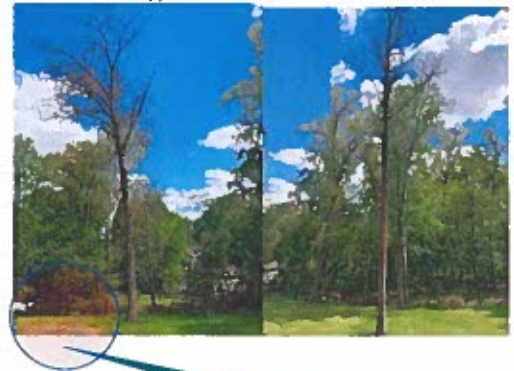
Trees were killed due to their proximity to the piping installation and grading.

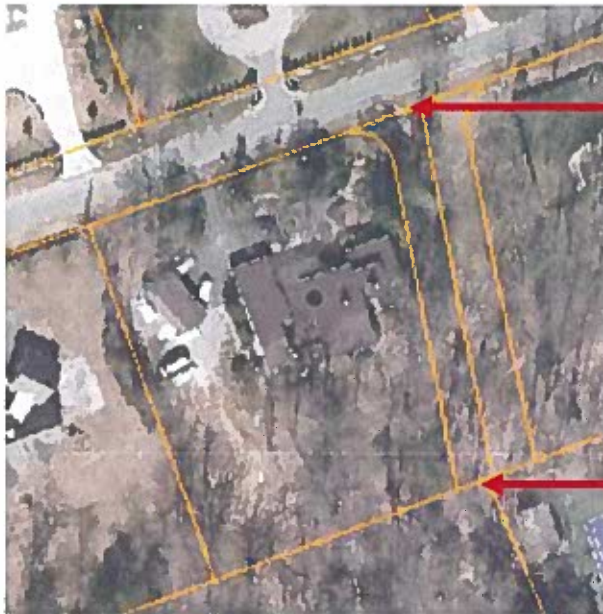
The Maryland Department of the Environment (MDE) visited the above site on December 21, 2023 and January 5, 2024 to determine whether any state regulated waters are present within the area of proposed subdivision. A culvert which appears to carry only stormwater runs under Newhall Road onto the property. There is a small depression where an additional drainage pipe enters. Flow from the culvert and drainage pipe enter another drainage pipe which runs the remaining length of the property. A small amount of flow was present on December 21. A review of precipitation records indicated that there had been rainfall during the days leading up to this visit. A subsequent visit on January 5 confirmed that there was no flow from the drainage pipe, therefore indicating that the flow seen on December 21 was likely due to precipitation rather than groundwater influence. Based on these observed field conditions, MDE does not consider the drainage pipe a Water of the State. See sketch on Page 2. It was determined that no authorization is required from the Department's Waterway Construction Division for work within the property since no regulated resources are present.

Approximate location  
of storm drain culvert  
outfall

Approximate location of drainage  
pipe outfall into stormwater only  
drainage feature (non-  
jurisdictional for MDE)

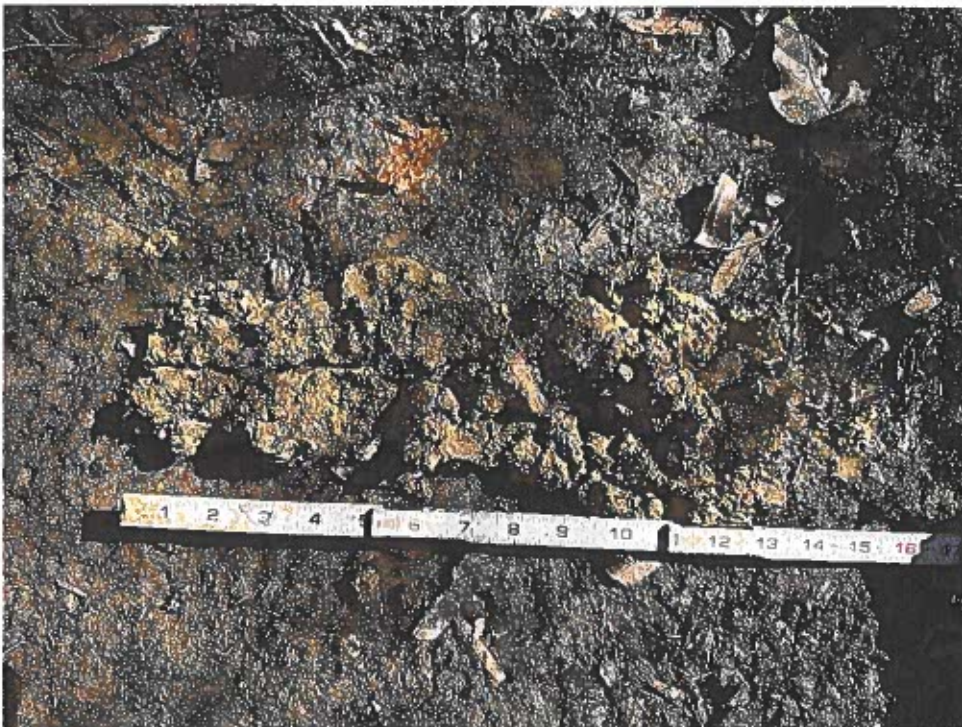
below the outfall pipes. One soil boring was taken in the headcut to a depth of 13 inches to determine if hydric soils were present. The boring revealed that approximately 80% of the soil profile is comprised of high chroma colors (10YR 4/6, 10YR 5/4, and 7.5YR 4/6) and would be classified as non-hydric (Exhibit 2, Photograph 6).

**6. View of non-hydric soil profile obtained from dry ephemeral channel (03/20/2024).**

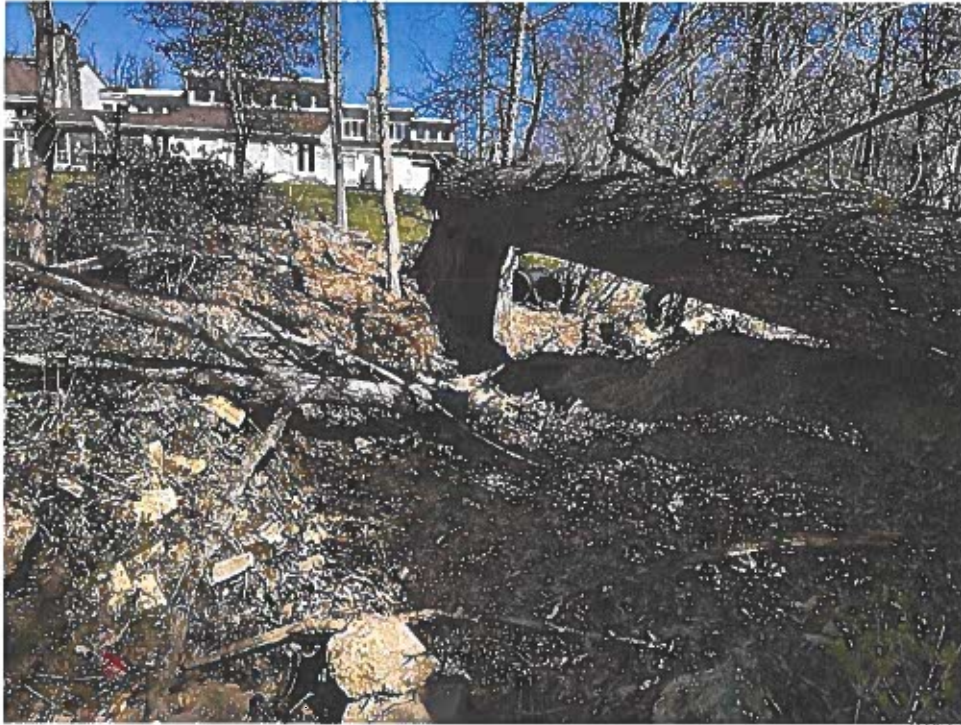
**7. Upper half of dry ephemeral channel looking towards twin outfall pipes (03/20/2024).**

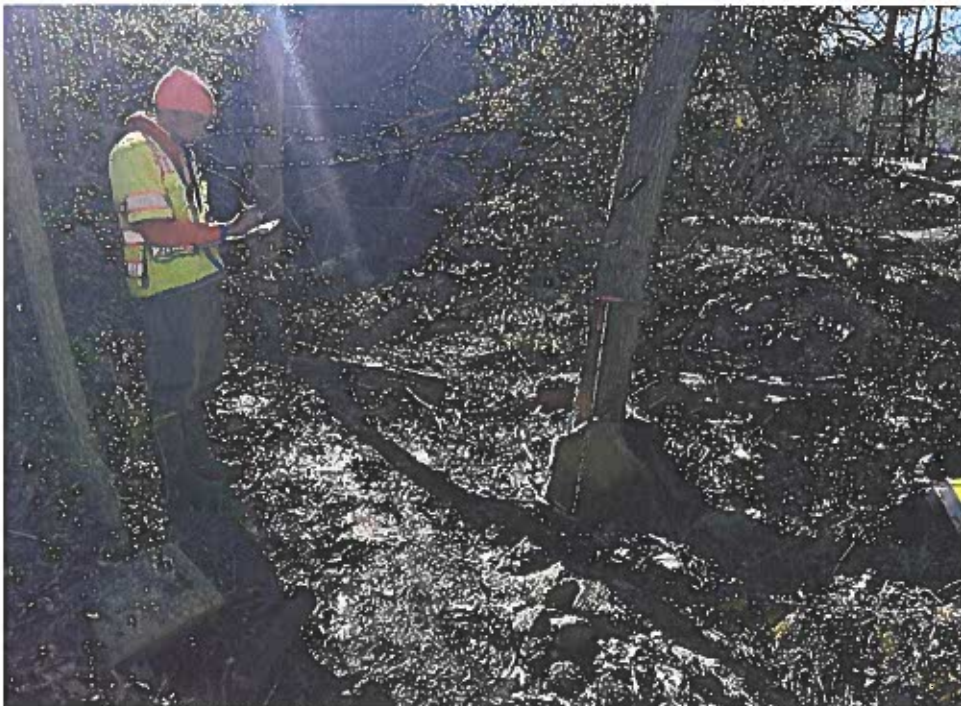
**8. Lower half of dry ephemeral channel looking downslope (Note: channel lacks clear bed and bank, depositional bars/benches, and active/relic floodplain) (03/20/2024).**

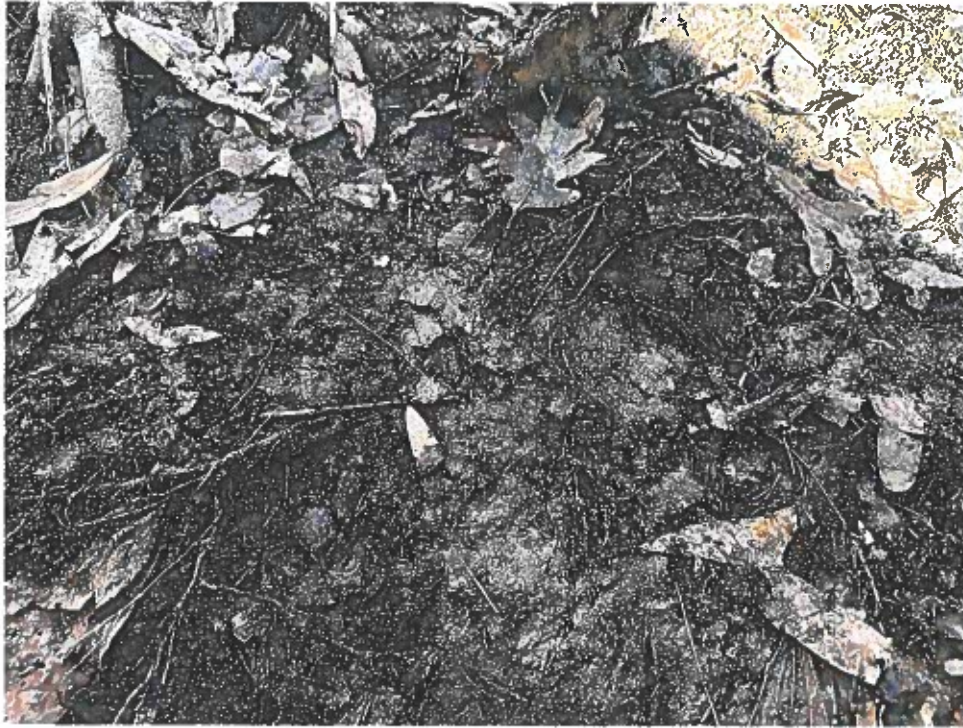
**9. View of fibrous roots in bed of dry ephemeral channel (03/20/2024).**

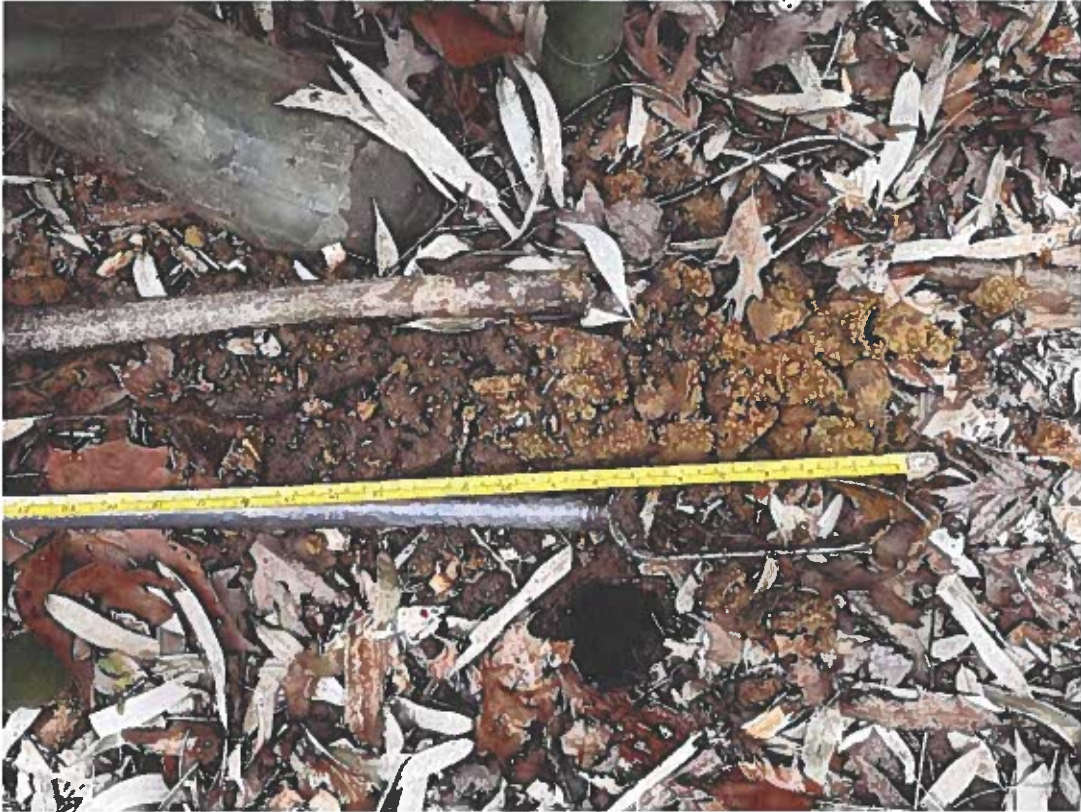
**Photo 9:** Reach B soil profile outside of stream (0" - 15")

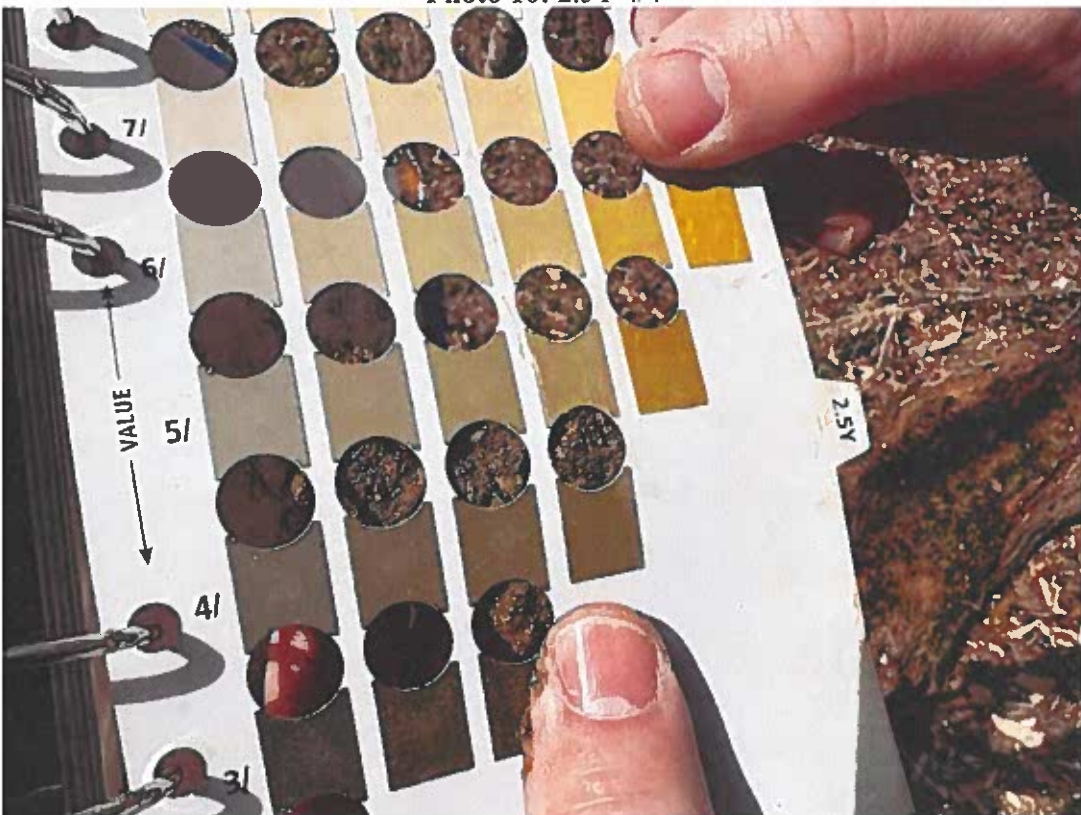
**Photo 11:** Reach B soil color along thalweg (2.5Y 5/4)

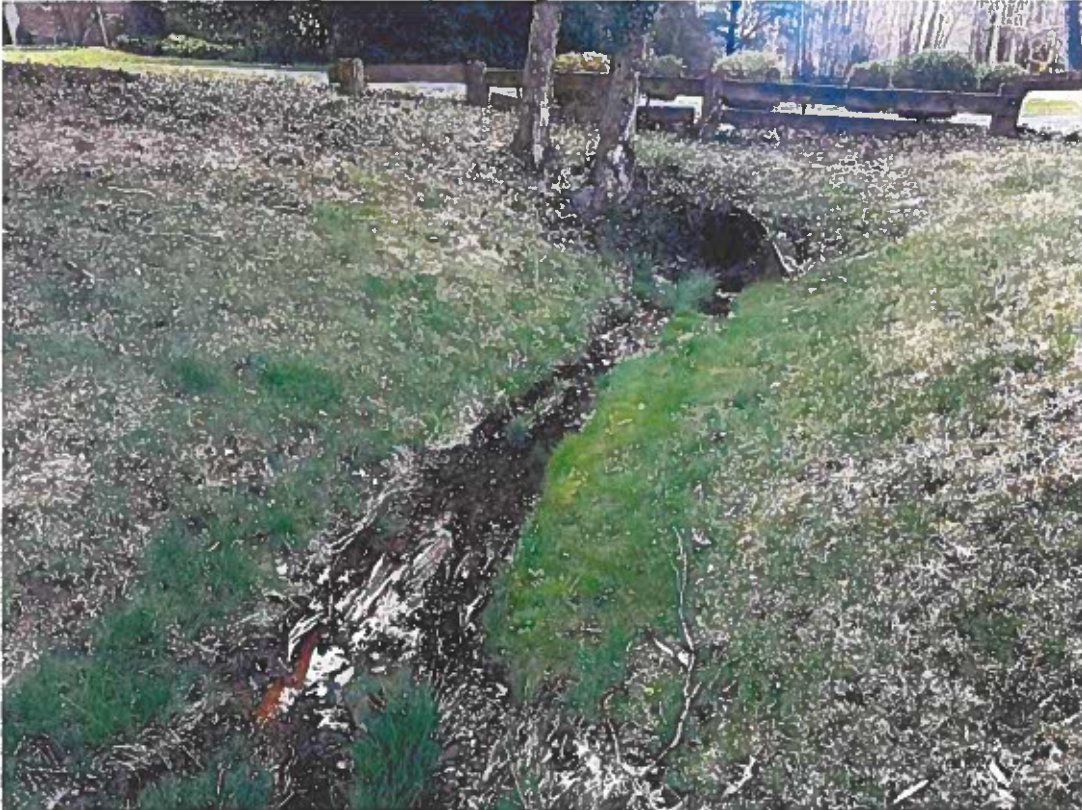
**Photo 16: Feature A (Logan Drive) – Facing South | Potential Intermittent Start Point**

attached photos 13-14) and down and along Moultrie Parkway (see attached photos 16-19) . Bob and Josh later also visited the section of the unnamed tributary at the Avenel Farm Drive crossing (see attached photos 20 & 21). S&EC confirmed that the only potential stream within 200' of Mr. Shirazi's properties exists from the outlet end of the recently installed pipes onto the triangle shaped property to the south. This potential stream continues south beyond 200' from Mr. Shirazi's properties where it eventually partially enters and partially flows over clogged/damaged pipes located between 9805 and 9901 Logan Drive downstream.

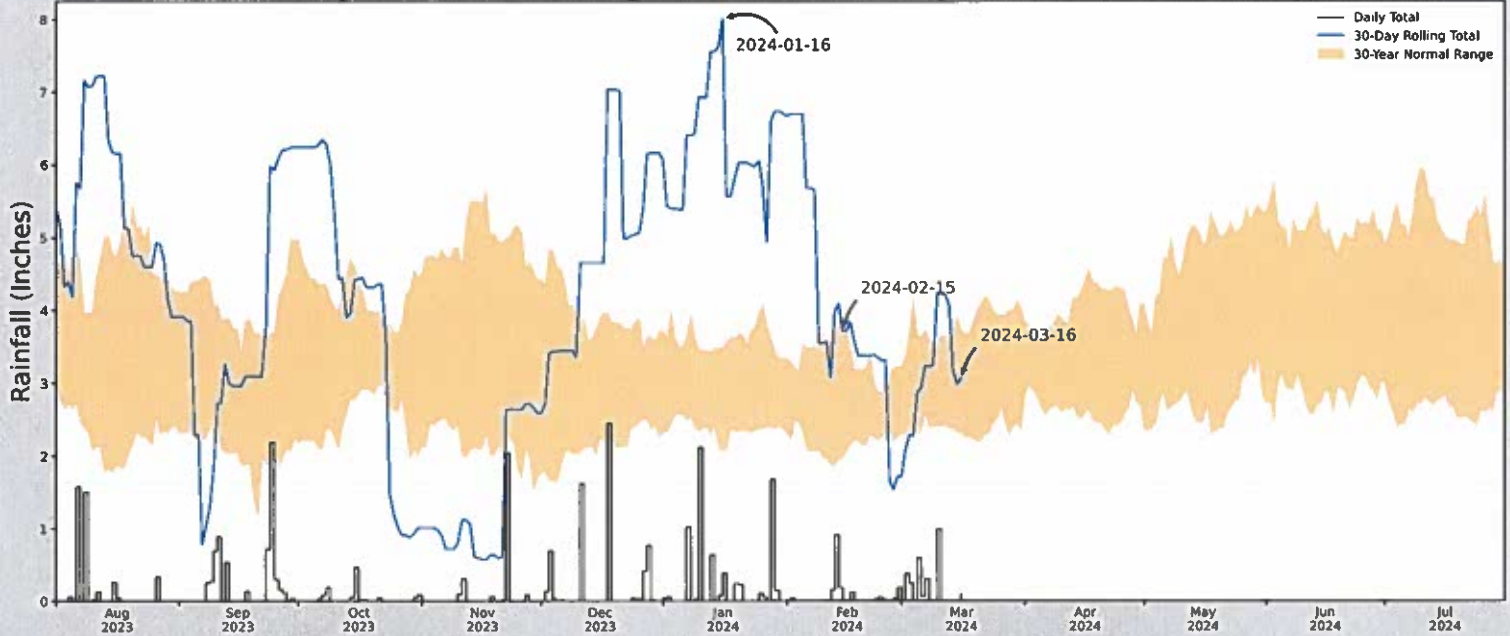
# Antecedent Precipitation vs Normal Range based on NOAA's Daily Global Historical Climatology Network

Coordinates	39.009172, -77.202564
Observation Date	2024-03-16
Elevation (ft)	355.68
Drought Index (PDSI)	Mild wetness (2024-02)
WebWIMP H <sub>2</sub> O Balance	Wet Season

30 Days Ending	30 <sup>th</sup> Mile (in)	70 <sup>th</sup> Mile (in)	Observed (in)	Wetness Condition	Condition Value	Month Weight	Product
2024-03-16	2.322047	3.718504	3.059055	Normal	2	3	6
2024-02-15	1.963386	3.85748	3.708662	Normal	2	2	4
2024-01-16	2.083465	3.477953	8.007874	Wet	3	1	3
Result							Normal Conditions - 13

No measurable rainfall had occurred within 48 hours of our onsite determination. We generated a U.S. Army Corps of Engineers (USACE) Antecedent Precipitation vs Normal Range report, also known as the Antecedent Precipitation Tool (APT), (attached) prior to our onsite determination. The result was that “Normal Conditions” existed at the time of our onsite determination. The previous 30 days wetness conditions were identified as “Wet”, but the prior 60 days were identified as “Normal”.

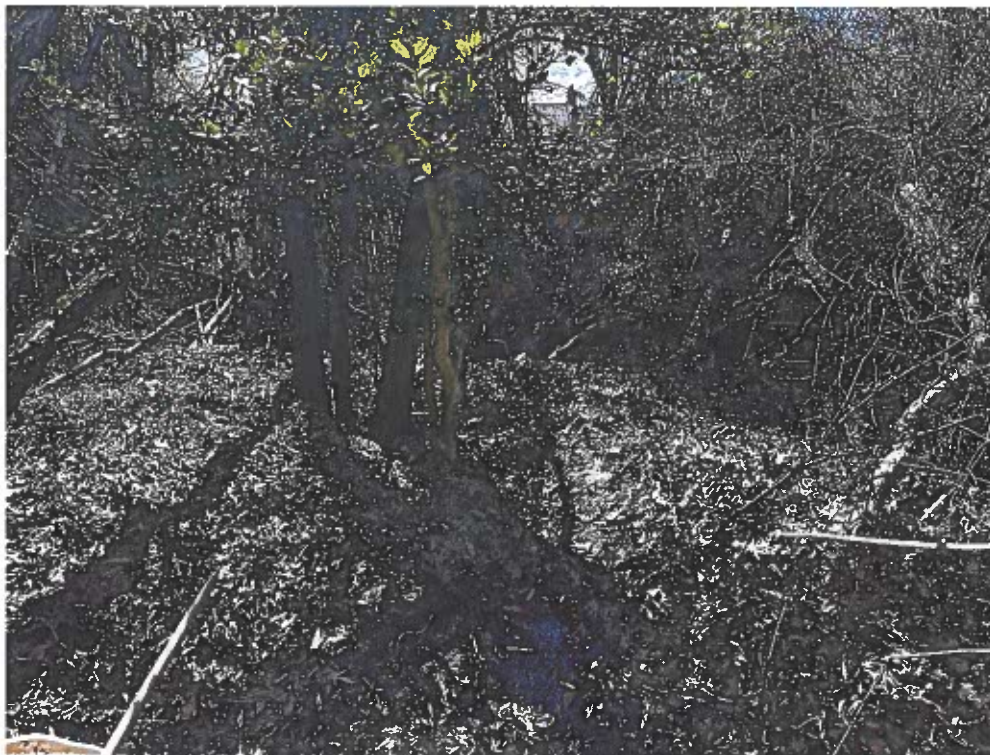
WSSI and S&EC have rated the continuity of banks and bed as weak, and the presence of in-channel structure to include riffles and pools as weak and absent in Reach A, respectively. Figure through Figure clearly illustrate the evolution of the stream from Reach A just south of the Property to Avanel Farm Drive that was taken during S&EC’s visit on March 20, 2024.

Figure 1- Reach A – No well-defined channel, riffles or pools.

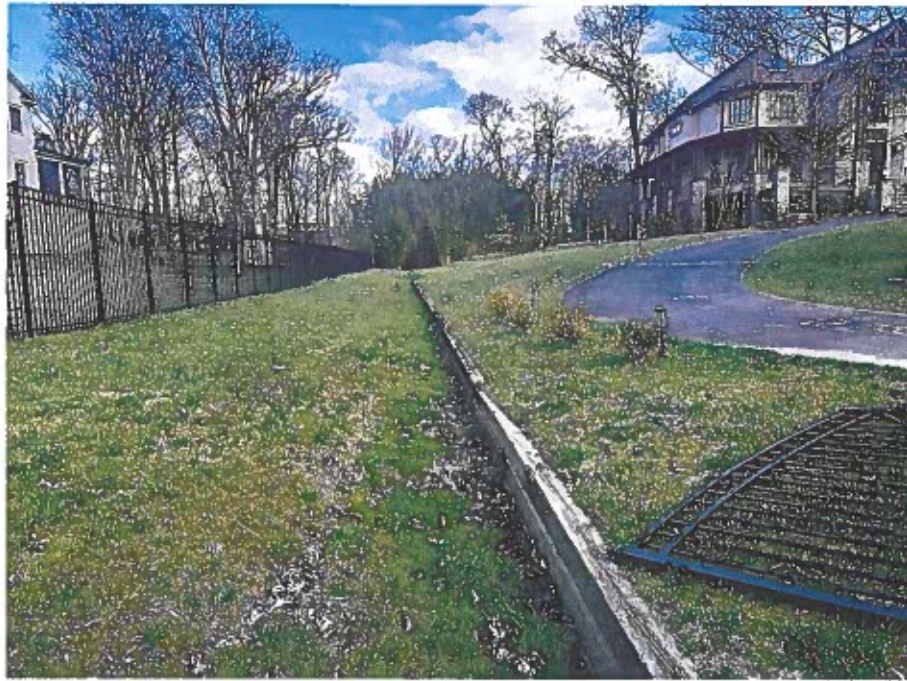
Figure 2- Downstream just north of Logan Drive – Piped; No well-defined channel, riffle or pools.

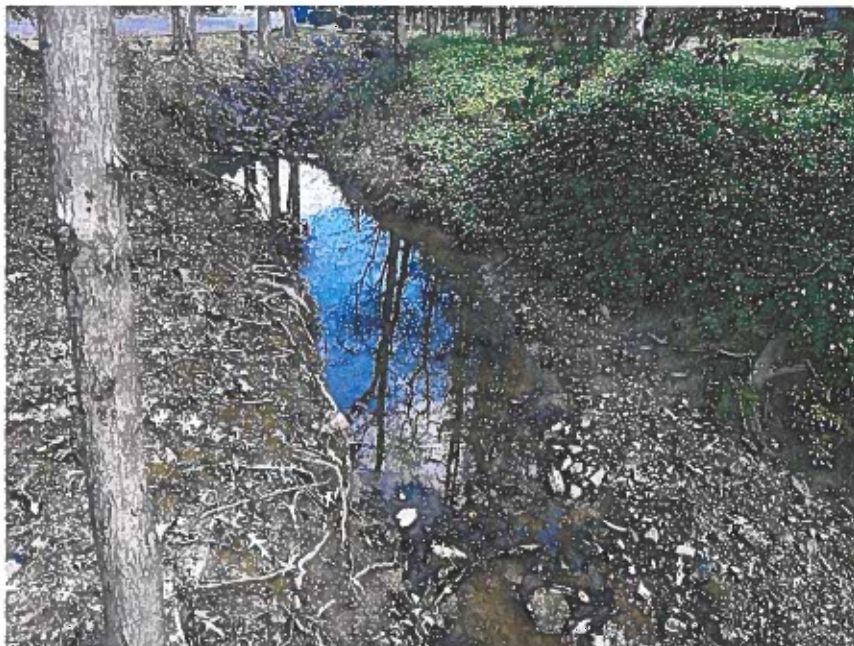
Figure 3- Downstream along Moultrie Parkway – Well-defined channel, riffles & pools.

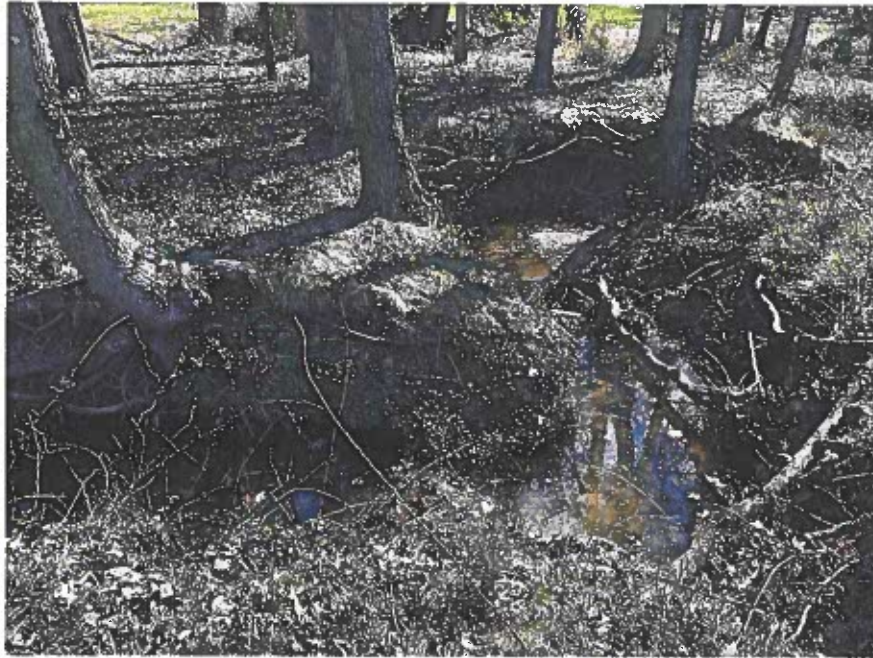
Figure 4- Downstream below Avenel Farm Drive – Well-defined channel, riffles & pools, and strong sinuosity.

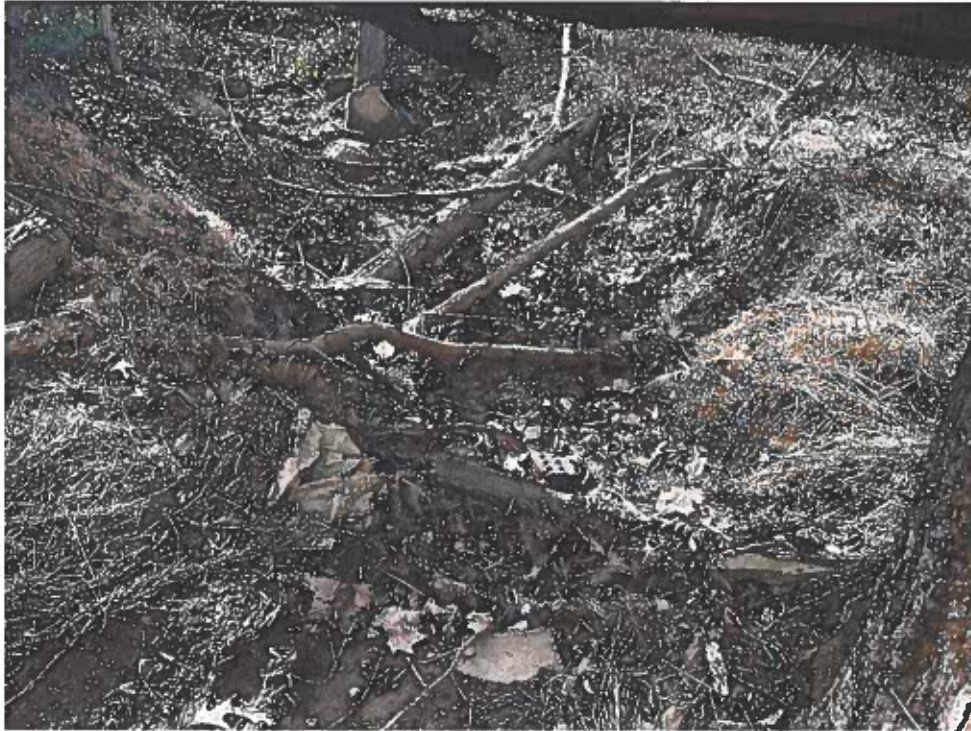
The Director's letter does not qualify Staff's assessment of the sediments, nor does it present any evidence for the assessment. Since it is impossible to qualify the sediments using the shared video or the DPS pictures, it is inferred that Staff may have assessed sediments along the undisturbed areas on the neighboring property. WSSI and S&EC have both assessed the sediments to be poorly sorted in Reach A. Figure 5- Reach A Streambed – Weak to no sediment sorting; also note amount of leaves. Figures 5 through 7, taken by S&EC during their site visit, differentiates the characteristic of the stream starting from Reach A through Avel Farm Drive.

*Figure 5- Reach A Streambed – Weak to no sediment sorting; also note amount of leaves.*

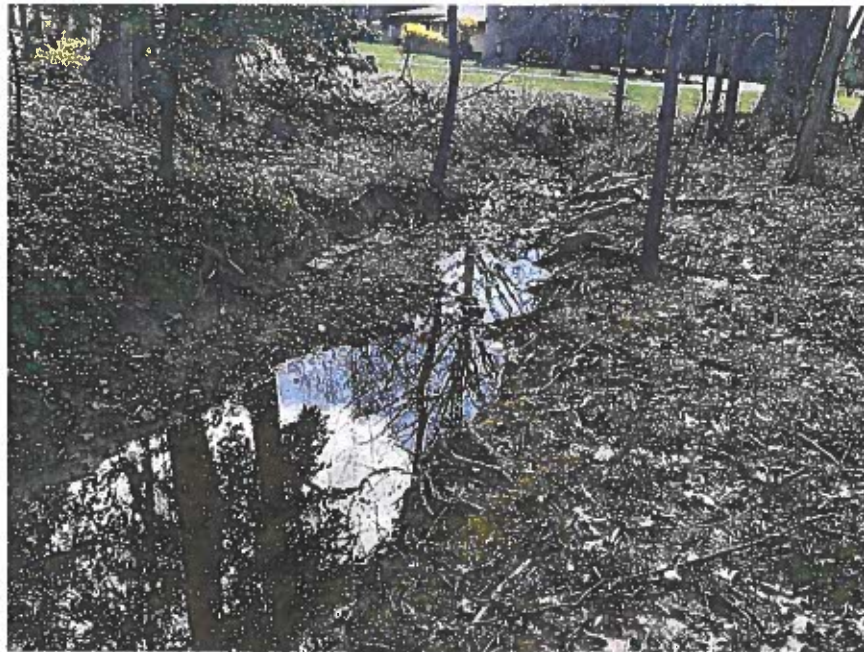
*Figure 6- Downstream along Moultrie Parkway – Streambed; strong sediment sorting, riffles & pools, no leaves.*

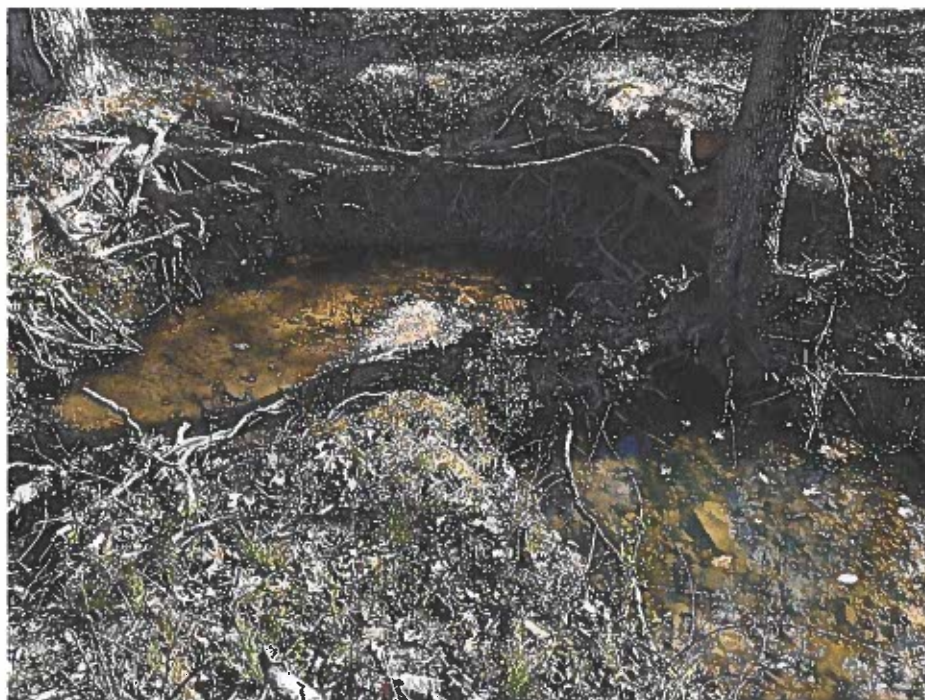
*Figure 7- Downstream south of Avenel Farm Drive – Streambed; very strong sediment sorting, riffles & pools, point-bar formation inside bend.*
