# APPEAL OF PERSIMMON TREE SUBDIVISION NATURAL RESOURCES INVENTORY/ FOREST STAND DELINEATION NO. 420240850

Staff Response to the Appeal of Denial of Natural Resources Inventory/Forest Stand Delineation No. 420240850 for Persimmon Tree Subdivision.

Montgomeryplanning.org Persimmon Tree Subdivision, Appeal of NRI/FSD No. 420240850

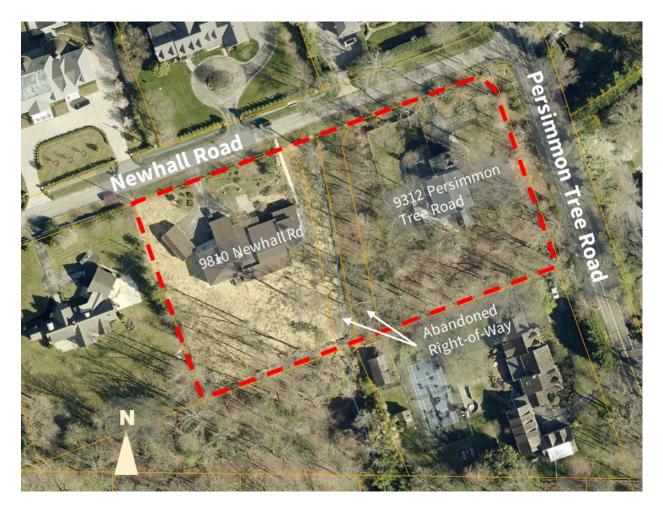
*Figure 1. Property of NRI/FSD No. 420240850 outlined in red*

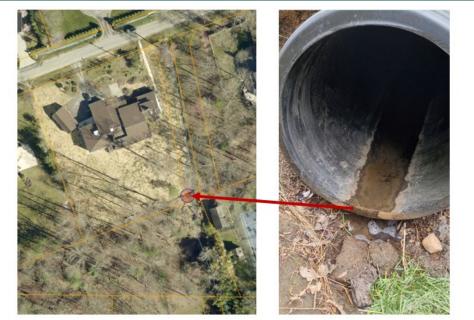
Figure 3. Baseflow (Field Visit by Planning Staff on April 25, 2024)

Baseflows: Observed baseflows within the channel indicate the presence of flowing water at least once per year. This suggests a sustained source of water feeding the channel (Figure 3) Field Visit by Planning Staff on April 25, 2024.

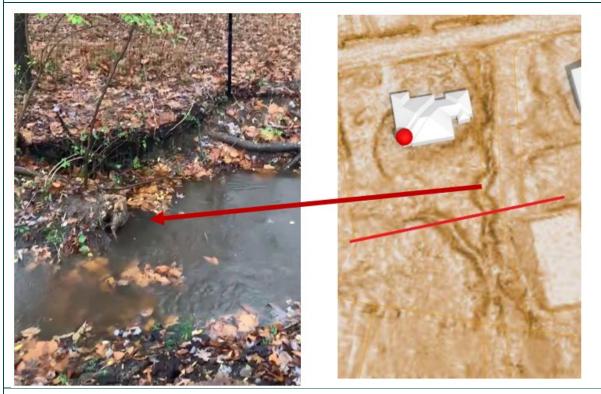
Figure 6. Fluctuating High-Water Marks

4. Fluctuating High-Water Marks: Evidence of fluctuating water levels is present, as indicated by sediment-stained leaves, blackened or decaying leaf litter, bare ground along the banks, and vegetation drift lines. These features suggest periodic inundation by the stream (Figure 6)

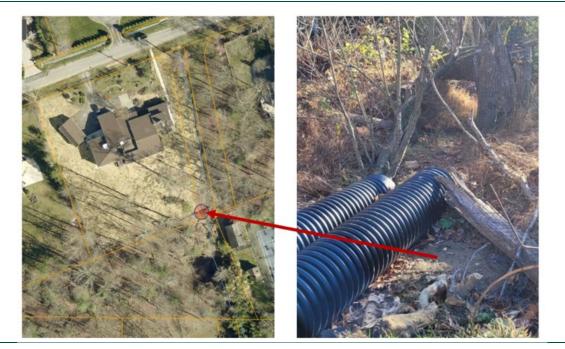
Figure 7. Evidence of Scouring

5. Evidence of Scouring: Signs of soil and debris movement (scouring) within the channel were observed. This indicates the erosive power of flowing water (Figure 7)

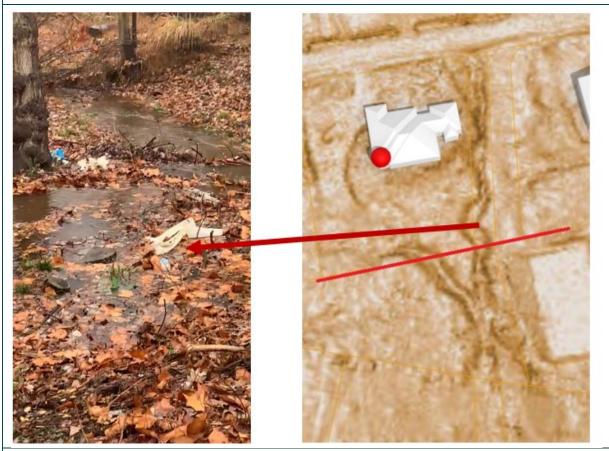
Figure 8. Transient Leaf Litter

6. Transient Leaf Litter: Leaf litter within the channel appears to be transient or temporary, suggesting periodic flushing by stream flows (Figure 8)

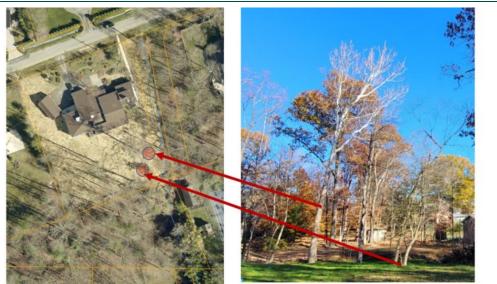
Figure 9. Wetland or Hydrophytic Vegetation

7. Potential Wetland or Hydrophytic Vegetation: The presence of wetland or hydrophytic (waterloving) vegetation further supports the identification of a stream (Figure 9)

During the review process of the NRI/FSD, Planning staff noted the key physical features to properly identify the intermittent stream include sinuosity (Figure 4), well-defined banks (Figure 5), deposits, sediments, debris, the presence of wetland vegetation (Figure 9), soil, and hydric indicators (Figure 10). When evaluating channels to determine whether they are ephemeral or intermittent, staff uses a number of criteria to make a technical decision. These criteria include sediment sorting, channel characteristics, and vegetative clues. Planning staff provided a PowerPoint presentation (Attachment E), which was subsequently shared with the meeting participants and included photographs and videos from the property supporting their determination. The photographs, videos, and Staff observations from the property demonstrate that prior to the disturbance (i.e., the installation of two pipes), the stream and its banks were well-defined.

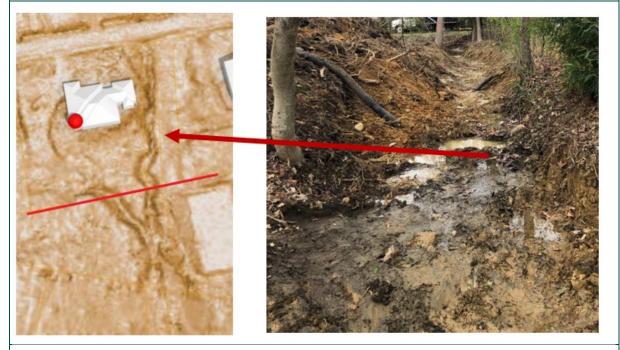
# Figure 10. Hydric Soil Indicators

8. Hydric Soil Indicators: Stream bank soils exhibit hydric indicators at or above the low flow conditions. Hydric soils are formed under conditions of saturation, flooding, or ponding, which is consistent with the presence of a stream (Figure 10).

Additionally, pictures from the DPS staff site visit on December 2, 2022, showed water ponding/accumulation in the channel being trenched (Figure 10. Hydric Soil Indicators). The National Weather Service records (Table 2. Precipitation Data, December 2022) for the area show zero precipitation in the two days before the DPS site visit (and no more than 0.25 inches of precipitation in the 24 hours starting 4 hours before the site visit). This suggests that the work being executed found seeps, springs, or wetland areas that were disturbed within the stream bed channel during the construction, causing the water to emerge from the ground. These features are currently observed on the adjacent property at 9306 Persimmon Tree Road. This evidence supports the

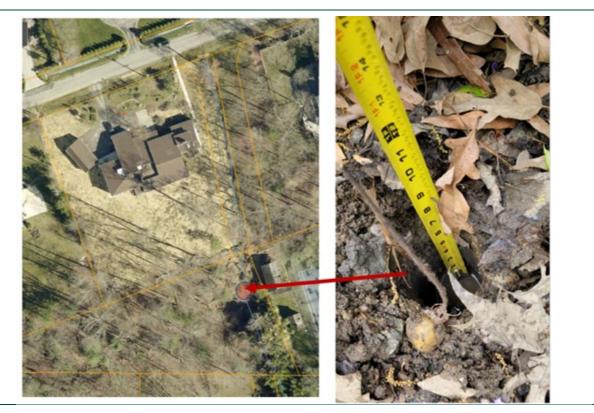
9. Underground Water Presence<sup>1</sup>: Physical presence is evidenced by saturated soil or water welling up from the ground (Figure 11).

*Figure 11. Underground Water Presence<sup>1</sup>: Water welling up from the ground (Field Visit by Planning Staff on April 25, 2024)*

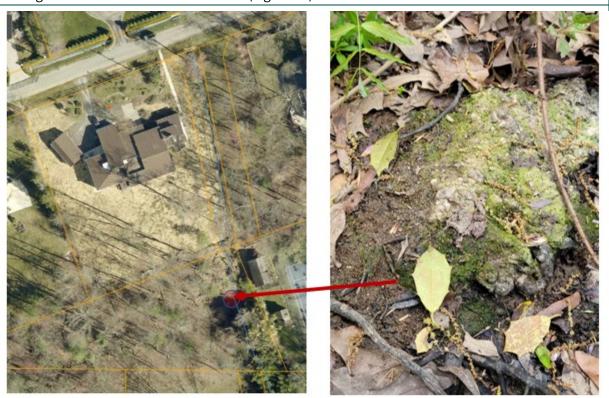
10. Algae-cover or Water-stained Rocks<sup>1</sup> (Figure 12).

*Figure 12. Algae-covered or Water-stained Rocks*<sup>1</sup> (*Field Visit by Planning Staff on April 25, 2024*)

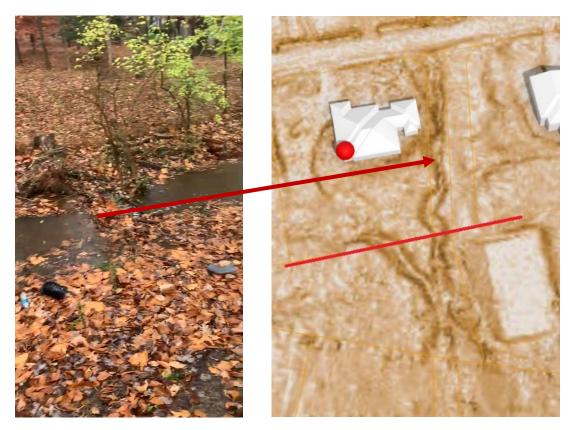
3. Well-Defined Channel Banks and Bed: The channel possesses clearly defined banks and bed, including riffles (shallow, fast-flowing sections) and pools (deeper, slower-moving sections). This morphology is characteristic of streams (Figure 5)

Figure 5. Well-Defined Channel Banks and Bed
