## MEMORANDUM

**RE:** **Randolph Hills Park Activity Building and Future Use Options**  
Pubic testimony will be taken

**Engineering Consulting Services**  
**Randolph Hills Recreation Building**  
**Westmoreland Hills Recreation Building**  
**Ken-Gar Palisades Recreation Building**

**FEA Project No.: R01.2006.004801**  
**December 11, 2007**

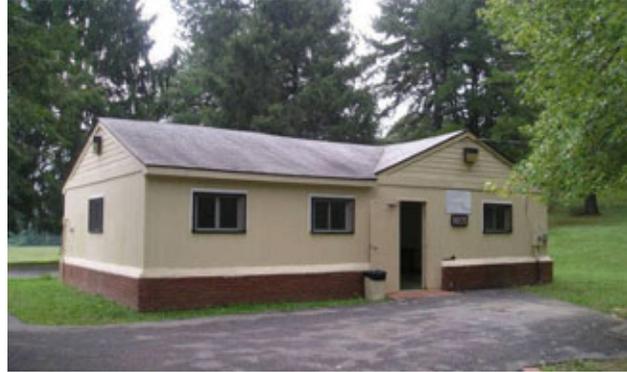
Figure A-1: Randolph Hills Recreation Building

"FEA observed severe structural deterioration due to water infiltration. The wooden sill plates and studs were in extremely poor condition, and high levels of moisture were found. There appeared to be potential microbial growth in the wall cavity as well as possible insect damage. Our assessment indicated the conditions observed were widespread and not isolated to the exploration locations."

"To correct the deficiencies noted, the recommended repairs would generally include removal of wall finishes, replacement of structural members, and abatement of hazardous materials. Also modification to roof framing components in order to meet current code requirements may be needed. Essentially, M\_NCPPC should expect overall removal, reframing and reconstruction of building wall components as well as a possible reconstruction of the foundation in order to restore the building. Based on the extent of deterioration, we recommend reconstruction rather than component repair."
