Sandy Spring Townhomes: Limited Site Plan Amendment No. 82016001B in Response to a Violation

Staff Report Date: 1/17/20

Limited Site Plan Amendment No. 82016001B:
Request to modify the layout of the turnaround plaza with associated seating and pergolas, modify condition 7b to require a 5'-0" sidewalk, modify condition 8 to update lot numbers that require special treatment and allow beaded vinyl siding at the end walls of highly visible facades, modify steel fencing details, modify the cap on brick piers; located on the south side of Olney Sandy Spring Road (MD Route 108) in between Norwood Road and Meeting House Road; 2.31 acres zoned CRN-0.75 C-0.25 R-0.75 H-45; *2015 Sandy Spring Rural Village Plan*.

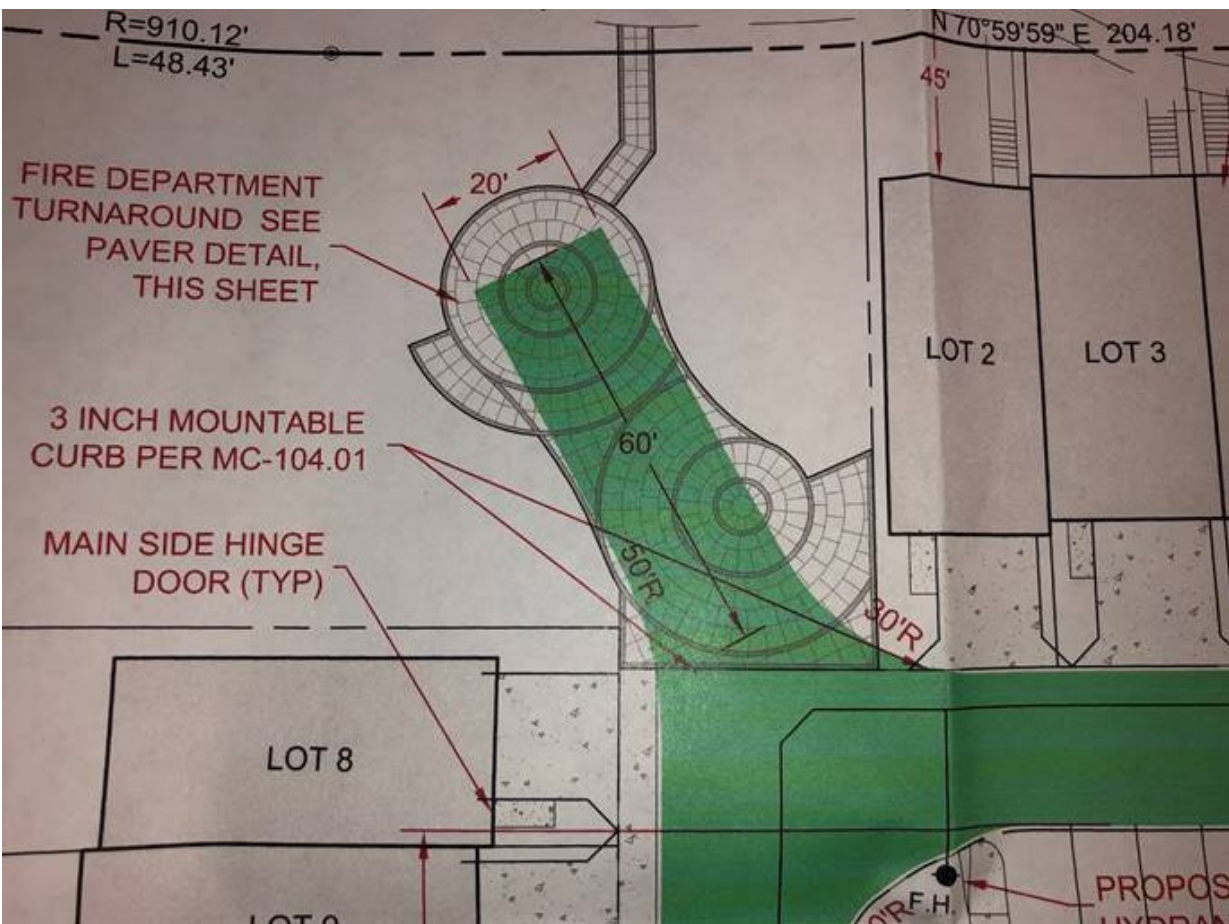
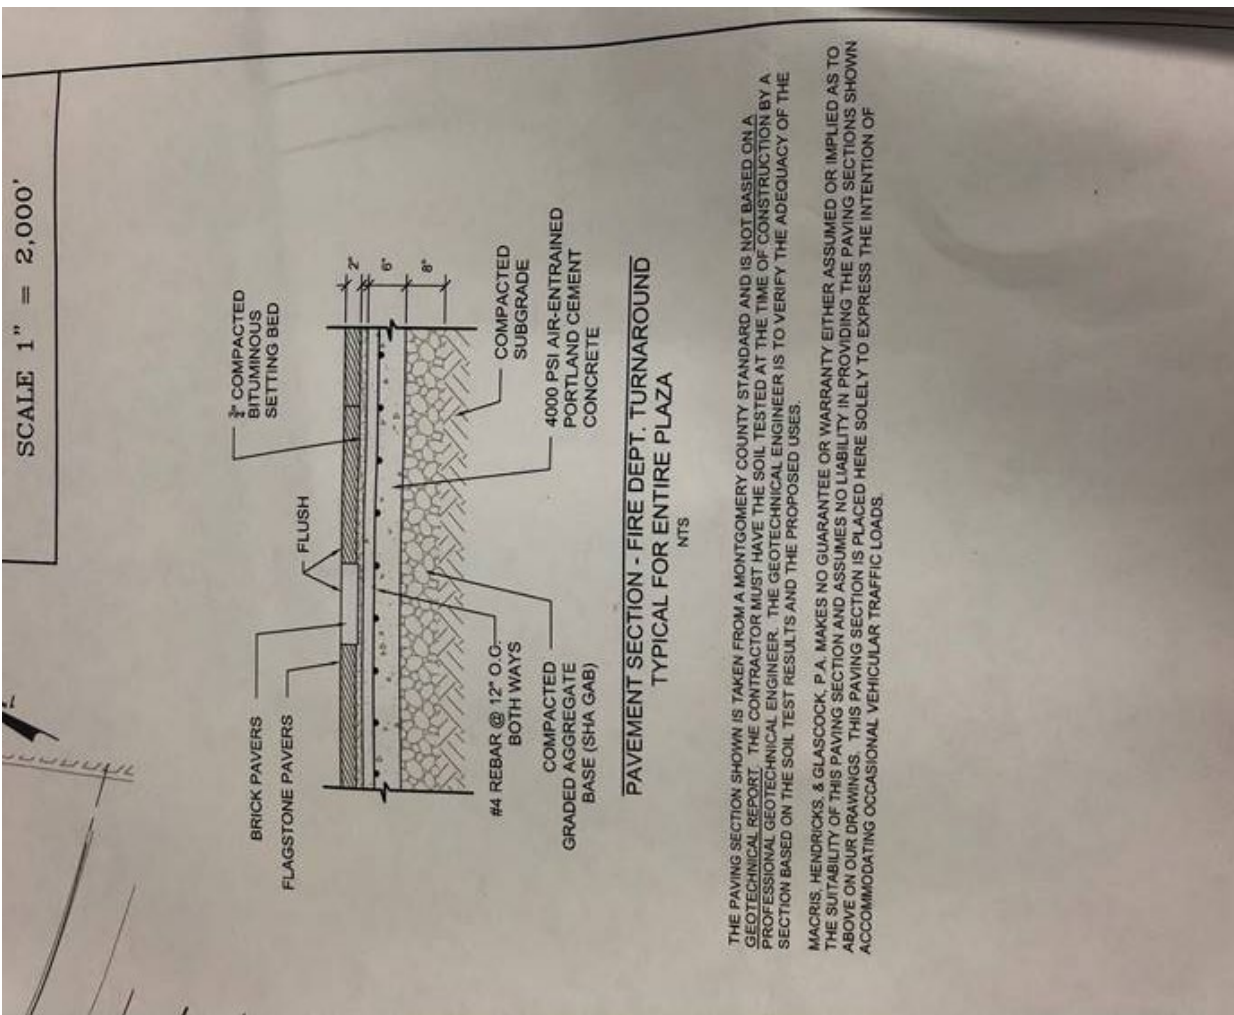
Below are the relevant details from the Feb 18, 2016 approved fire department access plan. As per Montgomery County Executive Regulation 8-16, everything in green (including the corner where Lot 2 meets the pedestrian plaza) is designated as fire department vehicular access and therefore must meet minimum load bearing requirements for either Montgomery County tertiary road standard or MCFRS apparatus, no less than 85 kips, whichever the applicant chooses to meet.

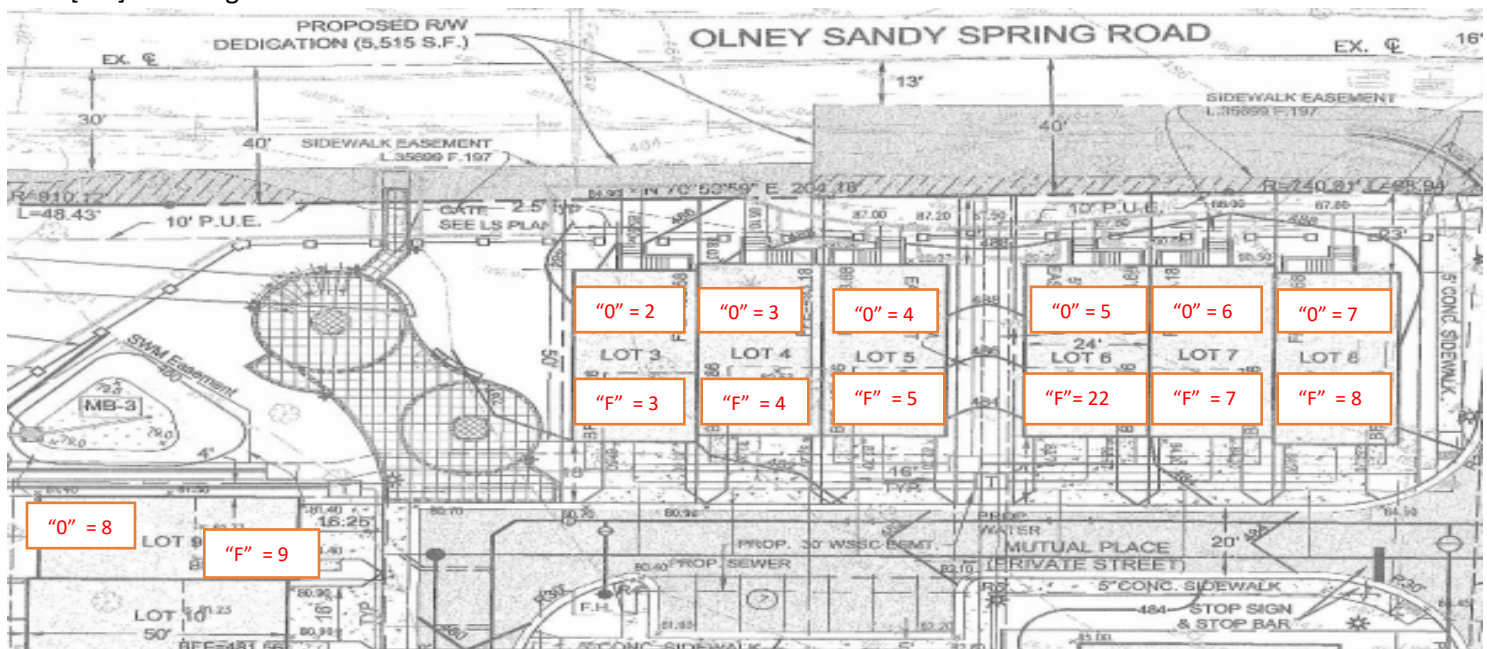
There are other requirements, but they all appear in compliance. The biggest discrepancy appears to be the use of vinyl siding in lieu of "hardy/cement plank siding". The following is the "A" Amendment Sheet C-1, with Original ["O"] & Final ["F"] Lot designations as indicated:

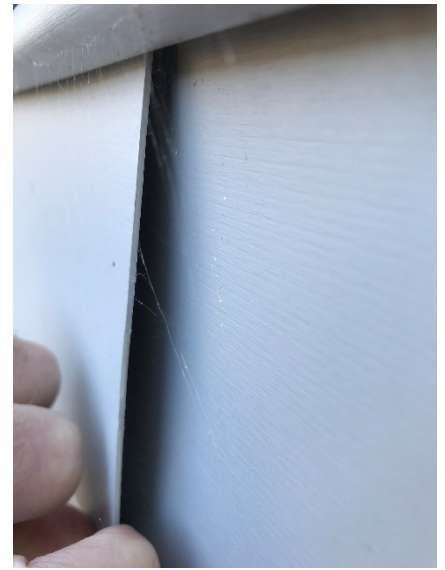
Front of Lot 8 (originally Lot 7)
1002 Olney Sandy Spring Road
Sandy Spring, MD 20860

Beaded vinyl siding on front of Lot3; NOTE: Typical for all 3 Lots where "hardy/ cement plank siding is required per Resolution.

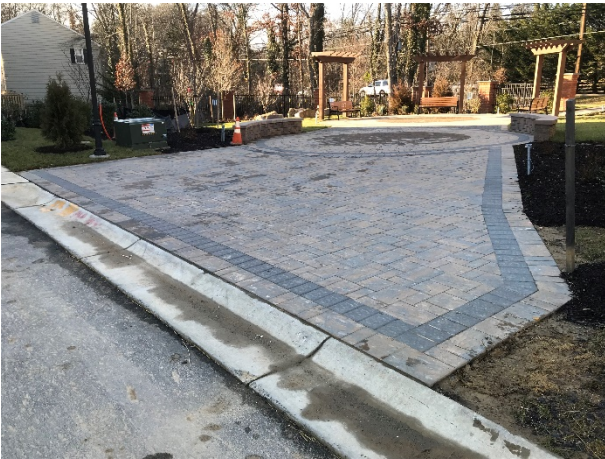
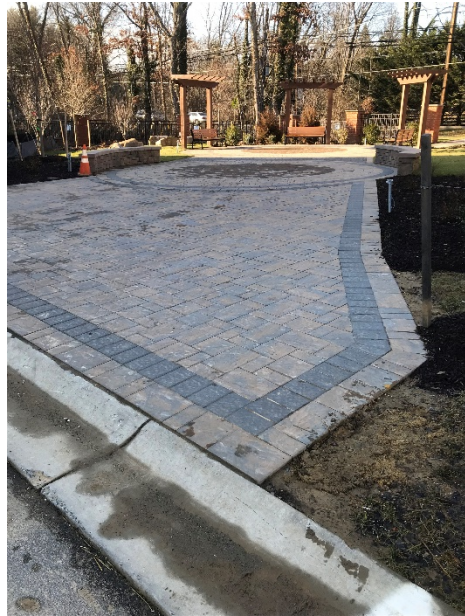
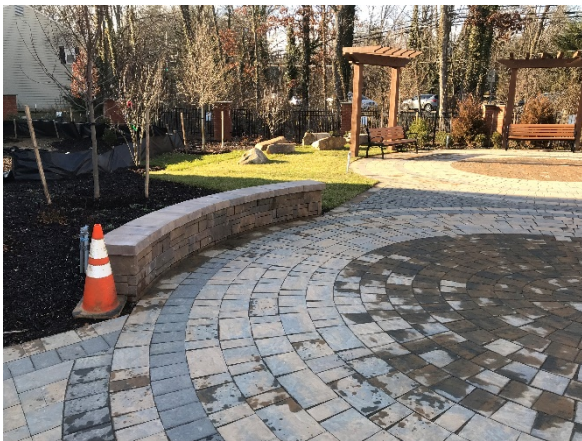
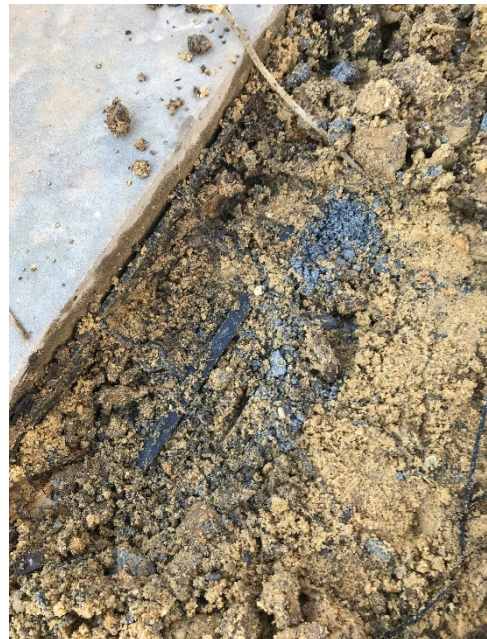
1. Changed emergency vehicle "turn-around plaza" area to typical pavers. This does not meet the stamped concrete requirement (changed to stamped concrete in 82016001A amendment). The installed pavers do not comply with CSP 820160010 in size or color (see details on Sheets L-3 & L-4, etc.) and concrete base (gravel and sand base installed). Refer to photos on pages 5 – 7.

The following photos show the open space/turn-around plaza area:

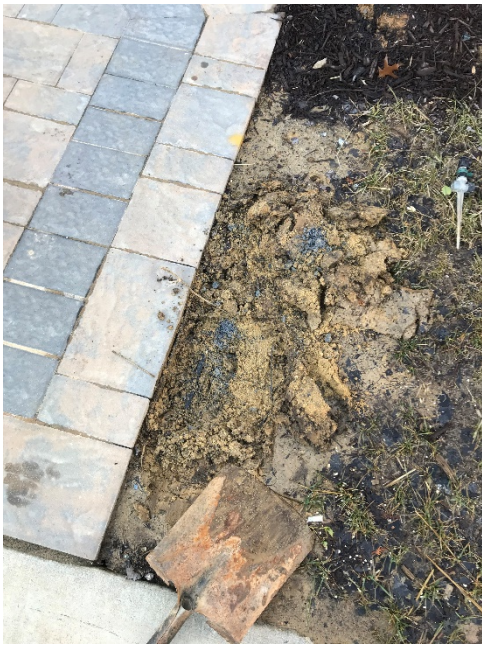
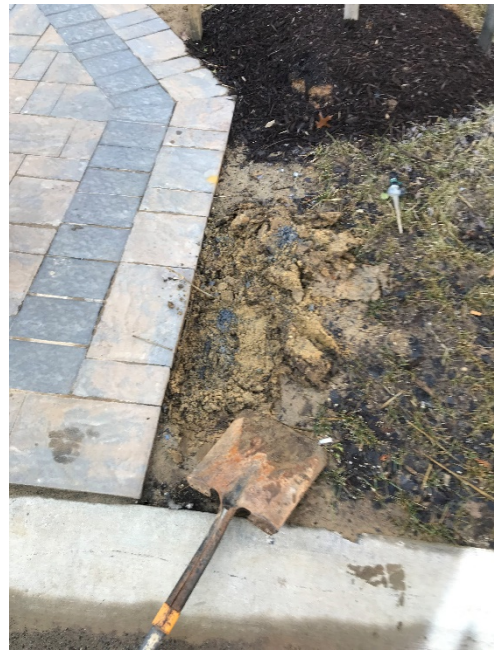
No evidence of required concrete base (Sheet L-4) – only CR6 base with sand setting bed
