Re: **Lot 21, Block 4, Edgemoor**
7611 Fairfax Road, Bethesda, MD 20814
Proposed Lots 23 – 24, Block 4, Edgemoor
Forest Conservation (Chapter 22A) Variance Request
MNCPPC # 620230060

Variance Justification

TREE VARIANCE EXHIBIT (APPENDIX A) - M-NCP&PC No. 620230060

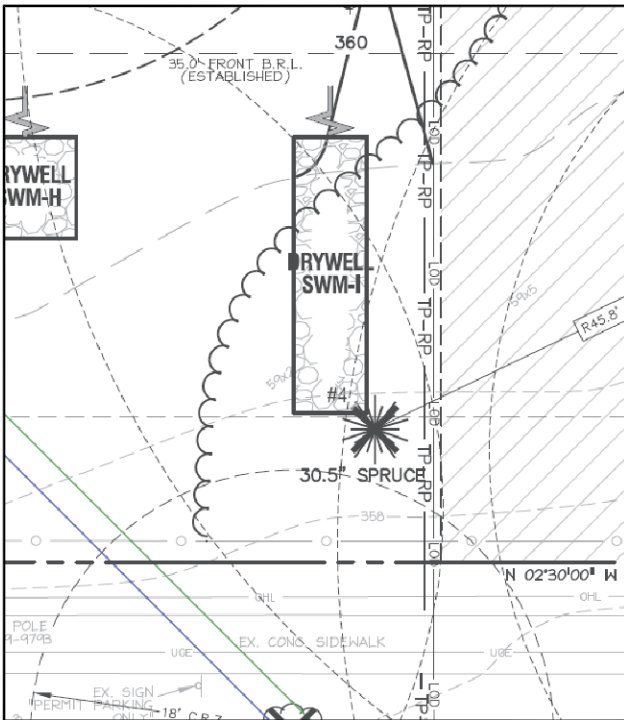
Appendix B: Arborist Tree Evaluation (Tree No. 4)

The susceptibility of norway spruce to construction damage can depend on a number of factors, such as the size and age of the trees, the proximity of the construction site, and the method of construction. Construction activities, such as excavation, grading, and the use of heavy machinery, can damage the roots and structures of nearby trees, leading to reduced growth, increased susceptibility to pests and diseases, and increased risk of failure. In some cases, construction can completely destroy trees and their root systems, leading to their death.

A visual "walk-around" evaluation was performed to determine the overall condition/health of the tree. As part of this evaluation we have determined that this tree is in good condition. Although, this tree may be in decline due to vine strangling (English Ivy). The severity of english ivy can be seen in the attached photograph. Slight deadwood was noted within the canopy, which is typical for this species, but the presence of strangling vines could also be contributing. We observed a twin stem at approximately 30-feet with included bark (with a potential seam). The included bark and seam is a weak point within the union which could be subject to failure. Due to this, we noted this tree to have a high probability of failure. Mitigation can be provided for the weak tree branch union and the english ivy can be trimmed from the tree. These measures would improve the trees likelihood of stability and longevity.

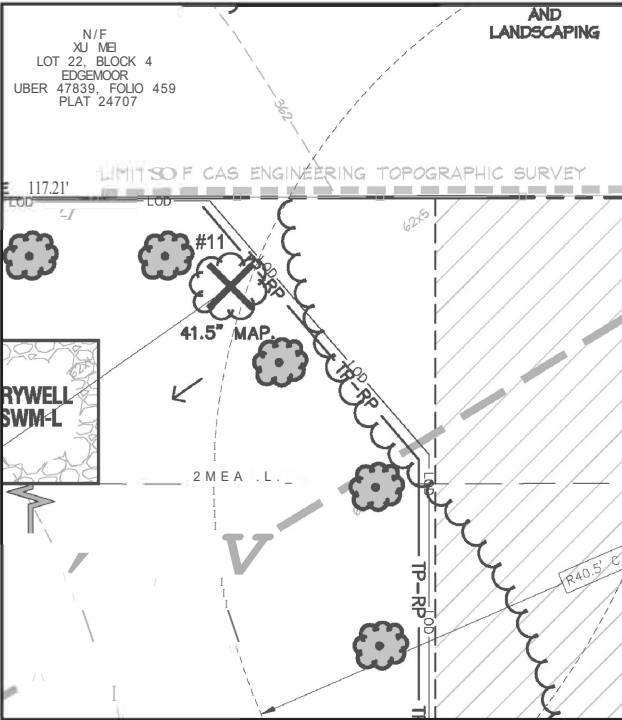
Appendix B: Arborist Tree Evaluation (Tree No. 11)

Silver maples (Acer saccharinum) are considered to be highly susceptible to failure. They are fast-growing trees with weak wood, which makes them prone to breaking and falling during storms or heavy winds. Additionally, silver maples have shallow roots that can easily be damaged by construction, erosion, or heavy machinery, further increasing the risk of failure. To minimize the risk of failure, it is recommended to plant silver maples in areas where they will have plenty of space to grow and away from buildings, sidewalks, and other structures that could be damaged in the event of a tree failure.

A visual "walk-around" evaluation was performed to determine the overall condition/health of the tree. As part of this evaluation we have determined that this tree is in poor condition due to decline, hollowing, and moderate defoliation (limb/caopy loss). Removal is recommended. We believe vine strangling (English Ivy) and species suscepability to decline/decay has contributed to the current condition. We observed significant decline, decay, hollowing (cavity and sounding), and dieback due to invasive vines. This tree has been classified as a hazard tree due to condition and proximity to an offsite structure (target).

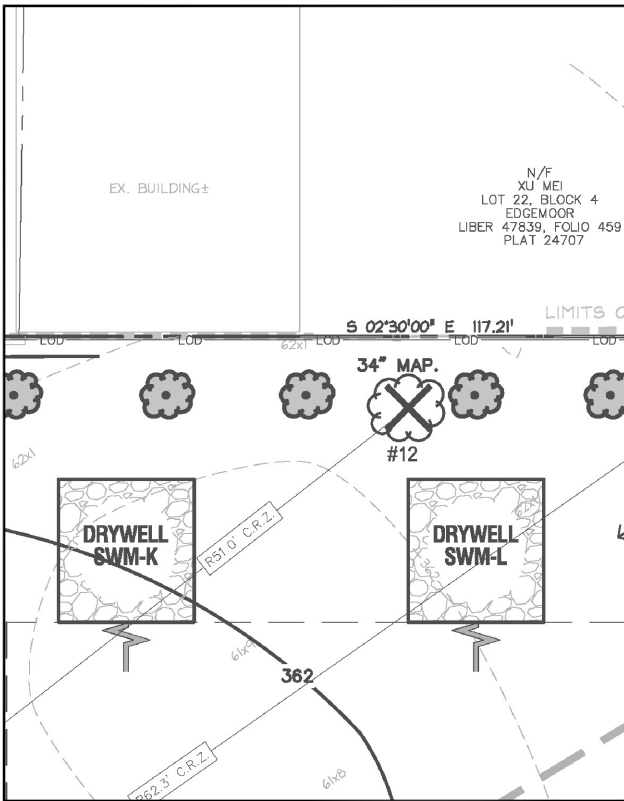
Appendix B: Arborist Tree Evaluation (Tree No. 12)

Silver maples (*Acer saccharinum*) are considered to be highly susceptible to failure. They are fast-growing trees with weak wood, which makes them prone to breaking and falling during storms or heavy winds. Additionally, silver maples have shallow roots that can easily be damaged by construction, erosion, or heavy machinery, further increasing the risk of failure. To minimize the risk of failure, it is recommended to plant silver maples in areas where they will have plenty of space to grow and away from buildings, sidewalks, and other structures that could be damaged in the event of a tree failure.

A visual "walk-around" evaluation was performed to determine the overall condition/health of the tree. As part of this evaluation we have determined that this tree is in poor condition due to decline and defoliation (limb/caopy loss). Removal is recommended. We believe vine strangling (English Ivy) and species succpeability to decline/decay has contributed to the current condition. We observed significant decline, apparent internal decay, and a severe loss of canopy. This tree has been classified as a hazard tree due to condition and proximity to an offsite structure (target).

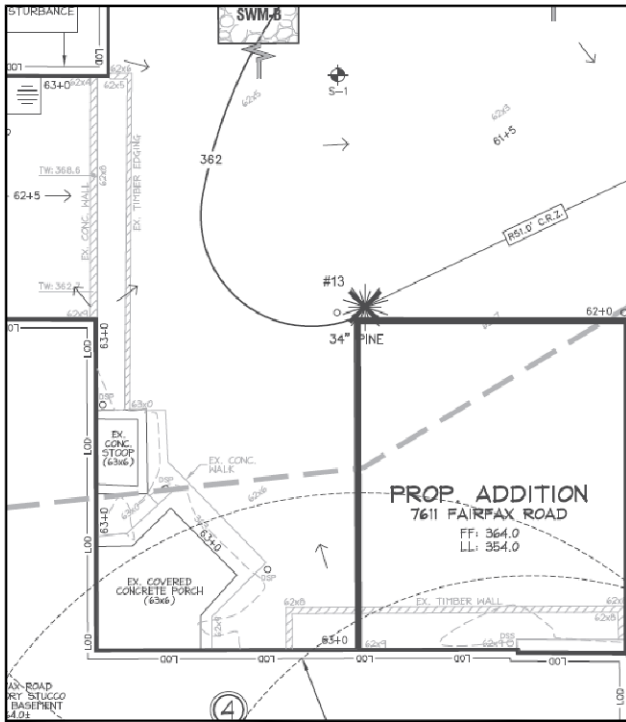
Appendix B: Arborist Tree Evaluation (Tree No. 13)

The susceptibility of shortleaf pines to construction damage can depend on a number of factors, such as the size and age of the trees, the proximity of the construction site, and the method of construction. Construction activities, such as excavation, grading, and the use of heavy machinery, can damage the roots and structures of nearby trees, leading to reduced growth, increased susceptibility to pests and diseases, and increased risk of failure. In some cases, construction can completely destroy trees and their root systems, leading to their death
