Hillandale Local Park, Preliminary Forest Conservation Plan, PP2015001

Description

- Preliminary Forest Conservation Plan associated with the Park Facility Plan for the complete renovation of Hillandale Local Park;
- 10615 New Hampshire Avenue, Silver Spring, Maryland;
- 23.35 acres zoned R-90 and C-O;
- 2014 White Oak Science Gateway Master Plan;
- Applicant: Montgomery County Department of Parks;
- Filing date: November 24, 2014.

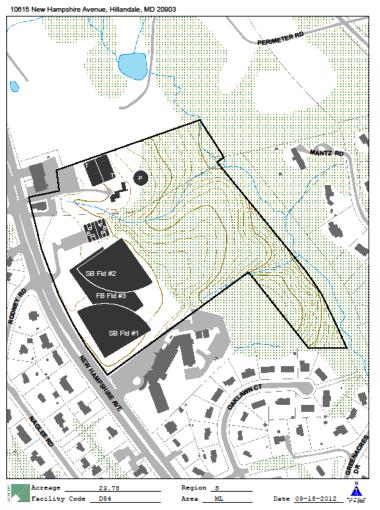
Figure 2: Park Map

The Hillandale Local Park is located in the eastern portion of Montgomery County at 10615 New Hampshire Avenue in White Oak adjacent to the Food and Drug Administration (FDA) consolidated Headquarters (Figure 1). The approximately 22.5 acre park consists of (Figure 2):

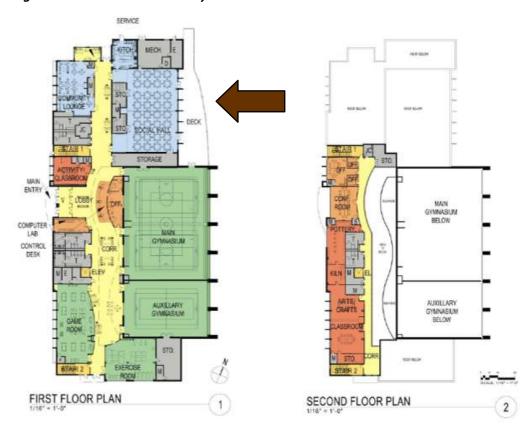
Figure 4: White Oak Community Recreation Center

The addition of the White Oak Community Recreation Center (CRC) includes a public meeting space with a kitchen and other amenities in a park setting (*Figure 4*). This 33,000 square foot building, located on parkland, opened in June of 2012. The CRC layout includes a community room and kitchen equivalent to the PAB function in addition to the following services: Gymnasium, Exercise Room, Senior/Community Lounge, Arts/Kiln Room, Game room, Conference Room, and Activity Room.
