Tree Protection Fence Detail

Greenman-Pedersen, Inc. 11000 Broken Land Parkway, Sui

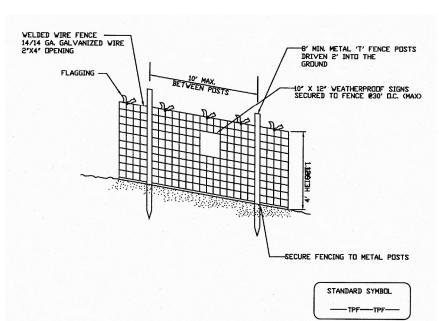
- 1. Practice may be combined with sediment control
- 2. Location and limits of fencing should be coordinated in field with arborist.
- Boundaries of protection area should be staked prior to installing protective device.
- Root damage should be avoided.
- Protection signage is required. Fencing shall be maintained throughout

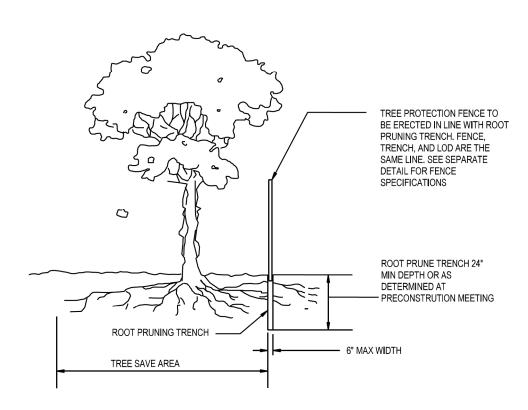
1. RETENTION AREAS WILL BE SET AS PART OF THE REVIEW PROCESS AND PRECONSTRUCTION 2. BOUNDARIES OF RETENTION AREAS MUST BE STAKED AT THE PRECONSTRUCTION MEETING

AND FLAGGED PRIOR TO TRENCHING. 3, EXACT LOCATION OF TRENCH SHALL BE DETERMINED IN THE FIELD IN COORDINATION WITH
