#### MEMORANDUM

#### **SUBJECT:** Concept Plan for the partial renovation of Dewey Local Park

**STAFF RECOMMENDATION:** APPROVE the Recommended Concept Plan, including the cost estimate.

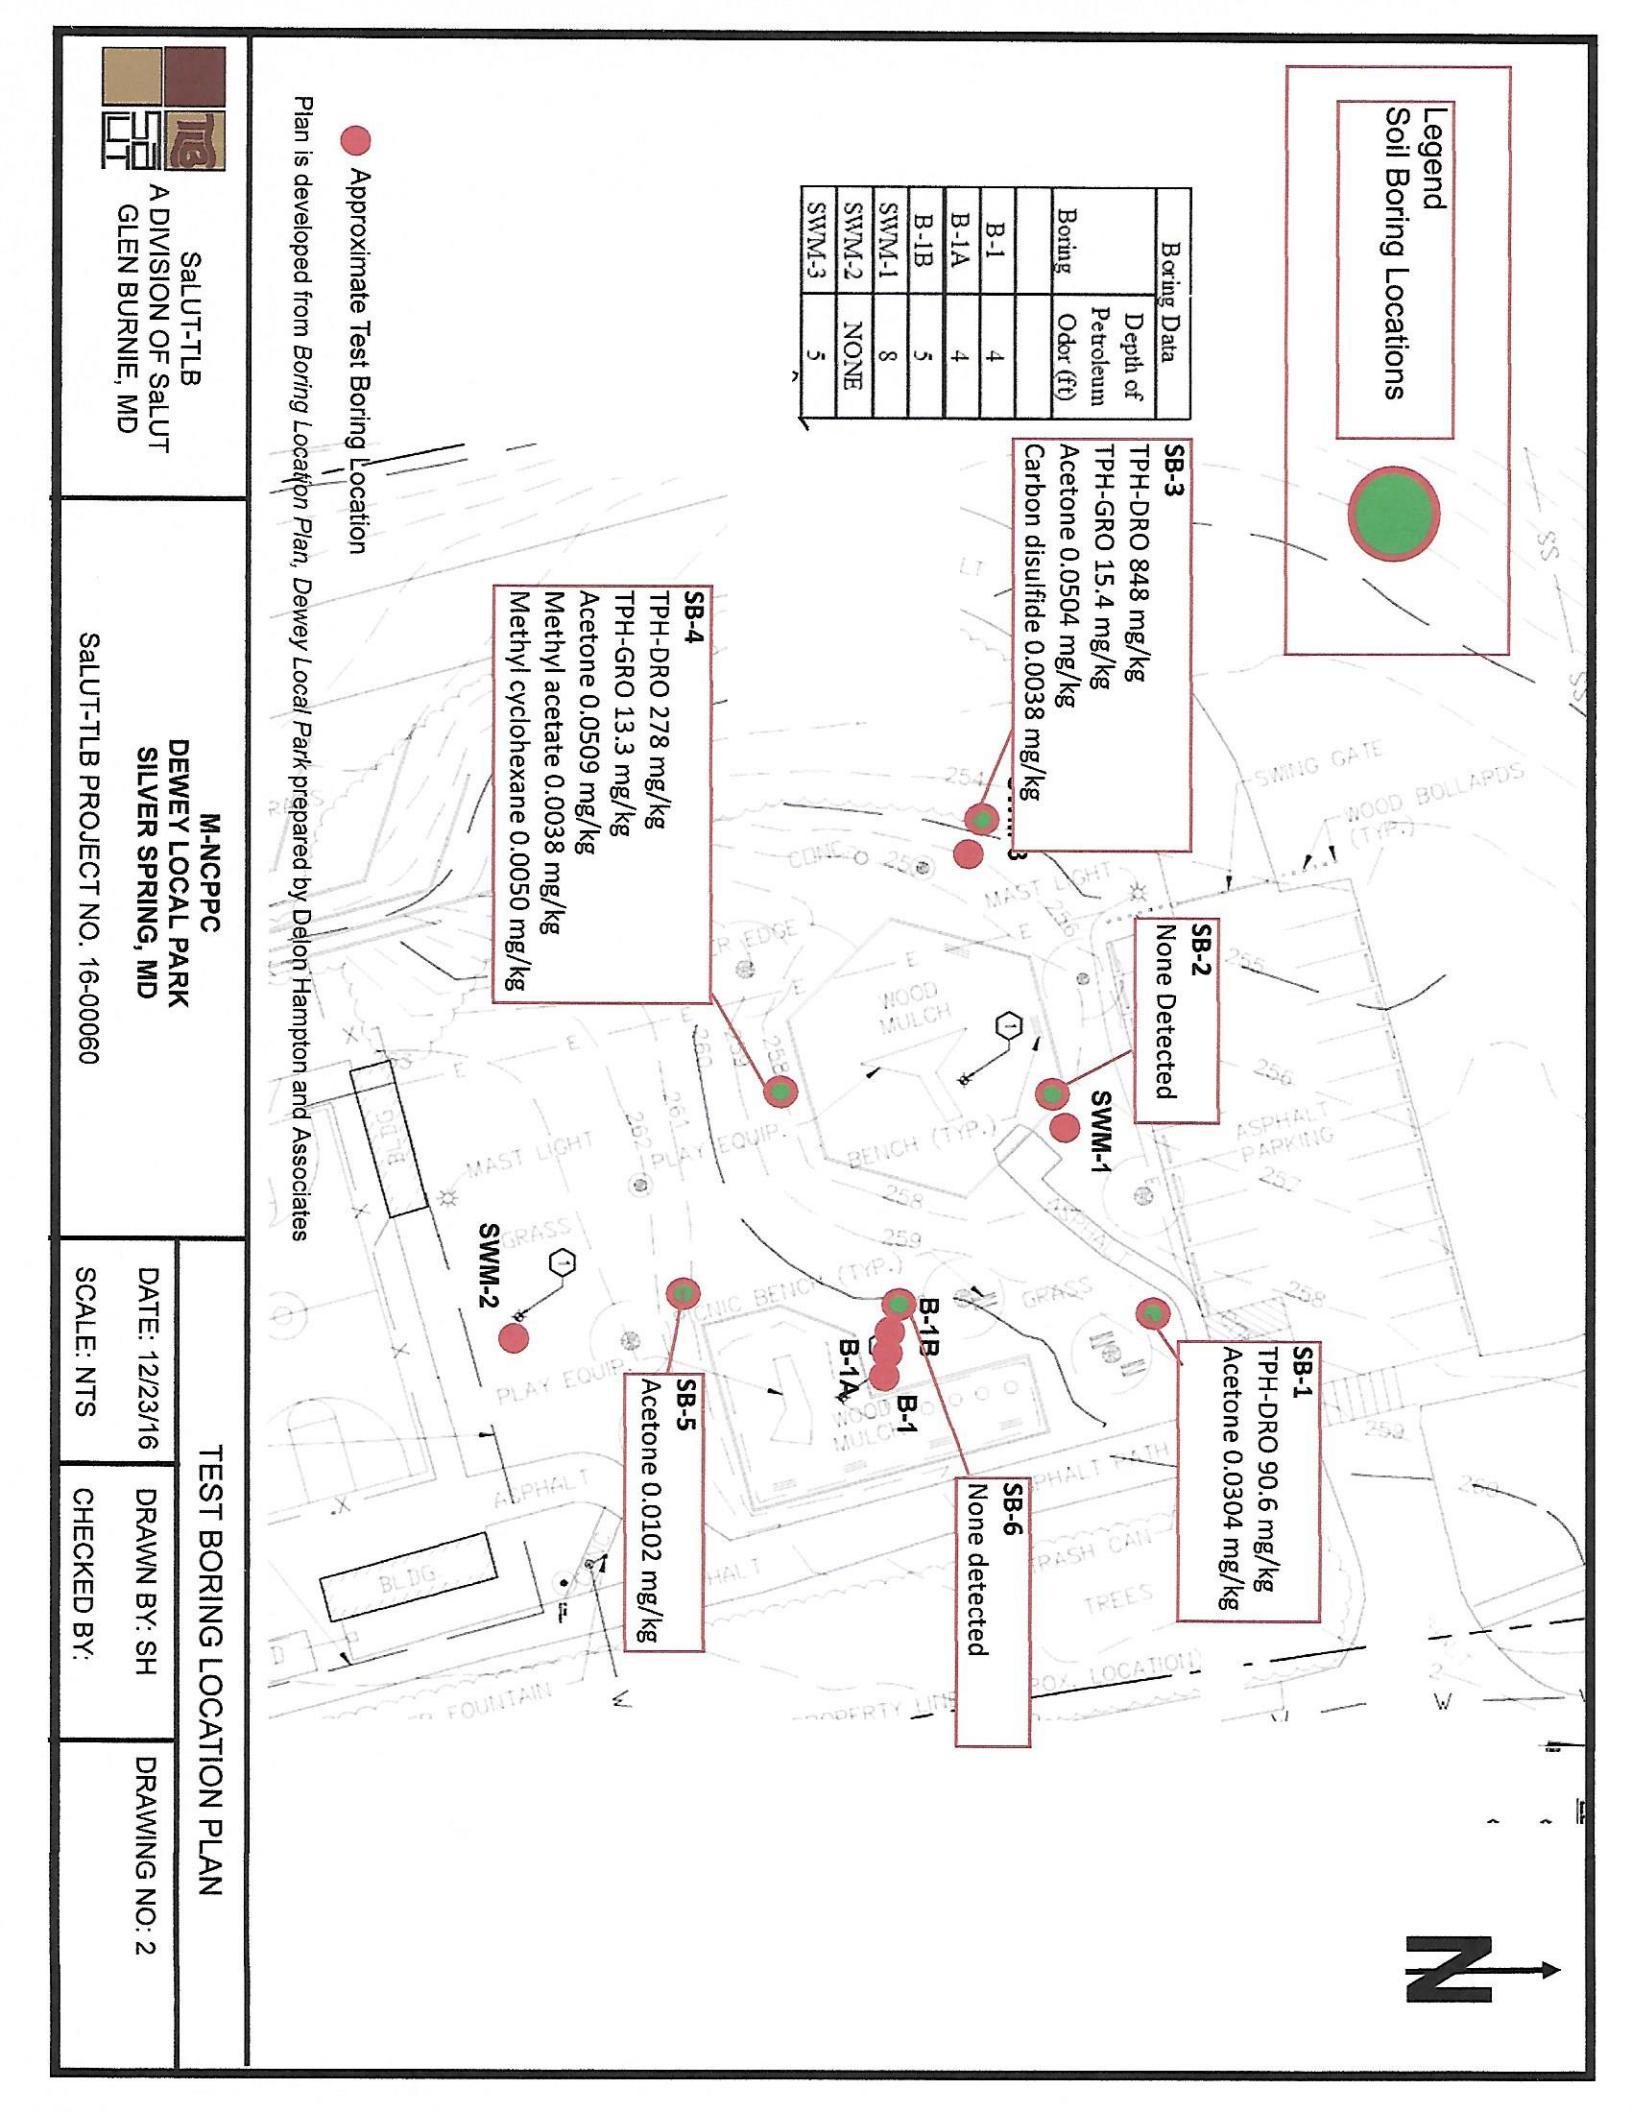
APPENDIX A: Test Boring Location Plan

A total of six soil boring were installed and soil samples were collected from each location. The drill string was advanced to an approximate depth of 12 feet at each location. The rig met refusal at a depth less than 12 feet at 3 locations. Sample locations can be found in Appendix A. Samples were placed into appropriate laboratory prepared containers and kept on ice.

There are detectable levels of TPH-DRO observed in three locations and TPH-GRO at two locations, see Appendix A. The analytical results indicate detectable levels of petroleum constituents in three of the six borings at relatively low concentrations. The soil underlying site at a depth of 4-5' are impacted by a petroleum release. An examination of the current conditions of the site and surroundings did not identify an obvious source for the contaminants. The current Generic Numeric Cleanup Standards (NCS) for Groundwater and Soil adopted by the Maryland Department of the Environment indicate a Total Petroleum Hydrocarbon – Diesel Range Organics (TPH-DRO) for Residential Soil is 230 Parts Per Million (ppm). These samples were collected from 4-5 feet below local grade. The analytical results indicate that SB-3 has a THP-DRO concentration of 848 ppm and the sample from SB-4 has a TPH-DRO concentration of 278 ppm and these are above the NCS.

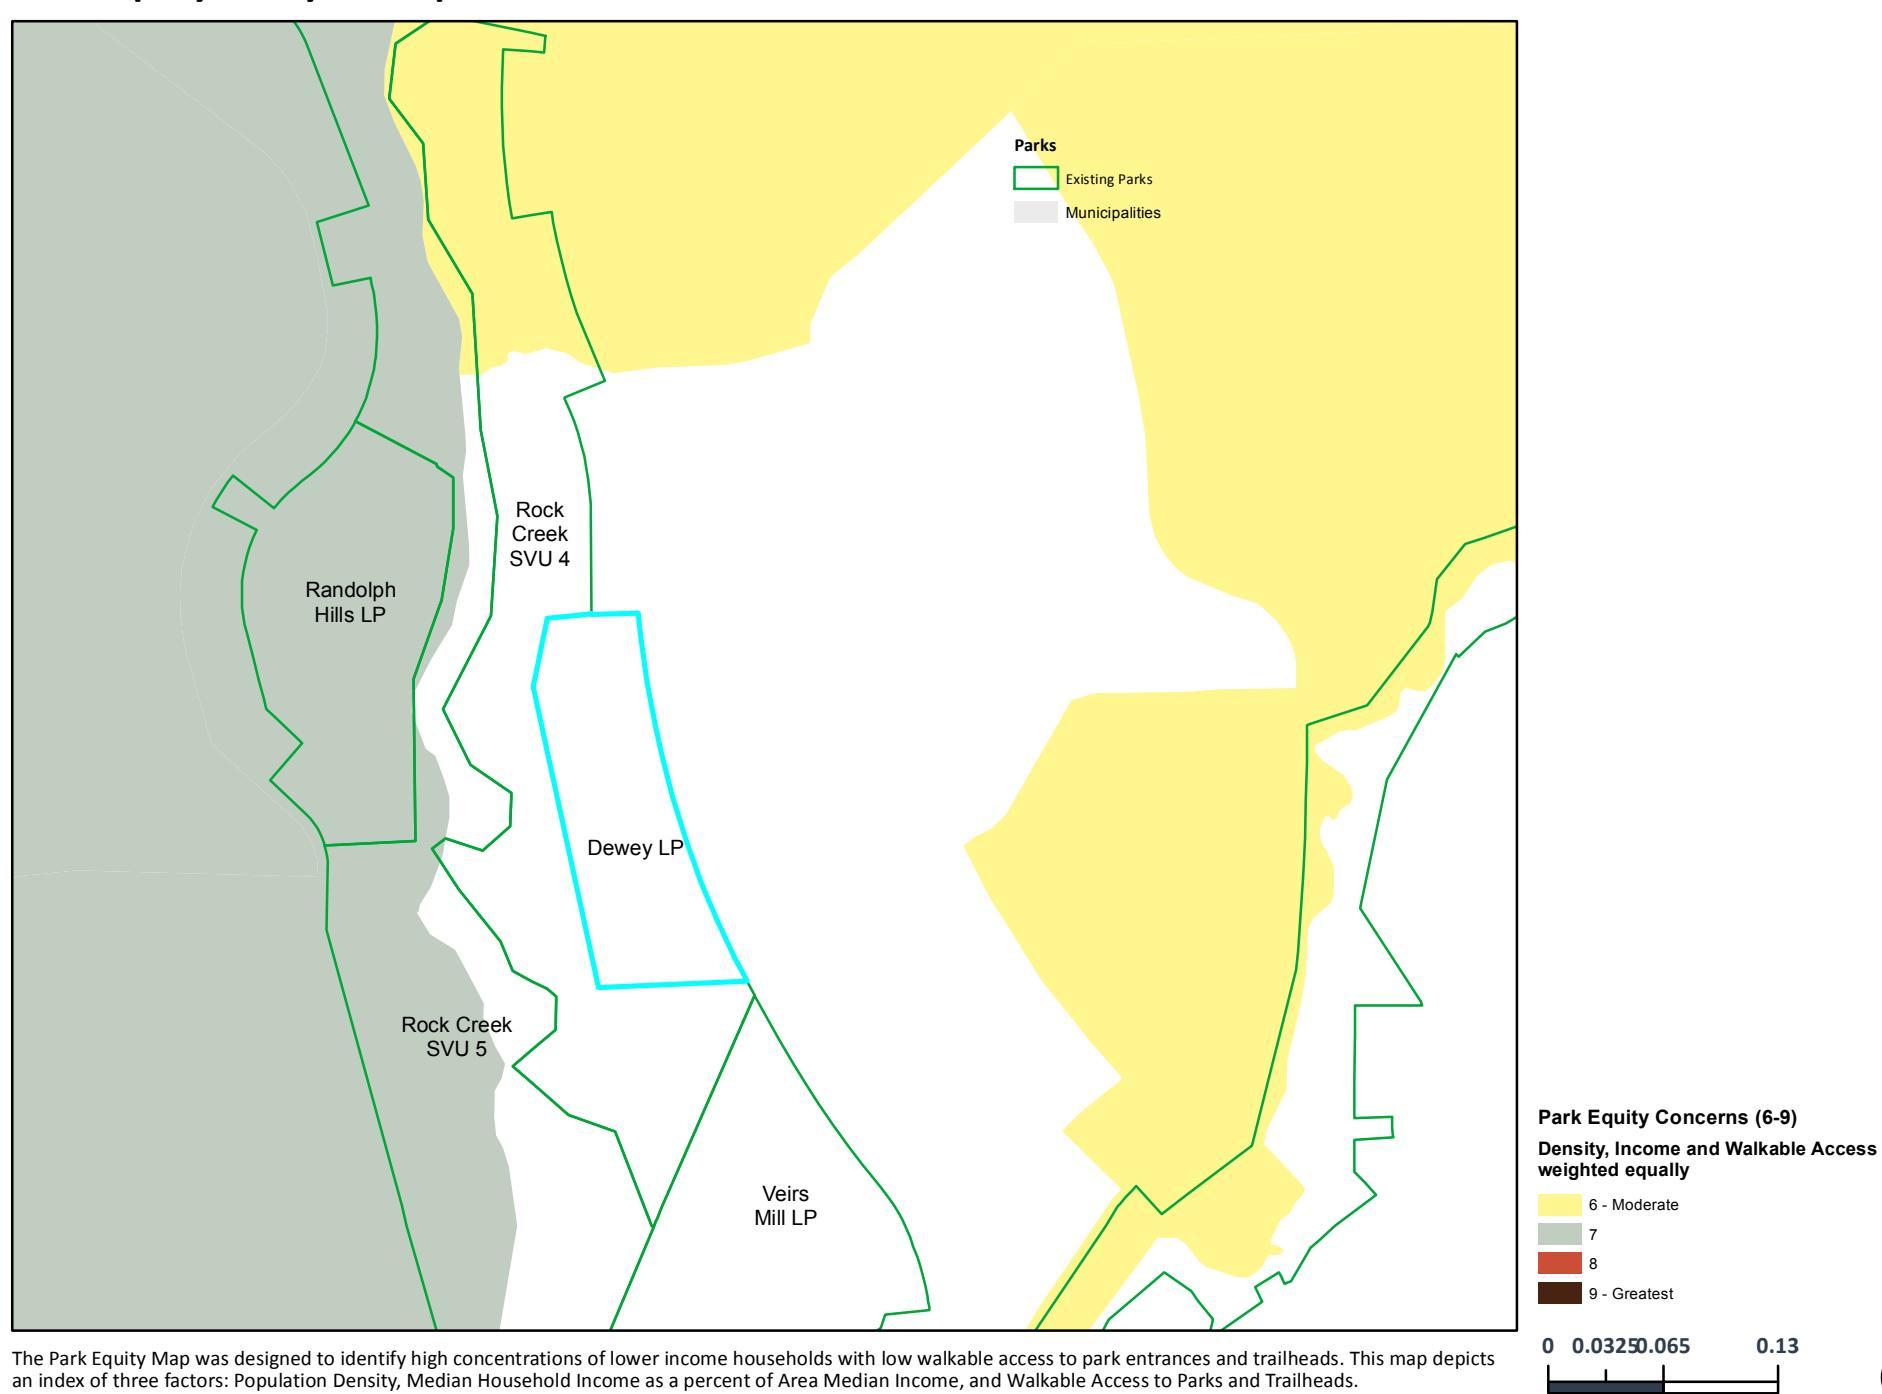
## Park Equity Analysis Map

Based on the Park Equity Analysis Chart in Appendix 4, the Park Equity Analysis area closest to Dewey Local Park, located just to the west, has a value of 7 (refer to Attachment 3). The number was derived as follows:
