Montgomery County Planning Board Public Hearing, Worksession and Action on Locational Atlas Listing of the Worthmiller House (M:35-211), 8104 Woodhaven Boulevard, Bethesda

WORTHMILLER HOUSE

DESIGNATION FORM

JANUARY 2020

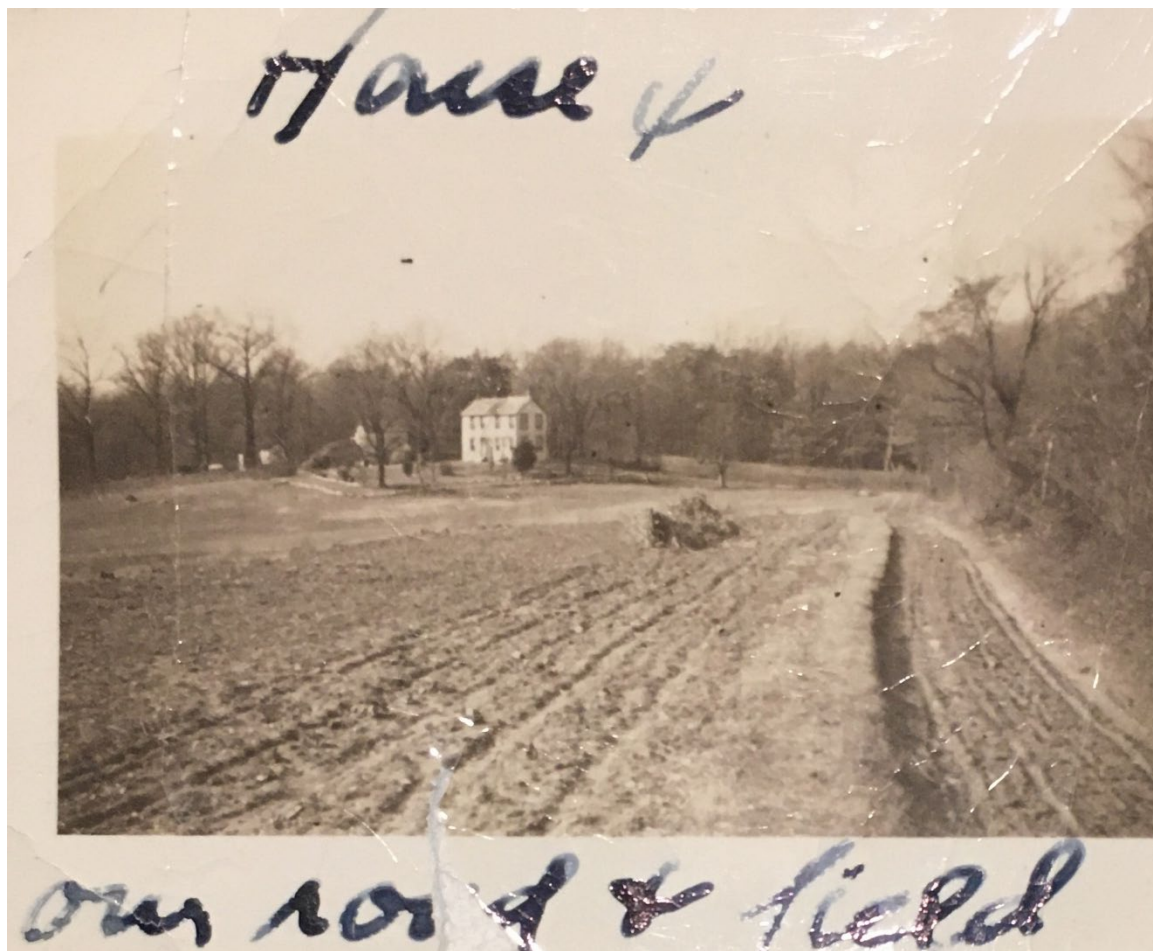
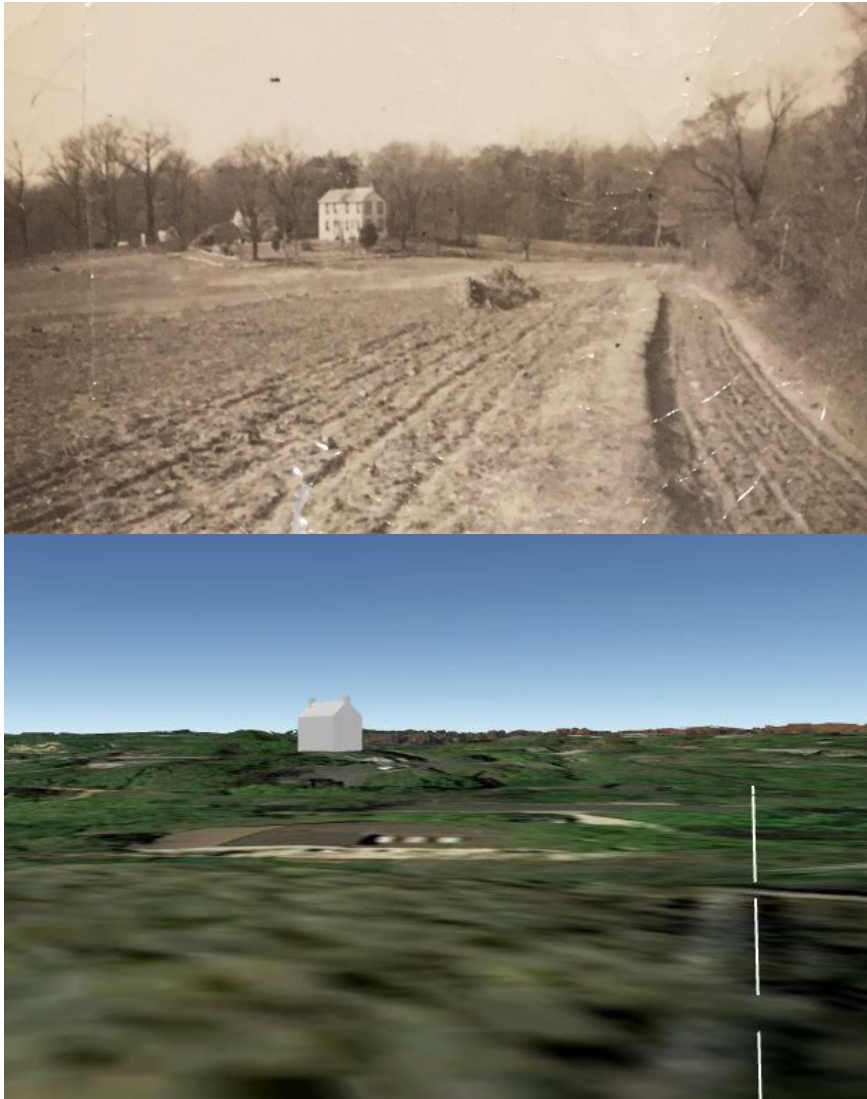
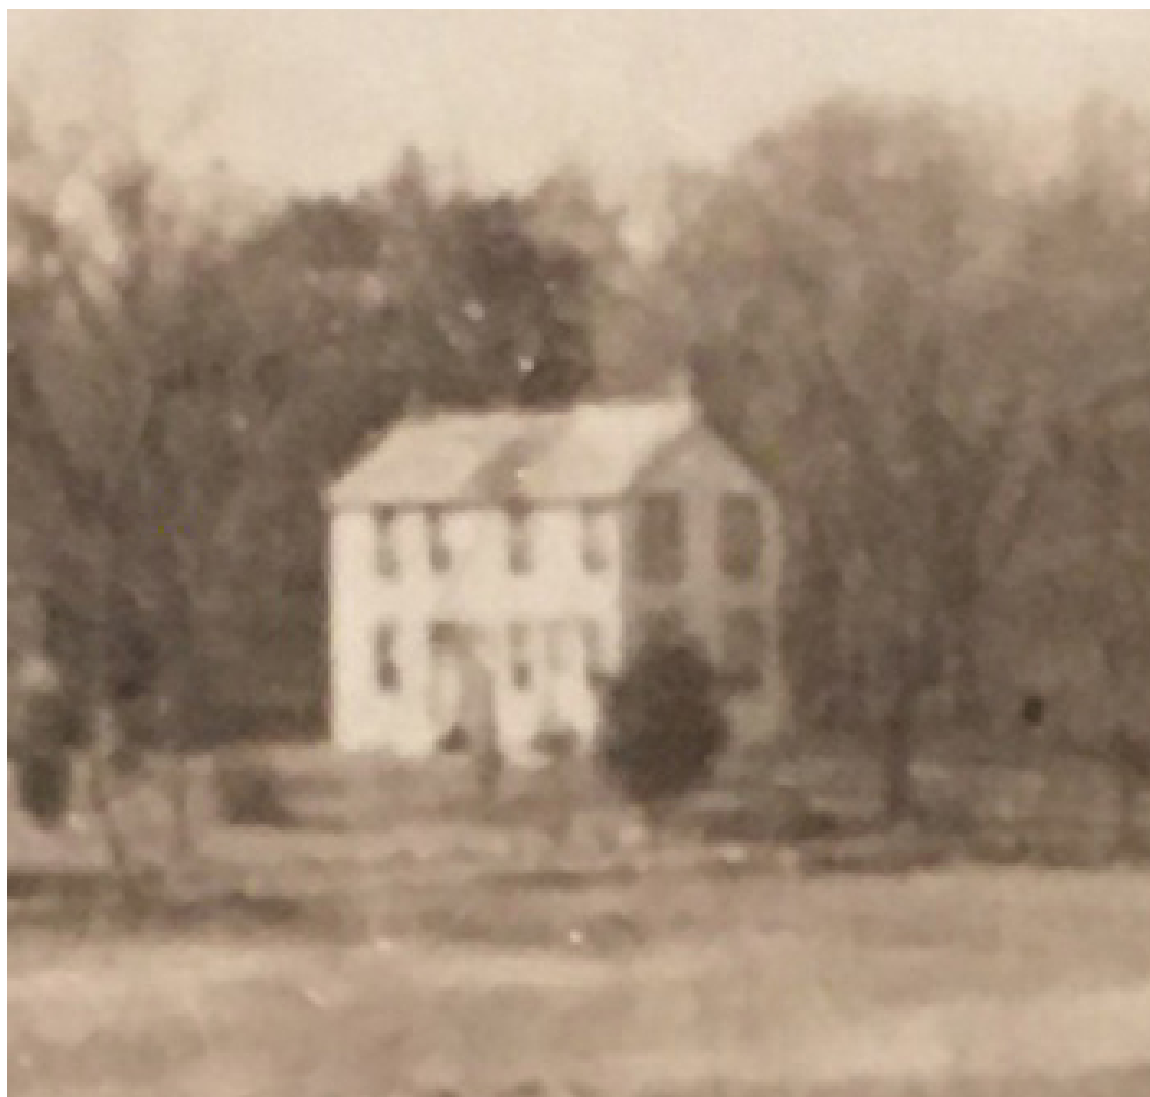
Figure 1: View of 8104 Woodhaven Blvd. looking northwest from the driveway (dirt path) off Wilson Drive, ca. 1937.

Figure 2: View of 8104 Woodhaven Boulevard looking northwest from the driveway off Wilson Lane, ca. 1937, and model of the original side-gable section of the present-day dwelling geolocated in Google Earth. The white line on the model shows the location of the no longer extant driveway (dirt path) recorded on historic maps. The similarities between the location, form, and orientation of the dwelling in these two views supports that the historic photograph shows the original house prior to the 1937 renovation.

Figure 3: View of 8104 Woodhaven Boulevard looking northwest, ca. 1937.
Source: Donald M. Wight.

Built ca. 1857, the original dwelling consisted of a four-bay, single-pile, side-gable, wood-frame dwelling with internal paired end chimneys, which have since been removed (App. 4, Fig. 1 and 3). This section presently rests on a continuous brick foundation that is partially parged with concrete. The foundation supports a wood-frame structural system that is clad with twentieth-century wood siding and capped with a slate-shingled roof. A non-historic, central brick chimney was added concurrent with the construction of the 1937 additions. Fenestration primarily consists of a mid-twentieth-century, single-leaf, wood door with pedimented entry porch; non-historic, double-hung, wood-sash windows; a non-historic, arched window; and two four-over-four, double-hung, wood-sash windows. The original four-bay fenestration pattern is no longer apparent due to significant reconfiguration of window and door openings and the likely reorientation of the façade from the south to the north elevation.

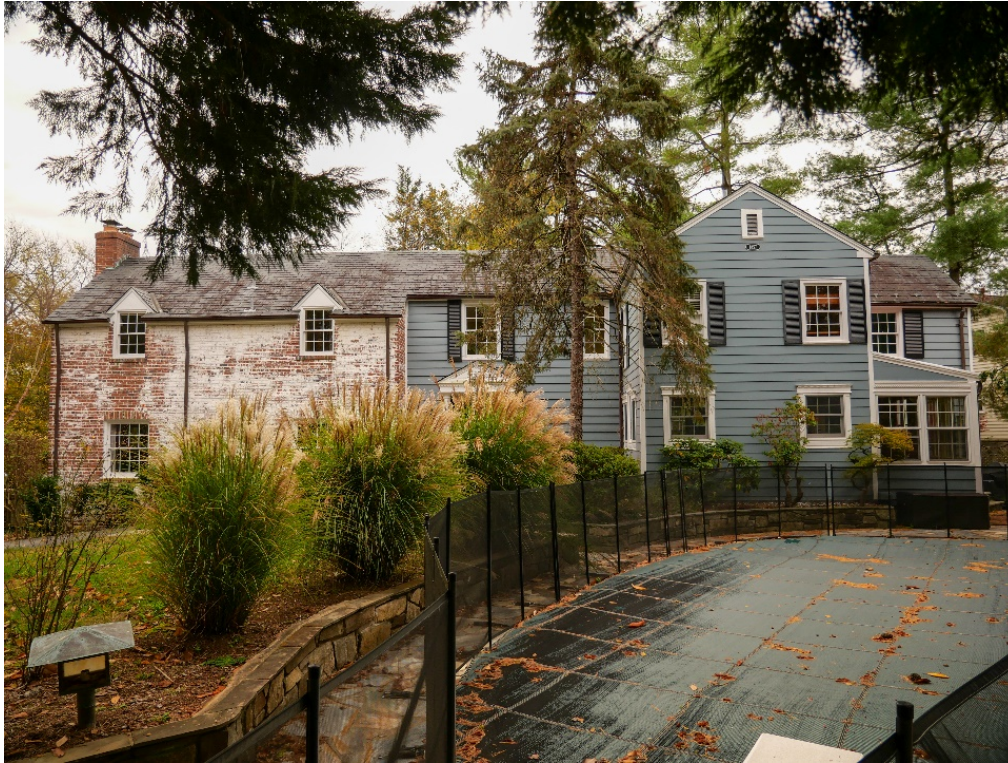
Figure 1: View of the façade (north elevation).

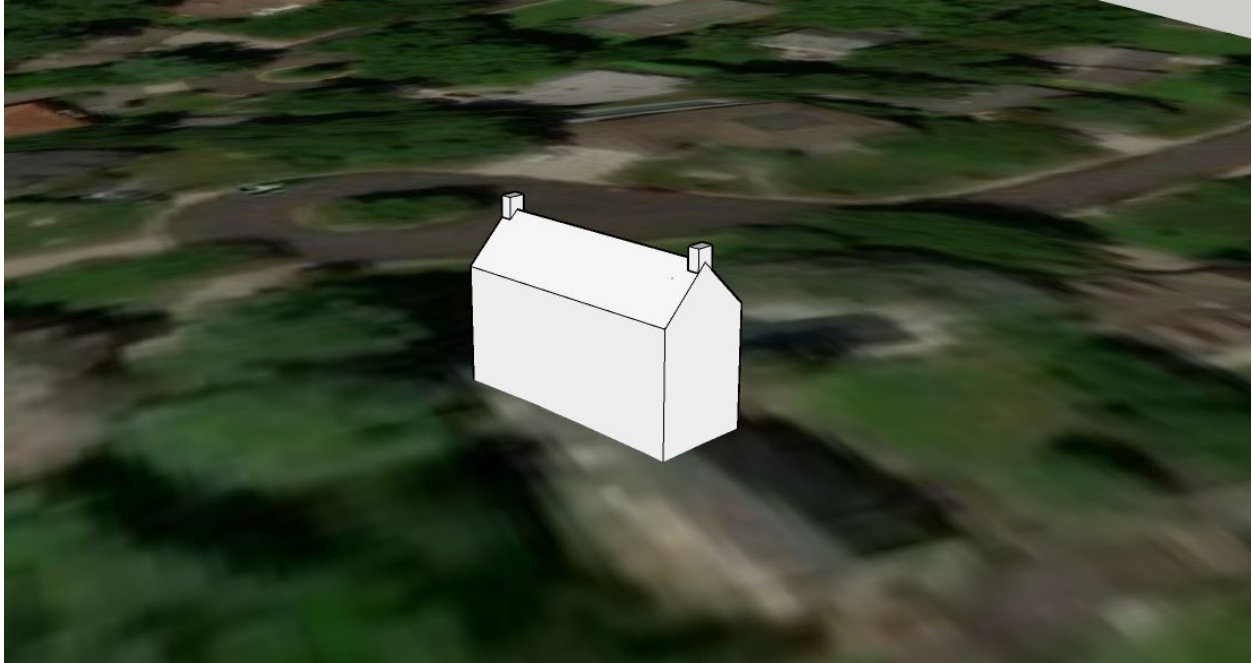
Figure 1: View of the south and east elevations of the original side-gable house, ca. 1857.

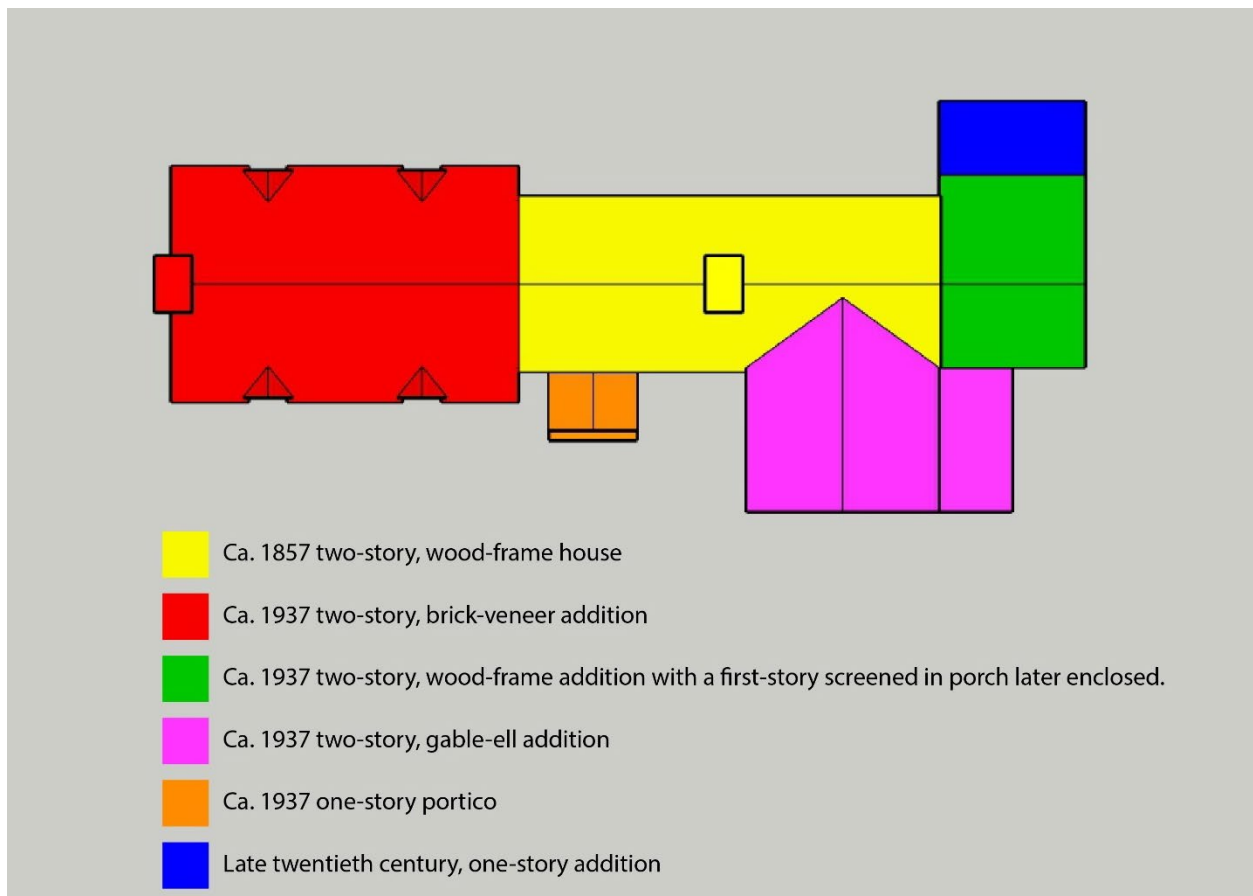
Figure 8: The plan view shows the different sections of the dwelling as described in the architectural description.
