PRELIMINARY STREAM AND WETLAND RESTORATION PLAN

PRELIMINARY PLAN
ASHFORD WOODS
FORMERLY KNOWN AS EGAN PROPERTY
#120200110
CLARKSBURG (2ND) ELECTION DISTRICT, MONTGOMERY COUNTY, MARYLAND

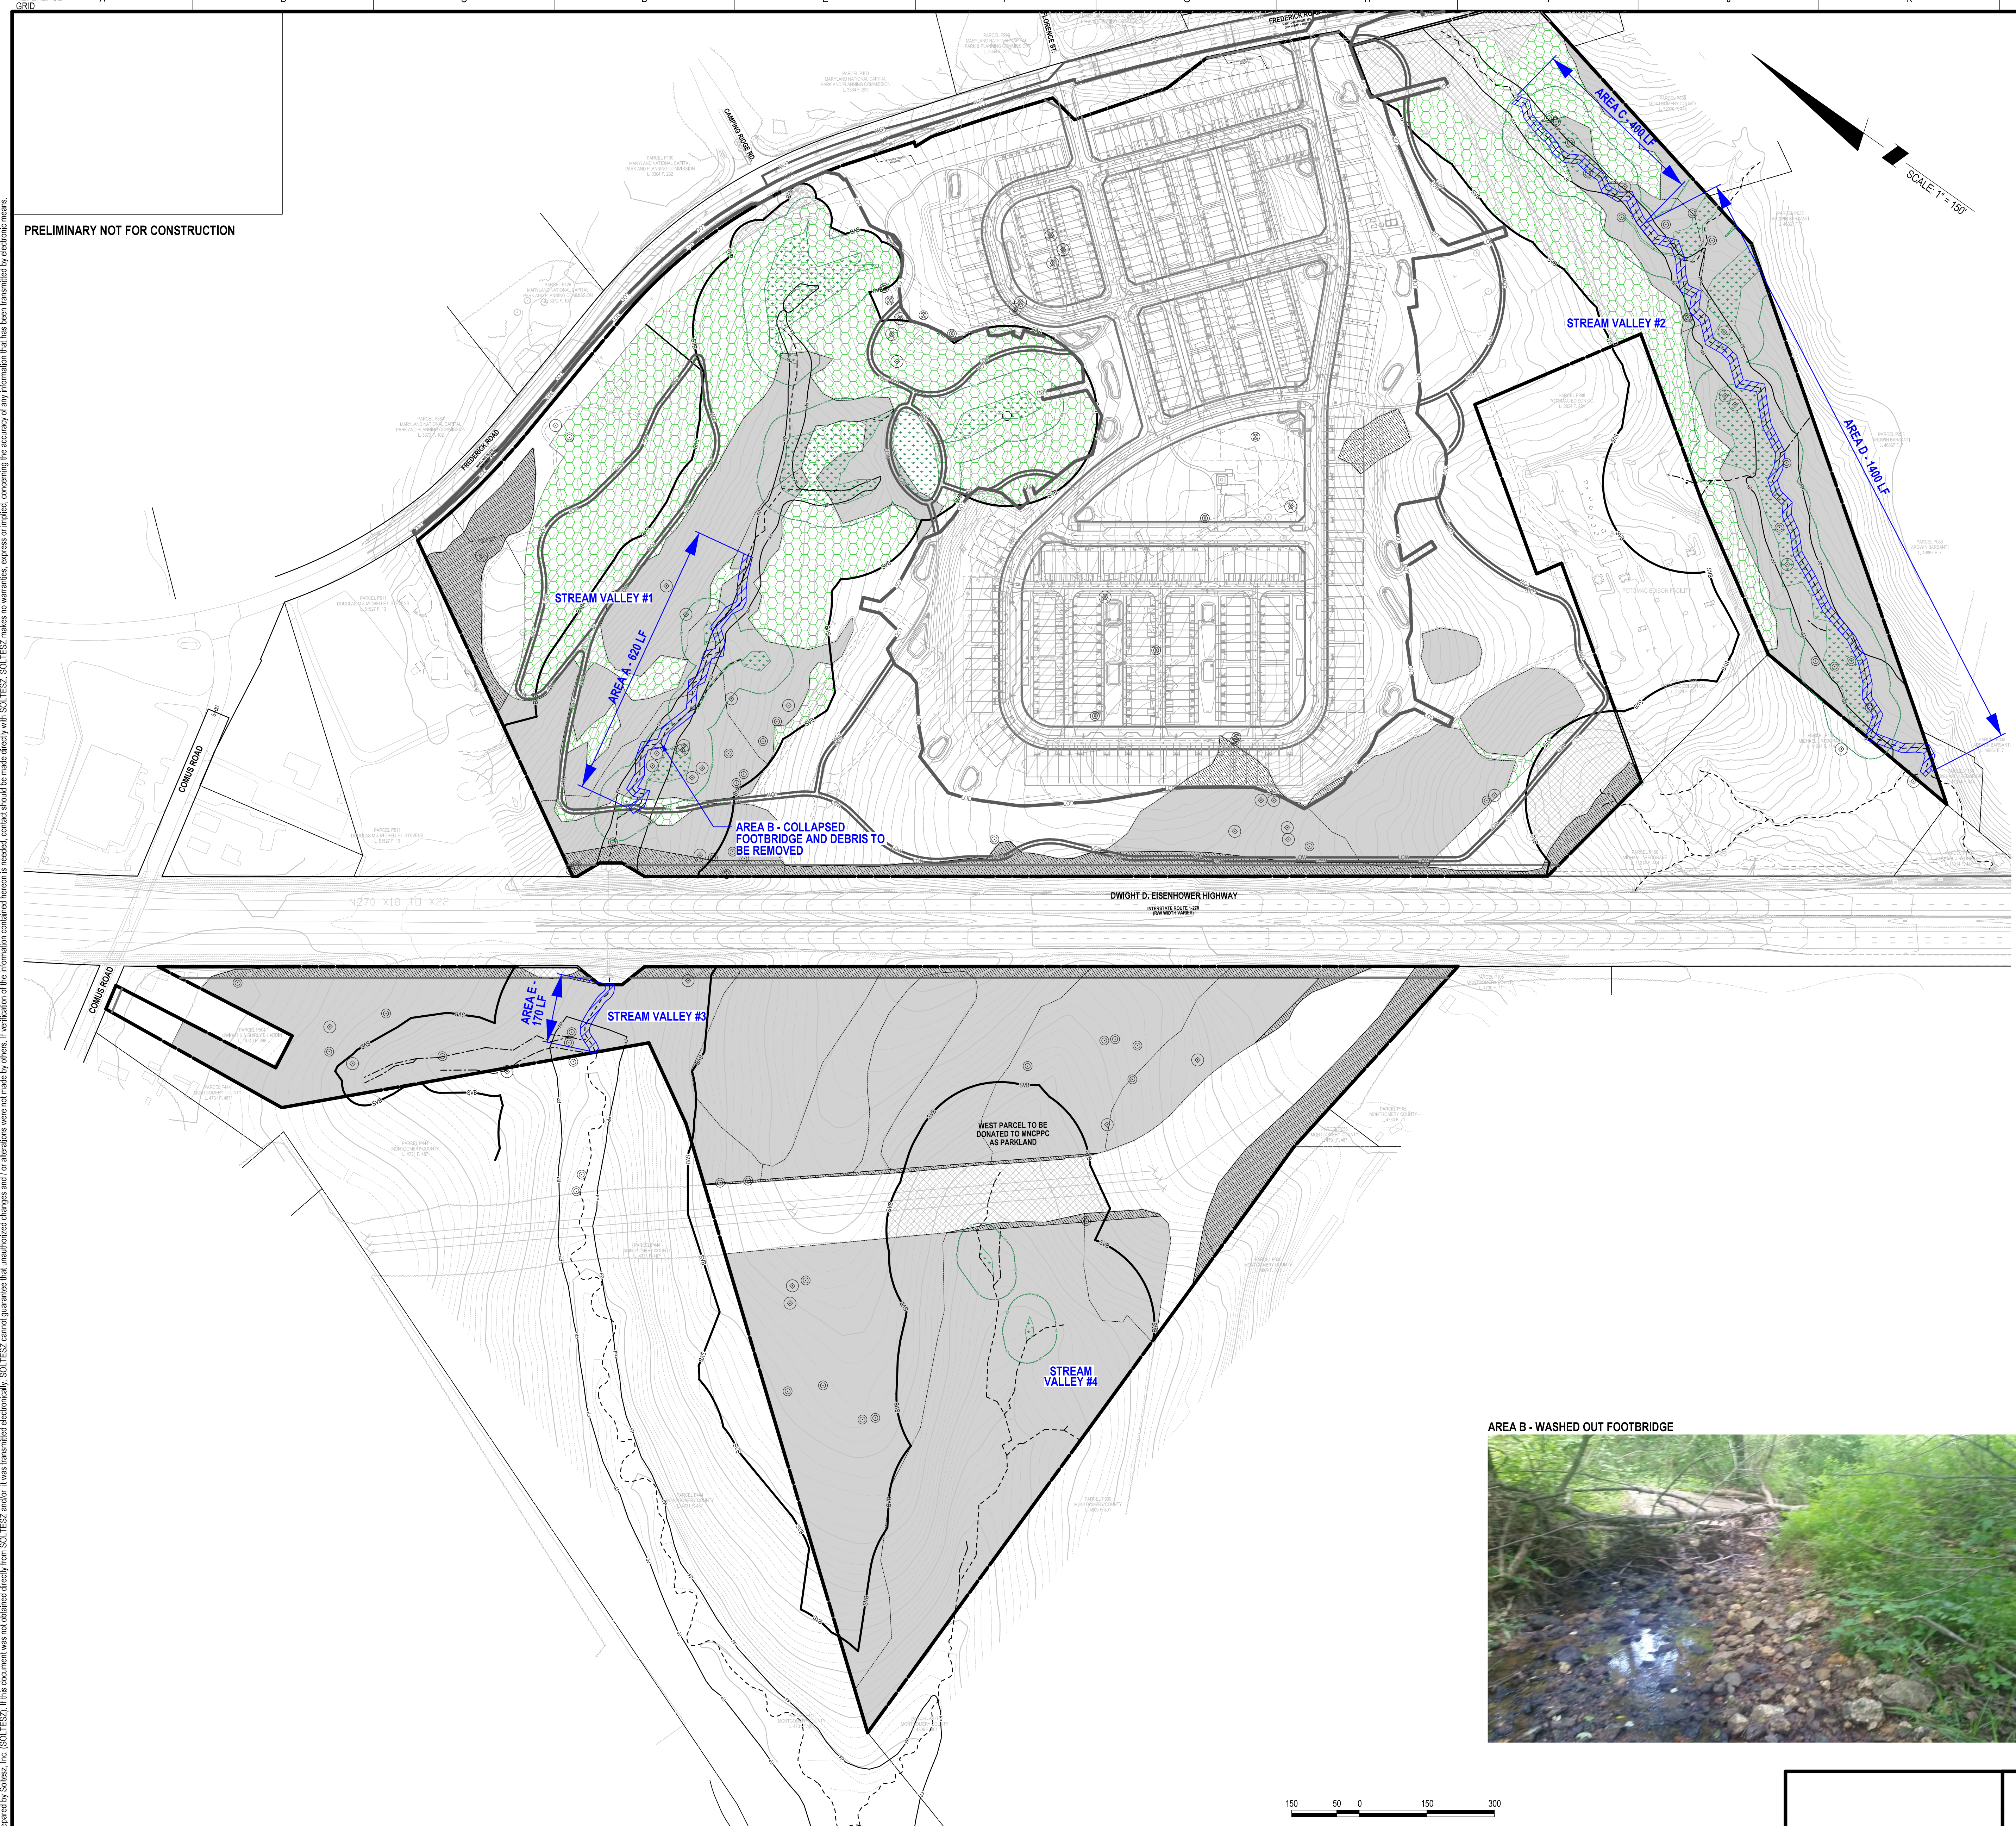
Stream Valley 1- While there are adequate vegetated stream buffers on both sides of the stream channel the entire length of the valley, there are some cleared areas in the buffer where large plastic drums and other construction waste have been placed near the stream channel.

- Area A - 620 LF
Starting approximately 165 LF from the wetland area and extending approximately 620 LF- only localized incision and banks are predominantly clay therefore not susceptible to high erosion. There is an abundance of biological activity in this stream area.
 - o Recommend removal of plastic drums and construction waste located near stream. Revegetate areas where items are removed.
- Area B- Footbridge
Abandoned footbridge has collapsed into widening stream channel causing debris jam.
 - o Recommend removal of failed footbridge and debris in stream channel.

Stream Valley 2- Overall adequate vegetated stream buffers on both sides of the stream channel for the majority of the Stream Valley.

- Area C - 400 LF
Starting approximately 220 LF from the pipe outfall beneath Frederick Road and extending approximately 400 LF- narrow vegetated buffer in some areas, occasional steep banks. *NOTE - This area will be reforested as part of the Forest Conservation Plan for this development to address the narrow vegetated buffer areas.*
 - o Restoration not recommended, area has not been adversely affected by the existing uses of the Subject Property.
- Area D- 1400 LF
Starting at the end of Area C and extending approximately 1400 LF- only localized incision, and channel can access the floodplain during bankfull event. There is a wooded stream buffer of adequate width and an abundance of biological activity in the stream channel.
 - o Restoration not recommended, area has not been adversely affected by the existing uses of the Subject Property.

Stream Valley 3- Overall adequate vegetated stream buffers on both sides of the stream channel the entire length of the valley. (NOTE- Stream Valley 3 is a continuation of Stream Valley 1 on the east parcel)

- Area E-170 LF
Starting from where the stream outfalls from the culvert beneath I-270 and extends to the end of the property approximately 170 LF- only localized erosion in one location. This Stream Valley is forested with gentle slopes, and there is an abundance of biological activity in this stream area.
 - o Restoration not recommended, area has not been adversely affected by the existing uses of the Subject Property.

Stream Valley 4- The wetlands and streams in this area are in good condition.

NOTE:
1. ALL EXISTING FEATURES LOCATED THROUGHOUT THE PROPERTY WILL BE REMOVED. ALL EXISTING FEATURES LOCATED WITHIN THE SVB WILL BE REMOVED AND RESTORED TO PVIOUS CONDITION.
