**STREAM RESTORATION EXHIBIT**

**STREAM AND WETLAND RESTORATION PLAN**  
**ASHFORD WOODS**  
**FORMERLY KNOWN AS EGAN PROPERTY**  
**#820210110**  
CLARKSBURG (2ND) ELECTION DISTRICT, MONTGOMERY COUNTY, MARYLAND

**SWR.01**  
OF 2  
PROJECT NO. 0775-90-00

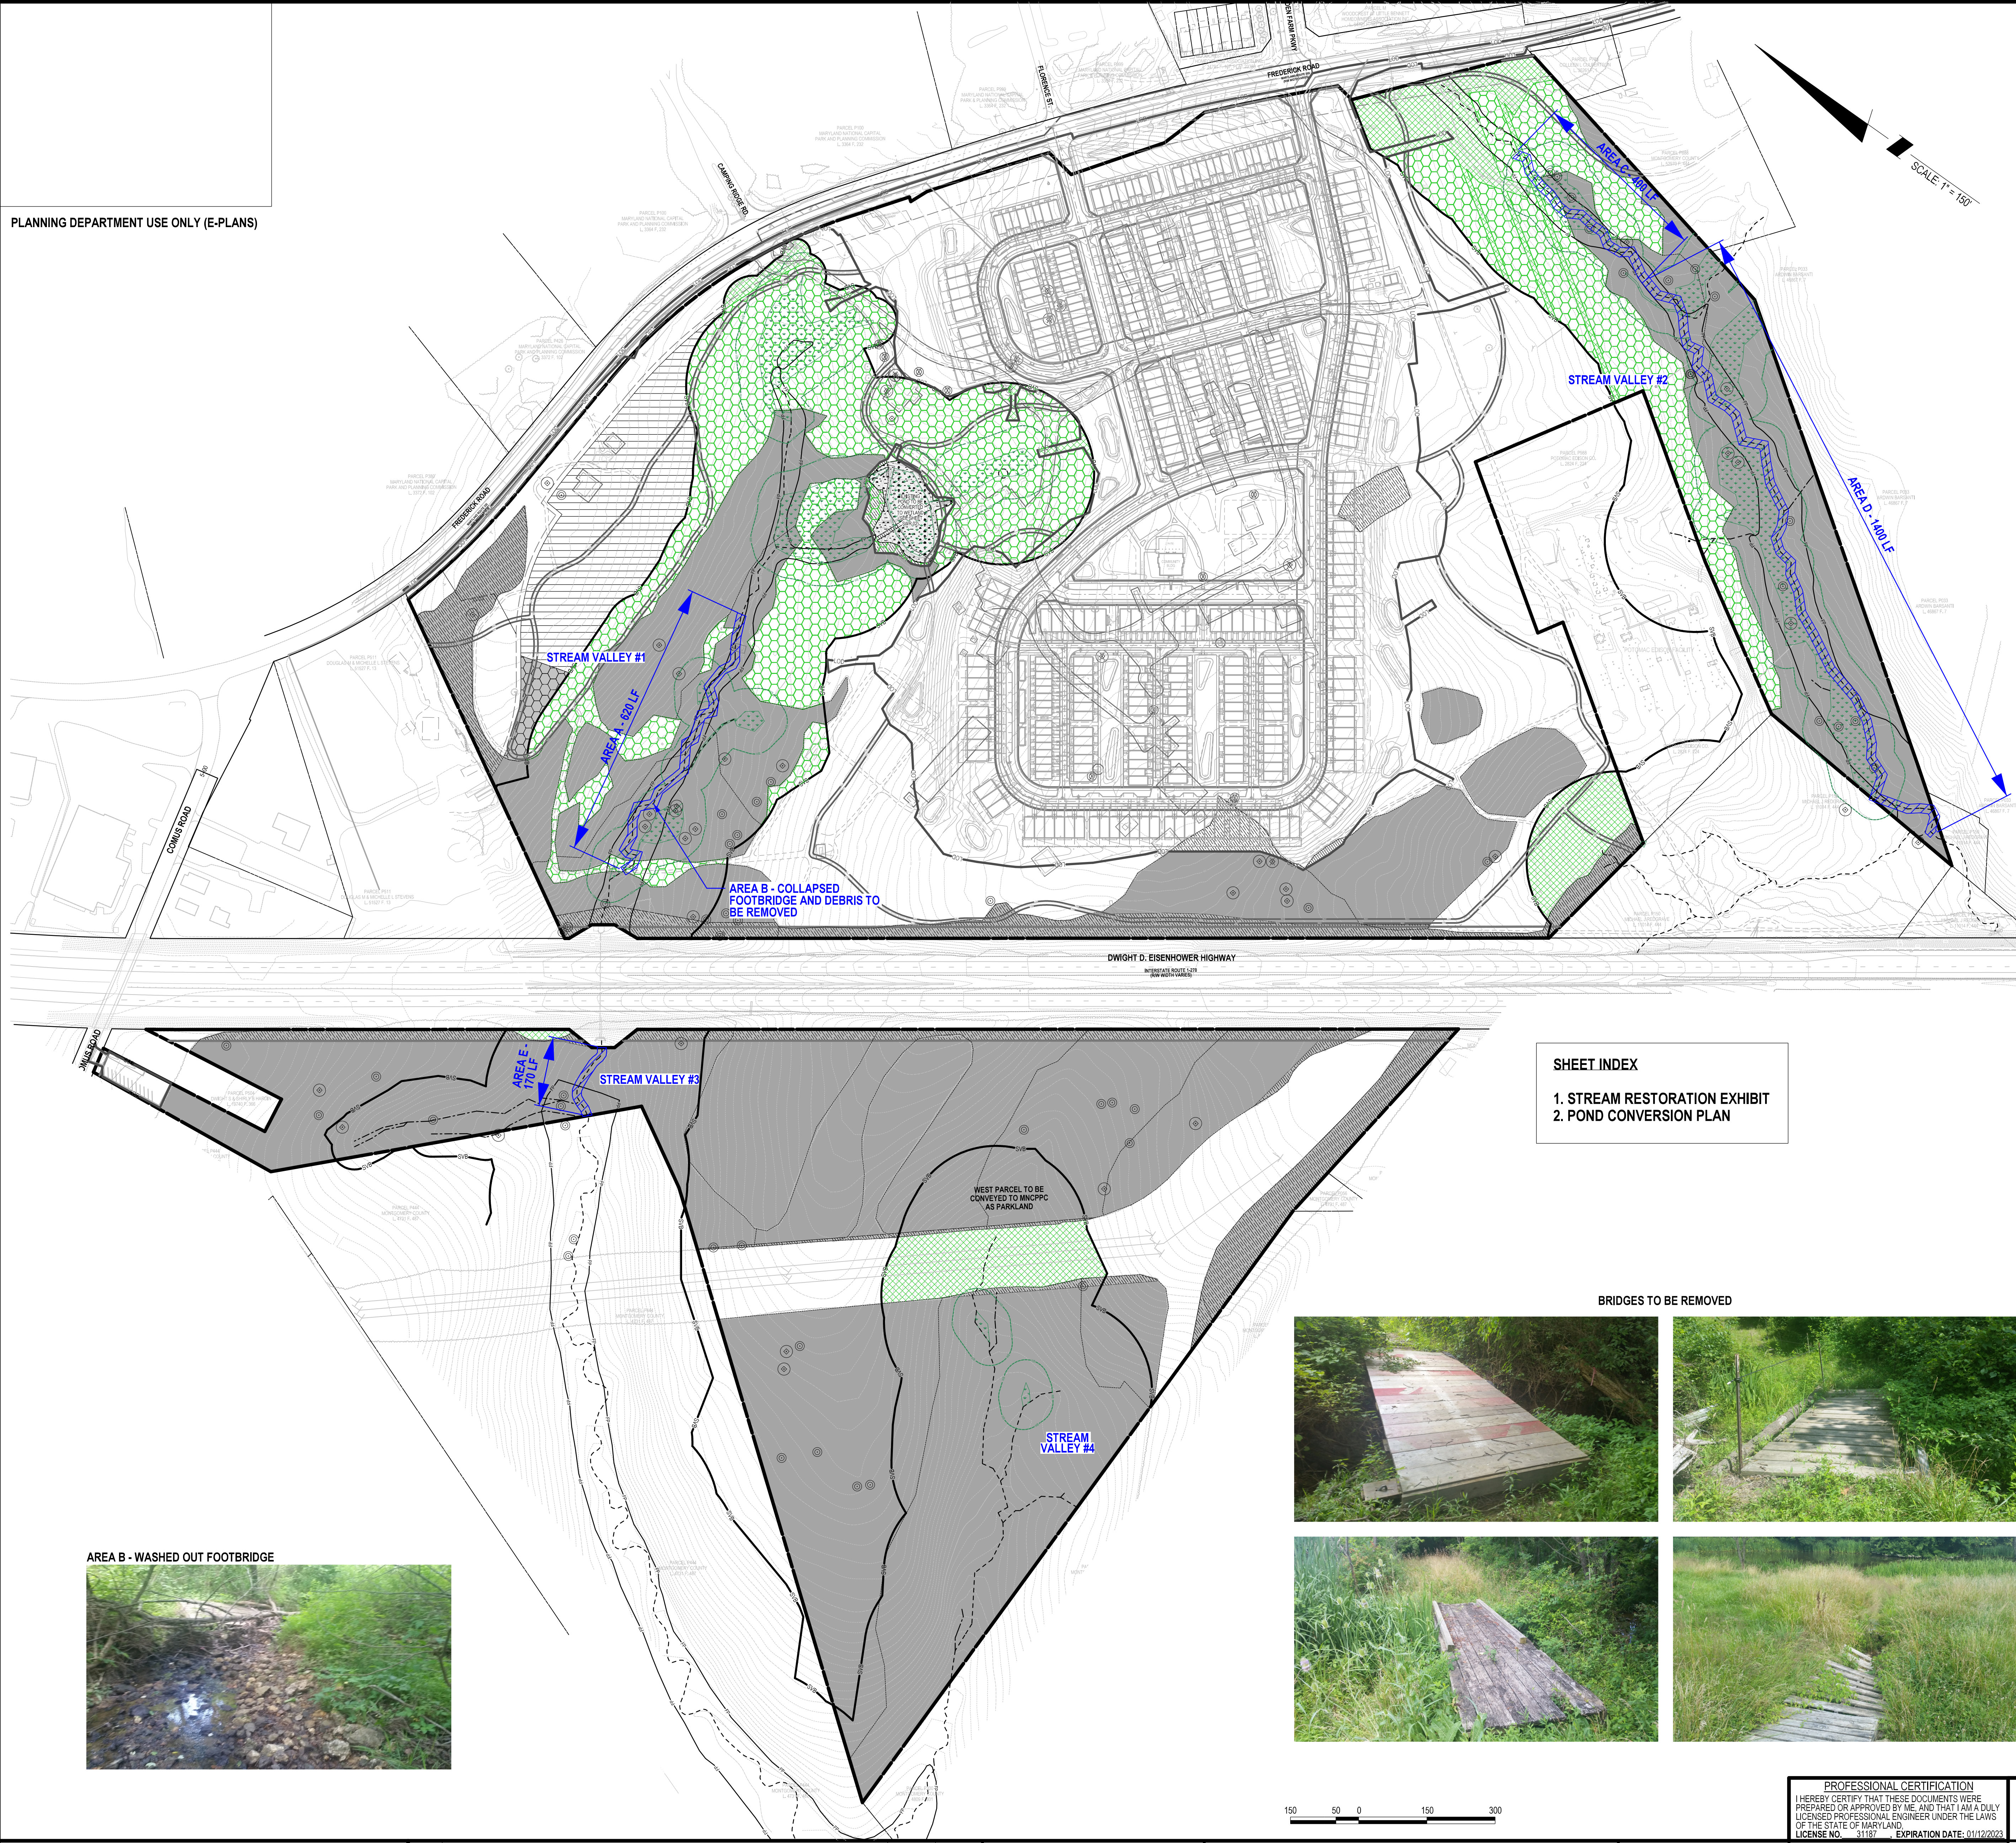
- Stream Valley 1:** While there are adequate vegetated stream buffers on both sides of the stream channel the entire length of the valley, there are some cleared areas in the buffer where large plastic drums and other construction waste have been placed near the stream channel.

- Area A - 620 LF  
Starting approximately 165 LF from the wetland area and extending approximately 620 LF- only localized incision and banks are predominantly clay therefore not susceptible to high erosion. There is an abundance of biological activity in this stream area.

- Area C- 400 LF  
Starting approximately 220 LF from the pipe outfall beneath Frederick Road and extending approximately 400 LF- narrow vegetated buffer in some areas, occasional steep banks. *NOTE - This area will be reforested as part of the Forest Conservation Plan for this development to address the narrow vegetated buffer areas.*

- Restoration not recommended, area has not been adversely affected by the existing uses of the Subject Property.
  - Area D- 1400 LF  
Starting at the end of Area C and extending approximately 1400 LF- only localized incision, and channel can access the floodplain during bankfull event. There is a wooded stream buffer of adequate width and an abundance of biological activity in the stream channel.

- Area E-170 LF  
Starting from where the stream outfalls from the culvert beneath I-270 and extends to the end of the property approximately 170 LF- only localized erosion in one location. This Stream Valley is forested with gentle slopes, and there is an abundance of biological activity in this stream area.

- Recommend removal of plastic drums and construction waste located near stream. Revegetate areas where items are removed.
  - Area B- Footbridge  
Abandoned footbridge has collapsed into widening stream channel causing debris jam.

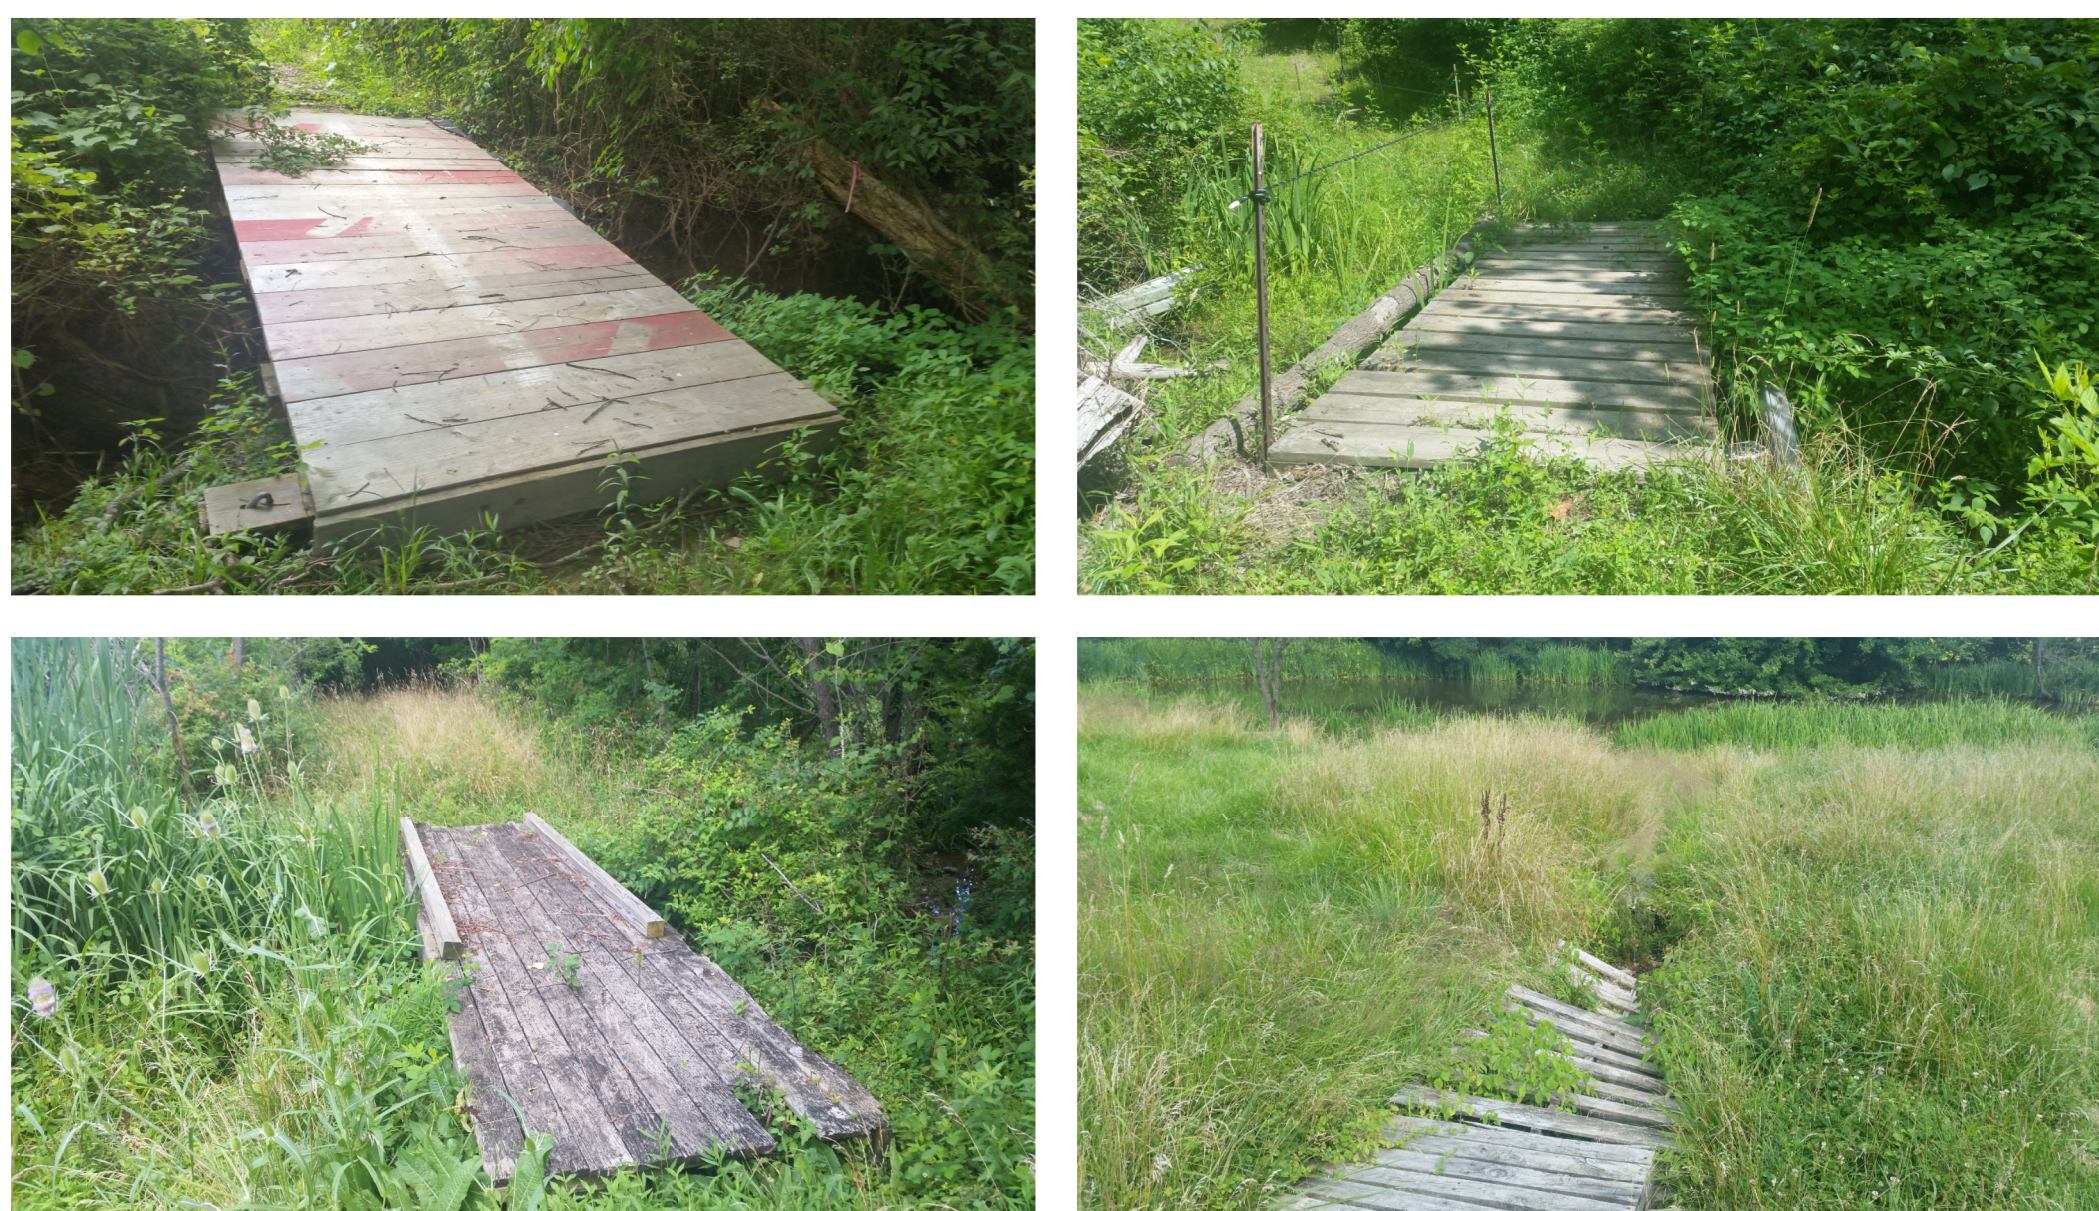
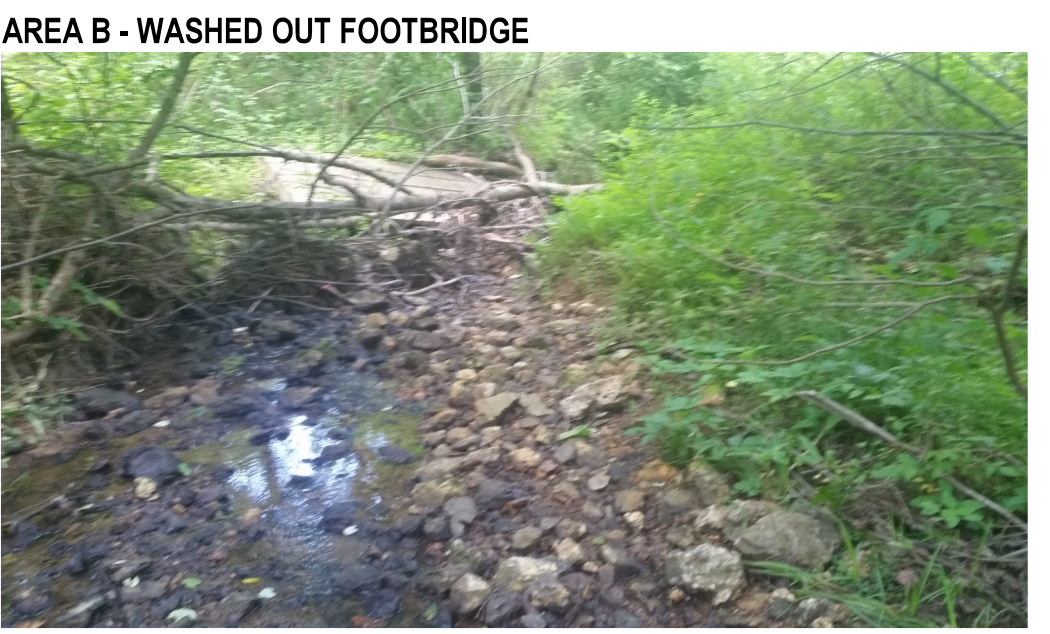
AREA B - WASHED OUT FOOTBRIDGE

BRIDGES TO BE REMOVED

- Recommend removal of failed footbridge and debris in stream channel.
- Stream Valley 2:** Overall adequate vegetated stream buffers on both sides of the stream channel for the majority of the Stream Valley.
